DUMMY HOUSING INSTALLATION (SERVICE CAMPAIGN TX0)

This TSB supersedes bulletin 15-01-015 to include retail vehicles.

Description: This bulletin describes the procedure to install a Dummy Housing to the passenger's seat connector on certain 15MY Genesis (DH) vehicles to seal the connection housing. In the event of water intruding into the interior cabin, an unsealed connector could result in connector pin corrosion.

Applicable Vehicles: Certain 2015 Genesis (DH)

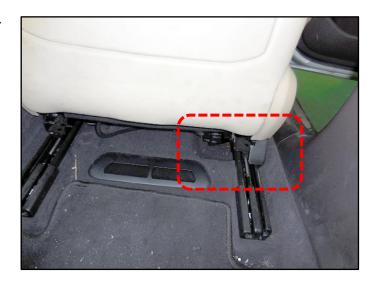
2. Locate the integration connector under the passenger's seat.

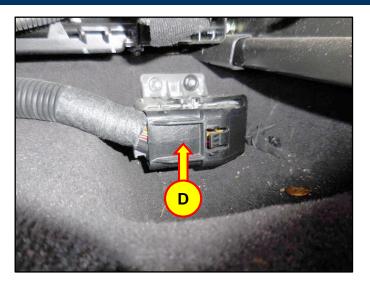
4. Disconnect the integration connector (D).

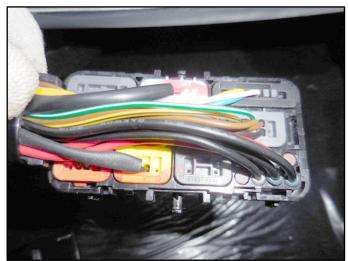
Photo to the right shows correct integration of the dummy housing with connector.

6. Install the dummy housing (F) to the connector. See below for connector diagram.
