**SB-10058466-4337**

**B38 Engine: Mixture Faults Stored in DME and Cylinder Head Cover Leaking Engine Oil**

F56 (Cooper)

With the B38 engine

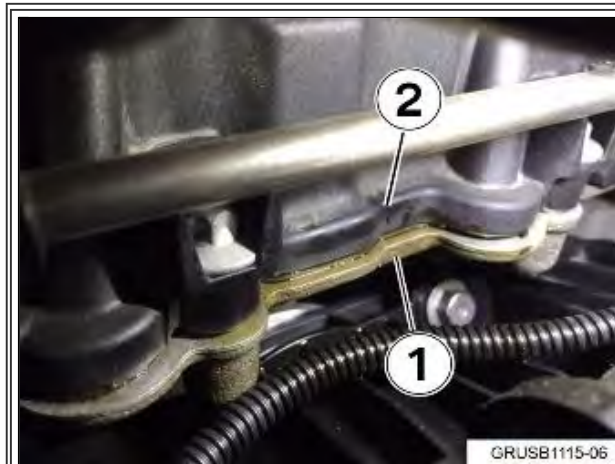
Engine oil leak (1) from the front edge of the cylinder head cover where it meets the cylinder head (2). In some cases the cylinder head cover gasket material may be bulging out from between the cylinder head cover and cylinder head mating surfaces.

1. Replace the cylinder head cover gasket with P/N 11 12 8 618 515 and the profile gasket for the HPP pump (P/N 11 12 8 618 520) per Repair Instruction 11 12 000, "Removing and installing/sealing cylinder head cover."
2. Replace the engine oil and filter. Do not reset the CBS for engine oil service unless the service qualifies to be performed.

**Note: Do not replace the cylinder head cover.**

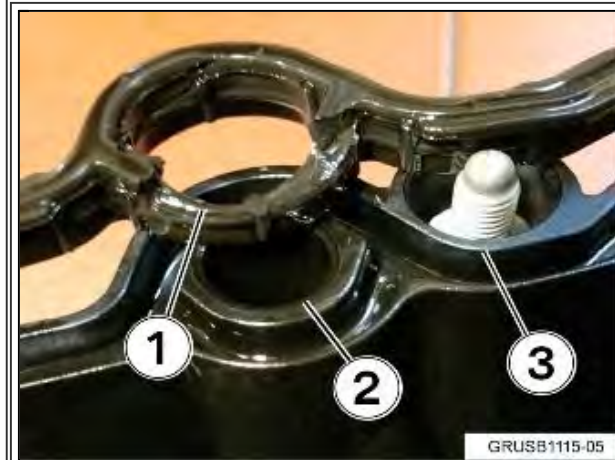
When the cylinder head cover is removed, the cylinder head cover gasket material is damaged (1) near the crankcase ventilation drains (2) or the bolt holes (3).
