SI B12 33 14  
Engine Electrical Systems

March 2015  
Technical Service

**Fault Code 1D2008 Stored in DME**

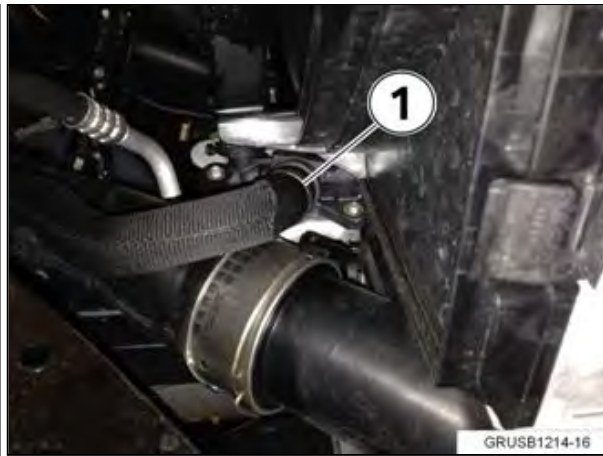
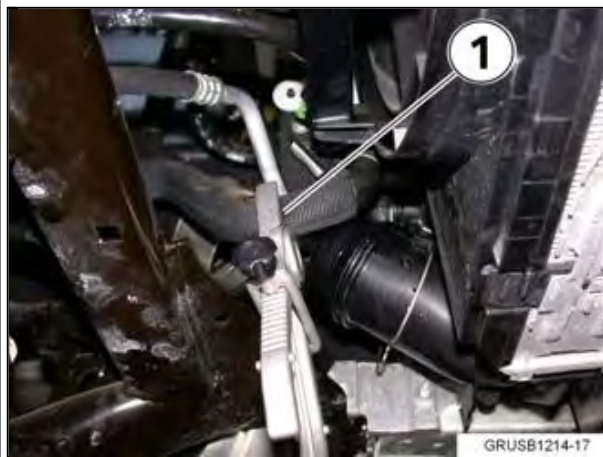
| | <p>Remove the front underbody protection panel (tightening torque of screws is 3Nm) to access the cooling lines to the transmission oil heat exchanger (1).<br/>(Note: All illustrations were taken on an F30 328xi N20).</p> |

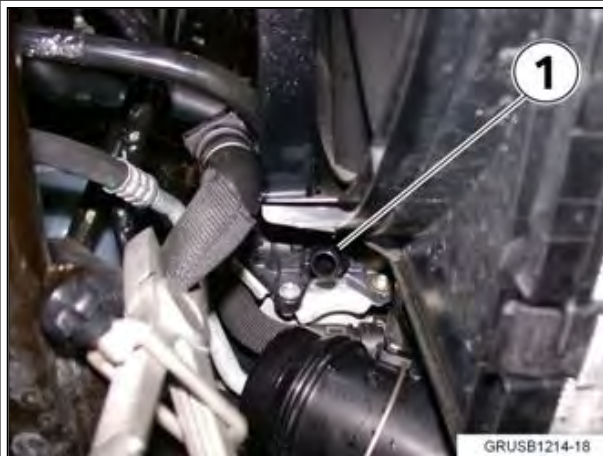
Clamp off the outflow hose (1) on the cooler with special tool 81 64 2 184 117 (SI [B04 07 11](#)). The outflow hose is the softer (rubber) of the two cooling lines on the heat exchanger.

After clamping, remove the outflow hose from the heat exchanger (1).

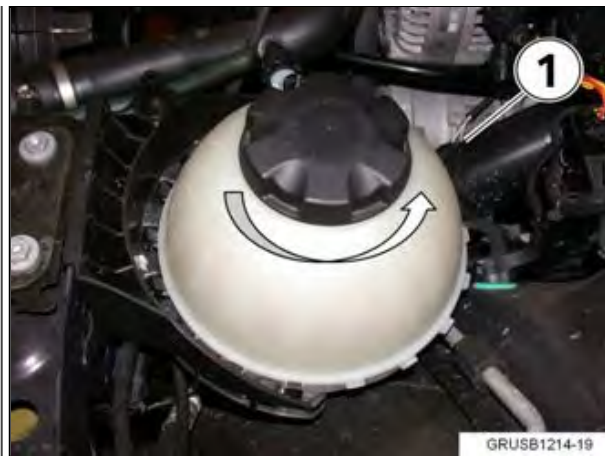
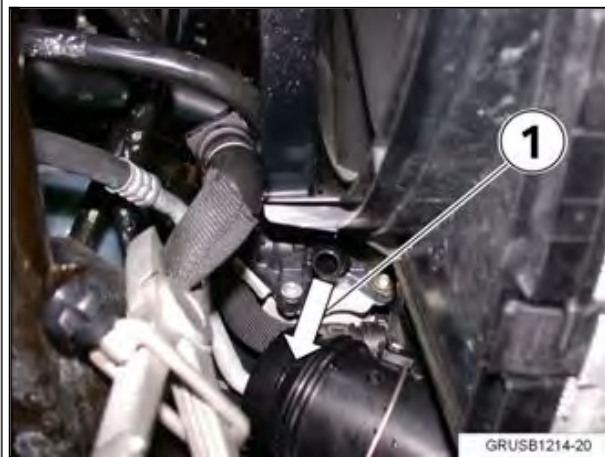
Loosen the cap on the coolant expansion tank (1).

**If any coolant starts leaking out of the transmission heat exchanger (1), the internal thermostat is jammed and the heat exchanger will need to be replaced. Follow Repair Instruction RA 17 22 010, “Removing and installing/replacing transmission oil cooler for automatic transmission (N20, N26, N55).”**

If there is **no coolant loss** out of the heat exchanger, replace the engine coolant thermostat.
