WIND OR WHISTLE NOISE FROM EXTERIOR MIRROR(S) AT HIGHWAY SPEED

TSB 15-0130

2013-2016 Escape

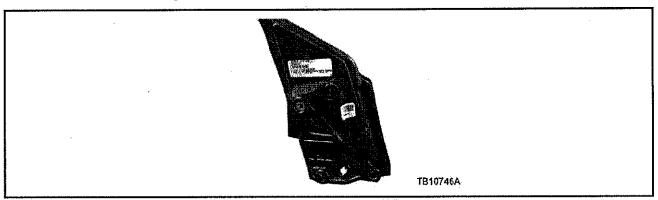
Figure 1 - Article 15-0130

- 1. Remove the suspected mirror assembly. Refer to Workshop Manual (WSM), Section 501-09.
- 2. Remove the inner sail molded gasket/barrier. (Figure 1)

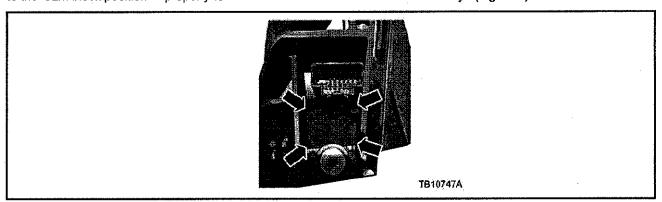
Figure 2 - Article 15-0130

- 3. Inspect the cavity below the electrical connector where the wiring feeds into the mirror head for the presence of a foam block to prevent air flow. Is the foam block present? (Figure 2)
 - a. Yes proceed to Step 4.
 - b. No proceed to Step 5.
- 4. Is the foam block positioned properly to seal off all 4 sides and corners of the cavity? (Figure 2)

- a. Yes this article does not apply. Refer to WSM, Section 501-00 for normal diagnosis.
- b. No properly position the foam block and proceed to Step 6. (Figure 2)
- 5. Install a foam block with locally available material and cut to the following dimensions 30 mm x 45 mm x 50 mm (1 3/16 X 1 25/32 X 1 31/32).
- 6. Reinstall mirror.
