NUMBER: 21-037-15 REV. A

GROUP: Transmission and Transfer Case

Transmission Heater Assembly Reinforcement Plate

2015 (DS)	RAM 1500 Pickup
2015 (DX)	RAM 1500 Pickup (MEXICO)

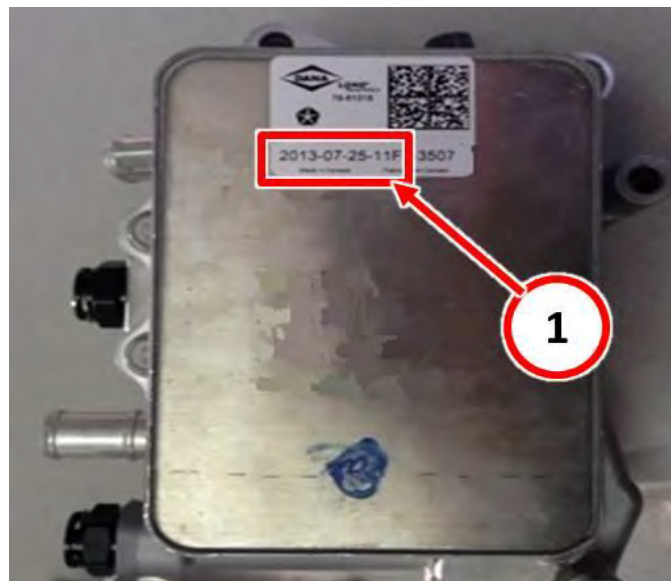
Fig. 1 Transmission Heater Assembly

A small number of customers may notice the presence of transmission fluid in the engine coolant.

1. Raise and support the vehicle on a suitable hoist. Refer to detailed service procedures in DealerCONNECT/TechCONNECT Service Info Section 04 - Vehicle Quick Reference> Hoisting> Standard Procedure.
2. Visually inspect the side casing of the Transmission Heater Assembly to determine the build date.

1 - Build Date Label (yyyy-mm-dd)

-
3. Is the build date on the Transmission Heater Assembly between 2014-12-02 and 2014-12-09?
 - a. Yes >>> Proceed to [Step #4](#).
 - b. No >>> This service bulletin does not apply. Further diagnosis is required including pressure testing of the Transmission Heater Assemblies outside of the build date range above.
 4. Replace the Transmission Heater Assembly. Refer to detailed repair procedures in DealerCONNECT/TechCONNECT Service Info Section 21 - Transmission and Transfer Case> Automatic - 8HP70/845RE> HEATER, Transmission> Removal/Installation.

NOTE: Although rare, if the presence of transmission fluid has been found in the engine coolant, the cooling system must be cleaned. Refer to detailed service information regarding cooling system cleaning and clean the system per current published warranty guidelines and labor times.
