**NUMBER:** 03-003-15**GROUP:** Differential &  
Driveline**DATE:** September 02, 2015

Front Of Vehicle Lateral Vibration During Low Speed Acceleration

2014 - 2015 (KL)

Jeep Cherokee

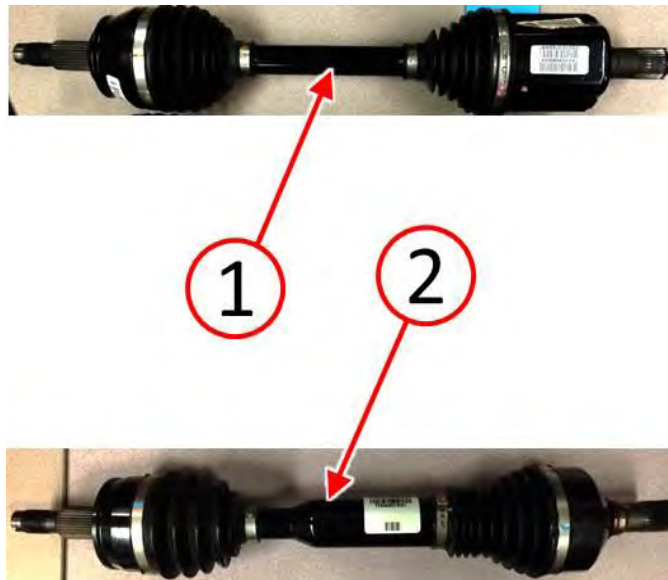
**Fig. 1 Axle Half Shaft Identification**

1. Inspect the front axle half shafts to identify which type is currently installed in the vehicle? Refer to (Fig. 1).
  - a. Straight Diameter Center Shaft (1) (Fig. 1)>>> Continue with the Repair Procedure Step #2.
  - b. Stepped Diameter Center Shaft (2) (Fig. 1)>>> This Bulletin does not apply. Normal diagnosis should be performed.

- 1 - Straight Diameter Center Shaft
- 2 - Stepped Diameter Center Shaft

2. Remove the front half shafts with straight diameter center shaft and replace with the stepped diameter center shaft half shafts listed in this bulletin. Refer to the detailed service procedures available in DealerCONNECT> TechCONNECT under: Service Info> 03 - Differential and Driveline> Half Shaft, Front> Removal/Installation.
