Program Bulletin

SB-10058751-3594

SUBJECT: Potential Fuel Line Interference

MODELS: 2015 Chevrolet Colorado
2015 GMC Canyon
Equipped with 2.5L Engine (LCV) and 4WD

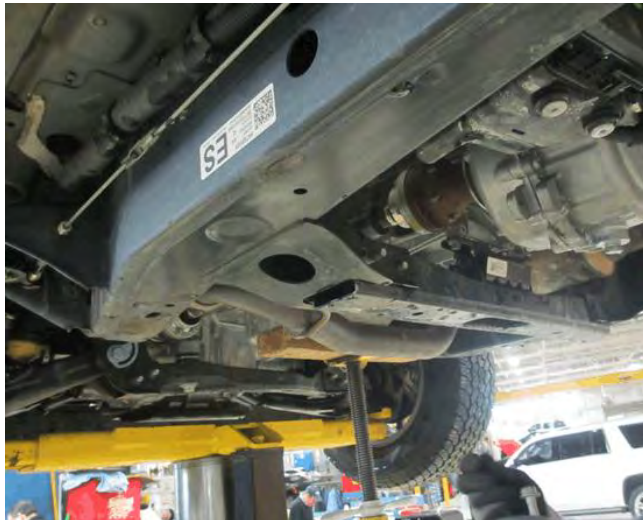
4215375

3. Support the powertrain/transmission with a transmission jack and wood block or equivalent.

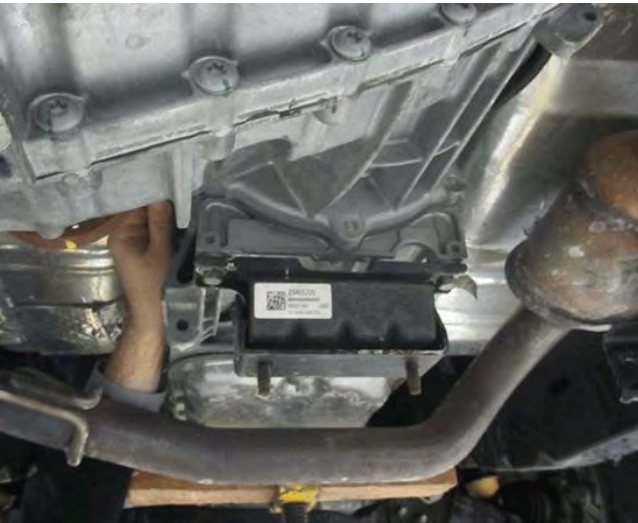
4215377

4. Remove the transmission crossmember from the frame, which includes 4 bolts to the frame and 2 nuts to the transmission mount.

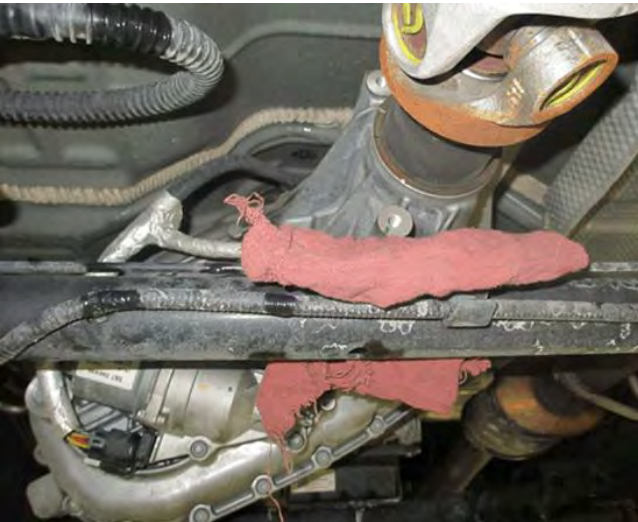
4215379

5. Add a shop towel under the rear of the transfer case for protection when it is lowered to just above the tubular crossmember.

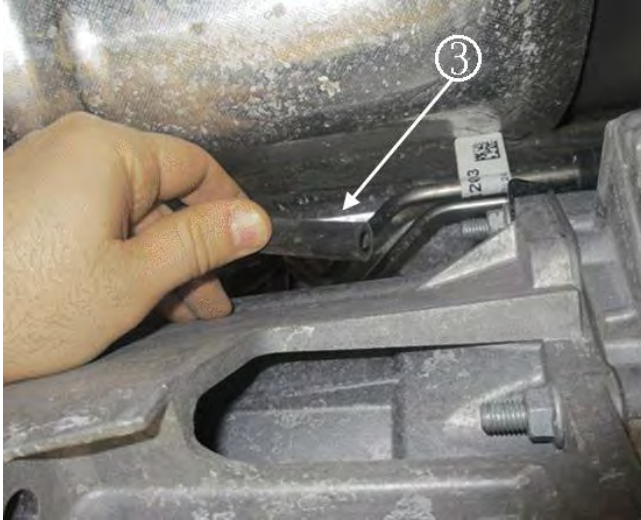
4215387

7. Remove the transfer case (3) vent hose from the transfer case vent.

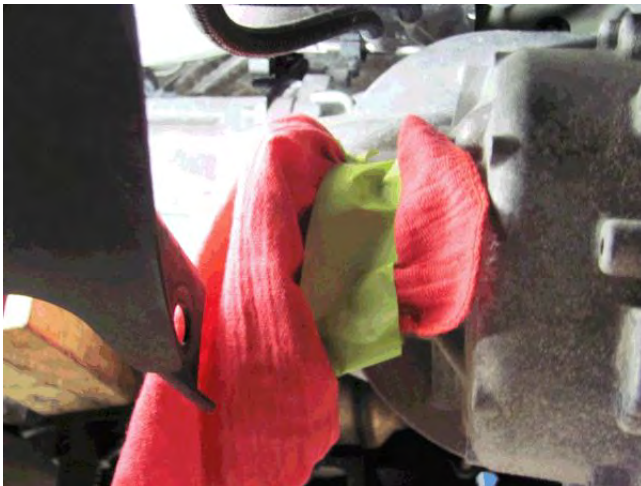
4215390

8. Add a shop towel and masking tape to the rear of the front propshaft attachment in order to shield this propshaft sealing joint from contamination.

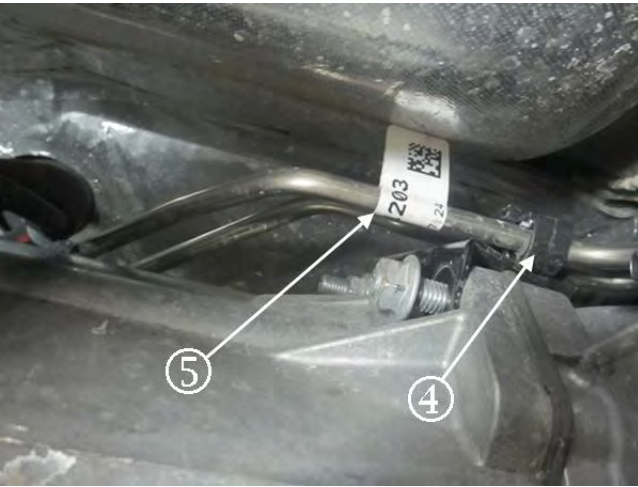
4215395

9. Remove the fuel line clip fir tree (4) from fuel line bracket.
10. Remove the fuel line part number label (5) from the fuel line. Do not use anything sharp against the fuel line to remove this label. Tearing the label is preferred if possible.

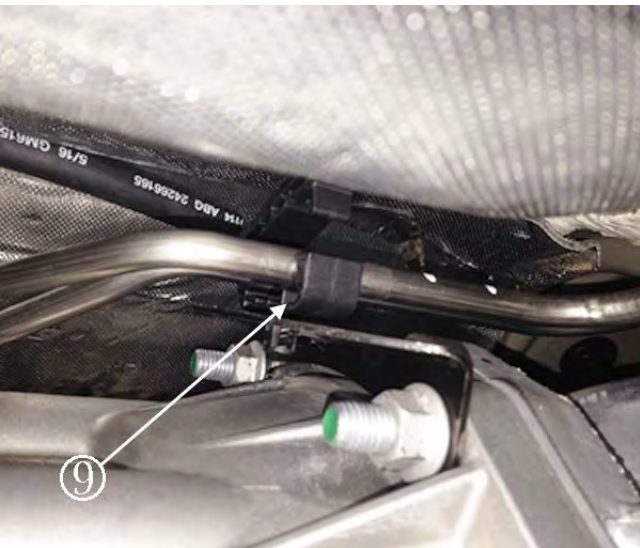
4215402

15. Push the fir tree on a new fuel line clip into the hole in the new triangular fuel line bracket until it is fully seated. Do NOT latch the fuel line clip onto the fuel lines until step 25. Only install the fuel line clip into the bracket with no lines. The latching side of the fuel line clip should face outboard. Photograph shows the fuel line clip latched onto the fuel lines to show the latching side of the fuel line clip.

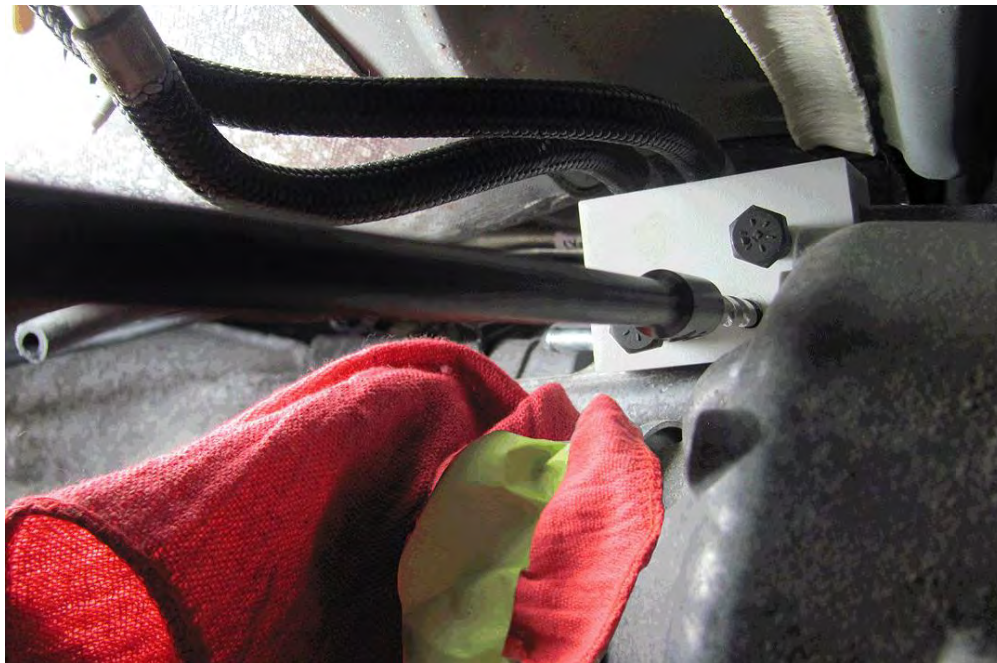
4215372

18. Insert the drill bit into the drill bit guide of the jig.
19. Drill a hole into the transfer case rib using a 7.5 mm (19/64 in) drill bit that is at least 203 mm (8 in) in length. The use of a 305 mm (12 in) drill bit extension is preferred.
20. Remove the shavings and other debris from the work area using a brush or vacuum.
21. Remove the shop towel and tape from the transfer case.

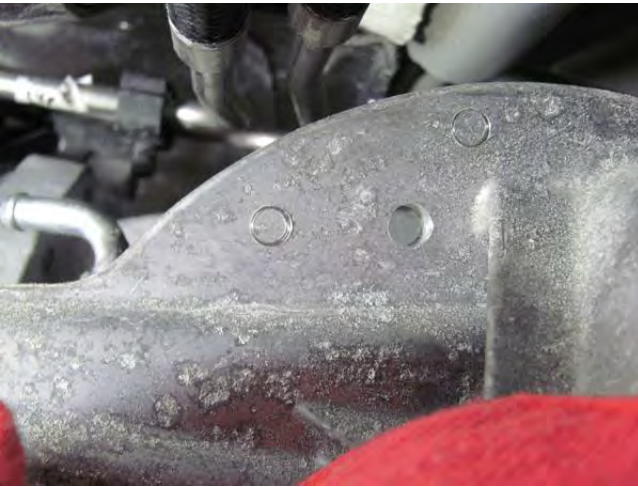
4215410

22. Feel on the backside of the hole that is drilled into the transfer case rib to make sure there are no burrs that could interfere with torquing the Z bracket to the rib. If any are present, remove these burrs carefully.

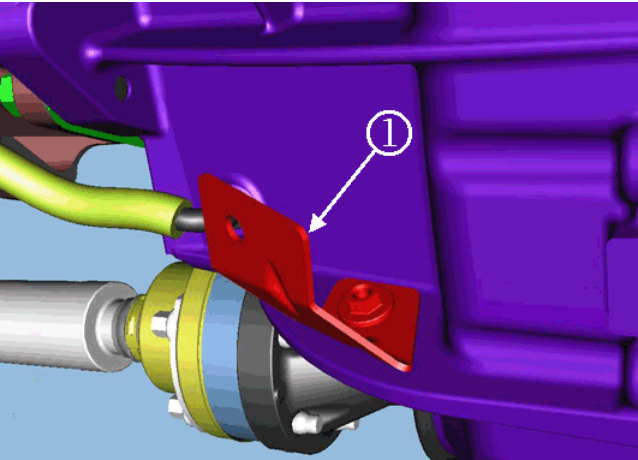
4215409

23. Install new supplied Z bracket (1) behind the rib on the transfer case with the weld nut on the opposite side away from the transfer case rib. Fasten an M6 bolt through the hole in the transfer case rib and Z bracket. Tighten the bolt to 9 Nm (80 lb in).
24. Add a second new fuel line clip. Do not install fuel line clip to fuel lines yet. Insert the fir tree on the clip into the new Z-shaped bracket until fully seated. The clip should not yet be installed onto the fuel lines when this is completed, just the clip into the bracket with no lines. The latch on the clip should face forward in the vehicle.
25. Position the fuel lines so that they sit properly in both open fuel line clips (on triangle and Z-shaped bracket) with no added stress on the lines. The fuel lines in the modified triangular bracket should be in the clips about 60 mm (2.4 in) forward from the original location.

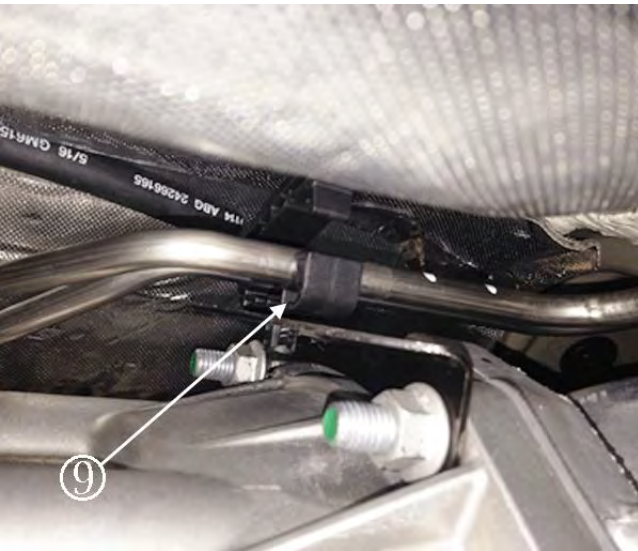
4215402

26. Once positioned properly, close the top half of the fuel line clips to latch them to the fuel lines. The fuel lines should be positioned in the clips properly.
27. Make sure that the fuel line clip is attached properly on the passenger side of the transmission. The clip could have pulled out of the fuel line bracket slightly during the repositioning of the fuel lines. Push the fuel line until it is fully seated again if this is the case.

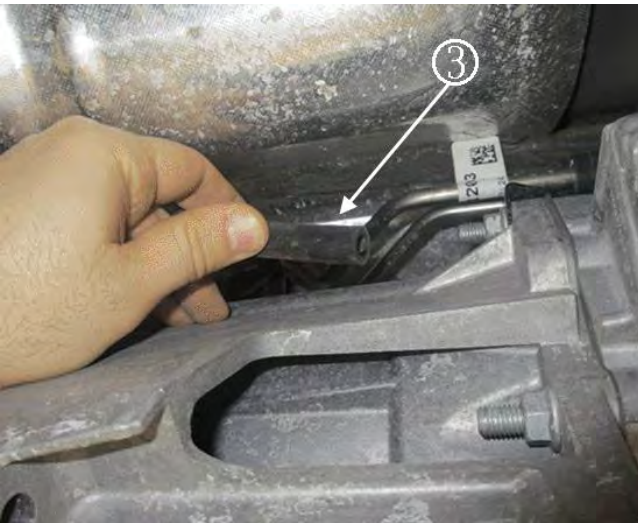
4215387

28. Reattach the transfer case vent hose (3) to the transfer case vent.

Caution: Ensure that the flexible coupling (1) of the exhaust is not bent or stressed and the transmission oil pan does NOT contact the exhaust crossover pipe (2) when the powertrain/transmission is raised. Maintain a minimum of 13mm (33/64 in) clearance between the components.

29. Lift the powertrain/transmission using a transmission jack until the powertrain/transmission is back into position.

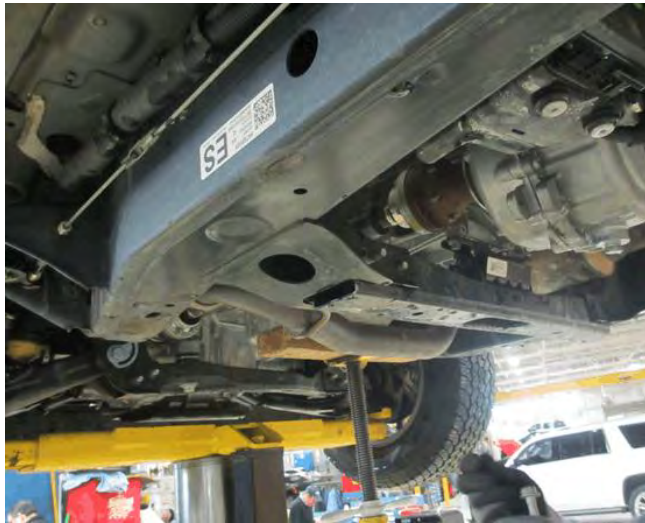
4215375

30. Install the transmission crossmember nuts back onto the frame (4 nuts). Tighten the transmission crossmember nuts to 100 Nm (74 lb ft).
31. Install the transmission mount nuts (2 nuts). Tighten the transmission mount nuts to 55 Nm (41 lb ft).
32. Lower the transmission jack.
