Service Campaign 66-01

SB-10058859-5664

AFFECTED: Winnebago Forza and Itasca Solei Model L36G

SUBJECT: Correct Furnace Installation

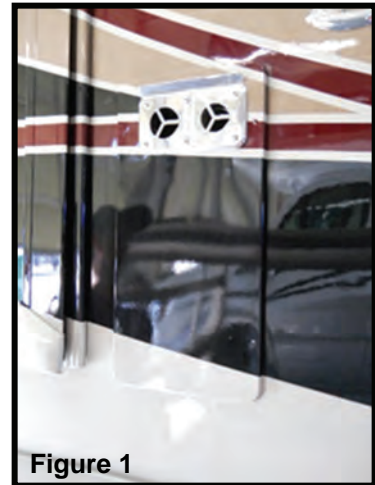
Figure 1 shows the furnace in the incorrect position and the service campaign will need to be completed.

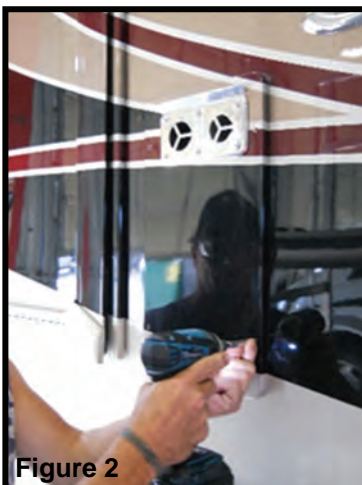
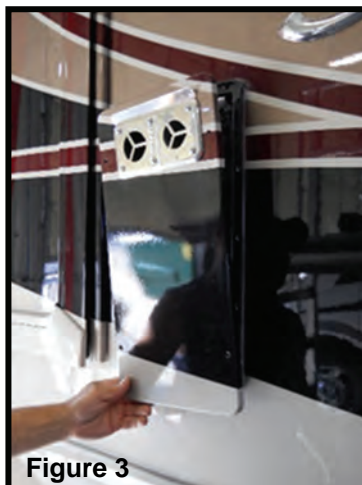
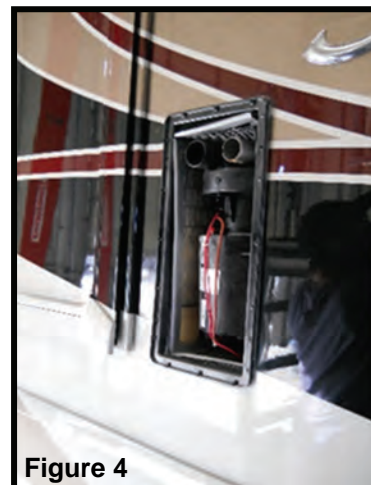
1. Turn off LP.
2. Remove 4 screws on furnace access door and remove door, Figures 2 - 4.

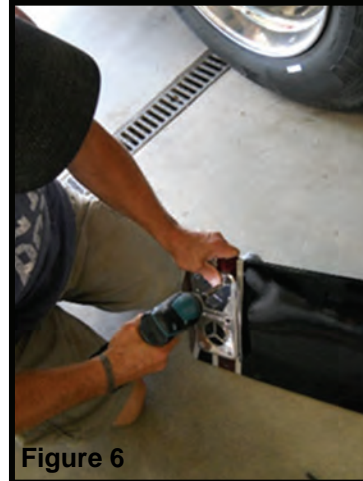
3. Remove vent from furnace access door, Figures 5 - 6. SAVE VENT FOR INSTALLATION IN NEW DOOR.

Write the coach serial number and Parts Order number on inside of door and return via prepaid freight to Winnebago Industries using the Part Return Packing Slip provided with this document. Attach an orange "Warranty Return Goods" label to the outside of the package. A newly painted door will be shipped to your dealership with the Furnace Re-Install Parts Kit. The original door will be used as a pattern for painting the new one. The turnaround time from receipt of the original door to shipping of the Parts Kit will be 2-4 business days.

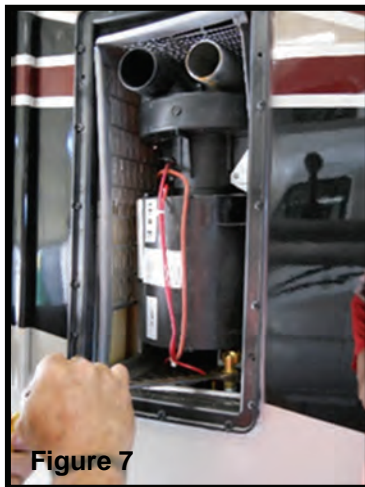
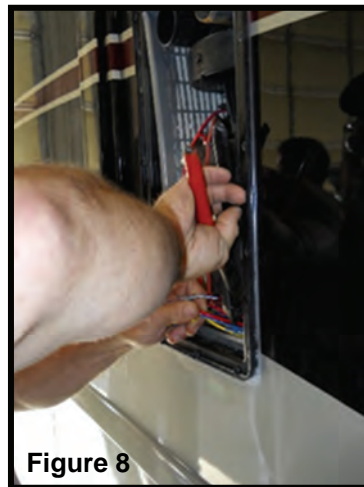
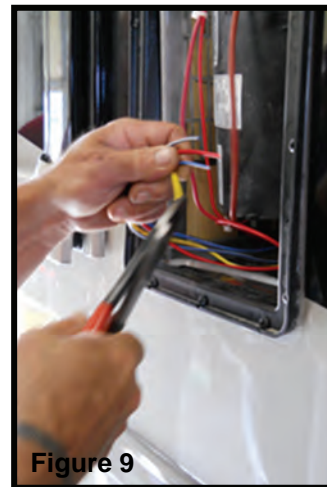
3. Disconnect LP line and cut wiring to furnace, Figures 7 - 9.

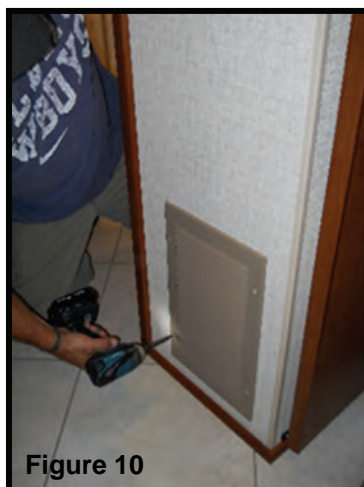
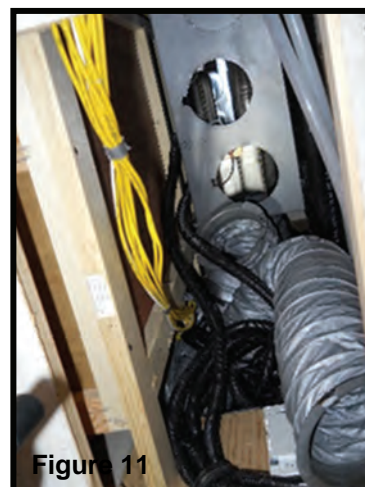
4. Inside of coach, remove vent in hallway to gain access to furnace ductwork, Figure 10. Detach ductwork from rear of furnace, Figure 11.

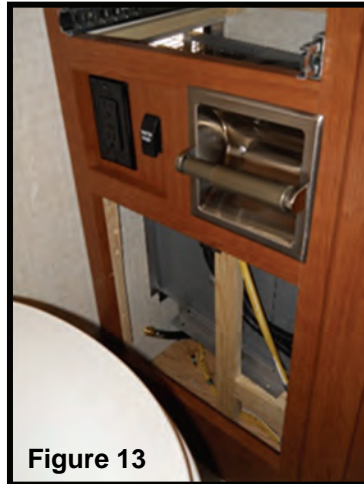
6. Remove drawer and magazine rack in bathroom for access to furnace, Figures 12 - 13.

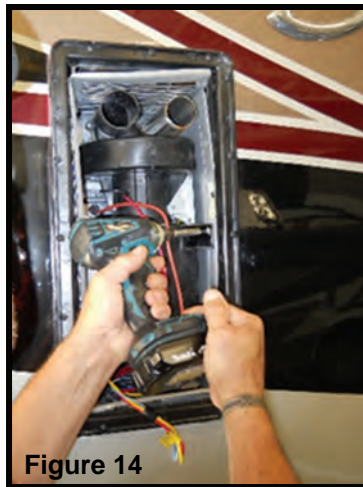
7. Remove screws holding furnace cage in place, Figure 14.

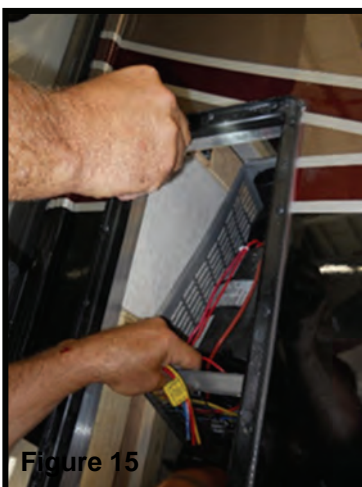
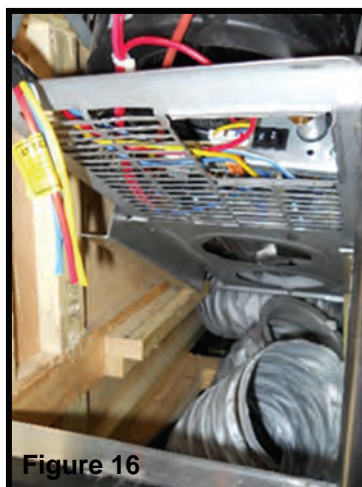
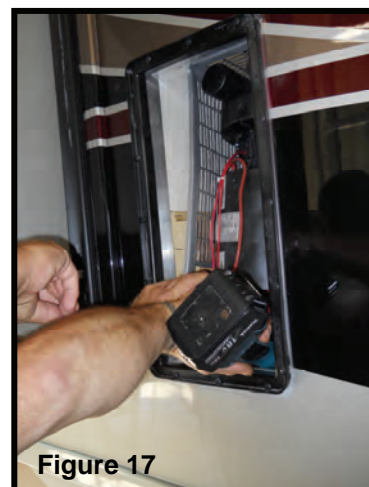
8. Push furnace assembly in and tip up to gain access to ducting underneath, Figure 15. Detach ducting, Figure 16. Detach brackets on underside of cage and discard, Figure 17.

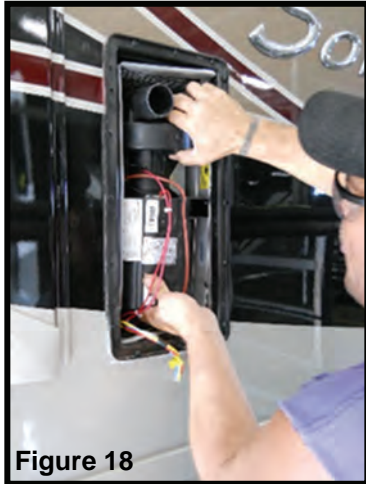
Figure 18

9. Remove furnace and cage from unit, Figures 18 - 20.

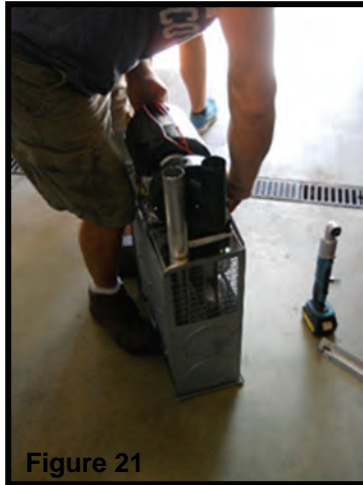
Figure 21

10. Remove furnace from cage, Figure 21.

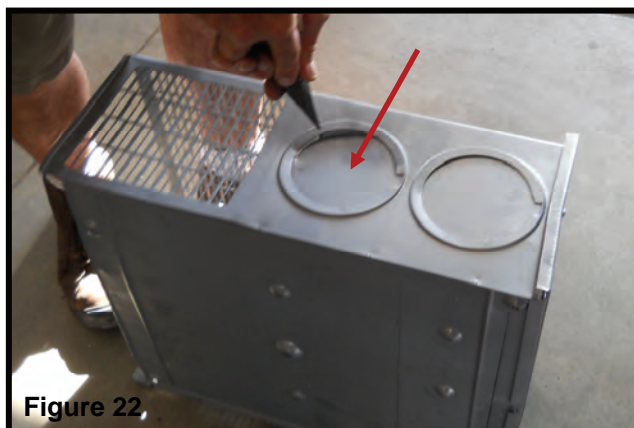
Figure 22

11. Remove 2 knockout plugs from top (future bottom) of cage and discard, Figures 22 - 23.

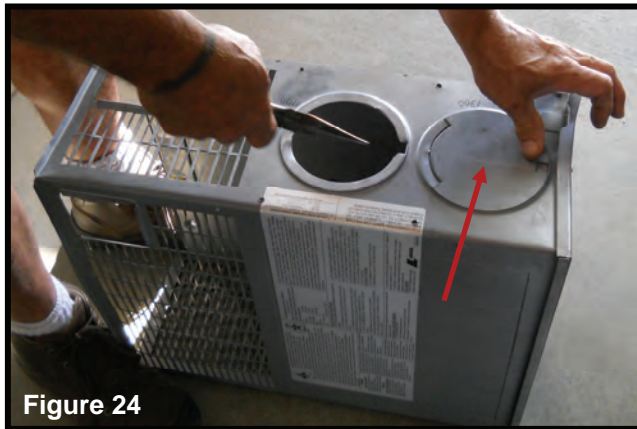
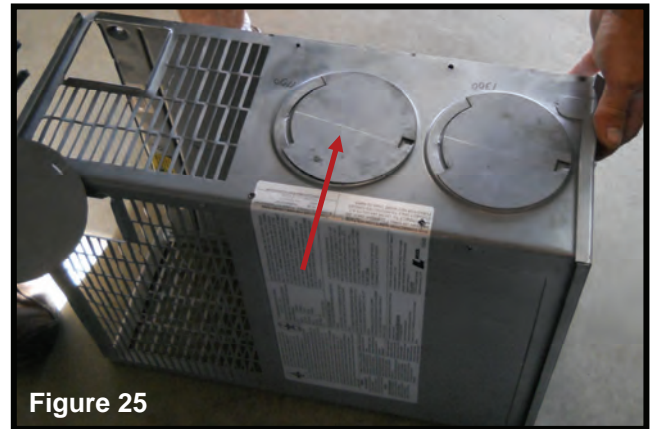
12. Install 2 knockout plugs in bottom (future top) of cage, Figures 24 - 25. Ensure plugs are secure and apply furnace tape around each plug.

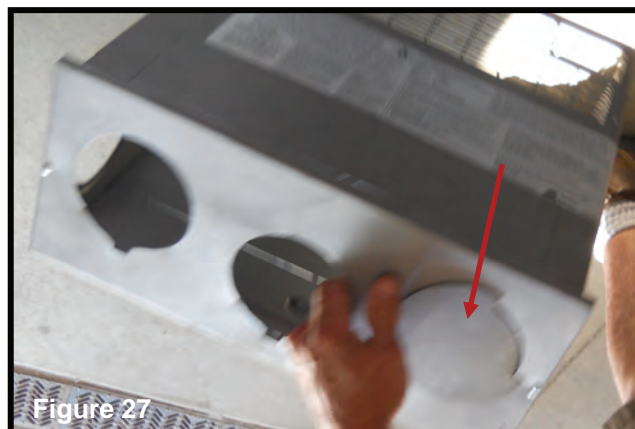
14. On back of cage, insert 1 knockout plug in bottom hole (future top hole) of cage, Figure 27. Ensure plug is secure and apply furnace tape around plug.

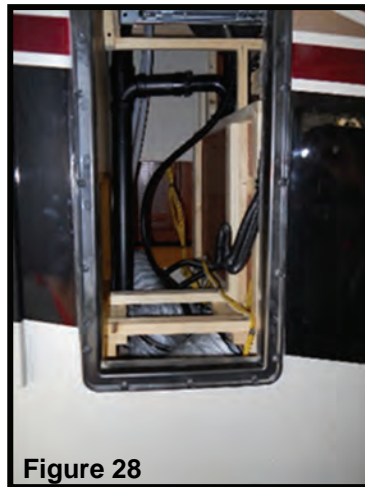
Figure 28

15. Route LP hose and wiring within opening as shown, Figure 28. At this time, use butt connectors and wire provided in kit to lengthen wiring as necessary.

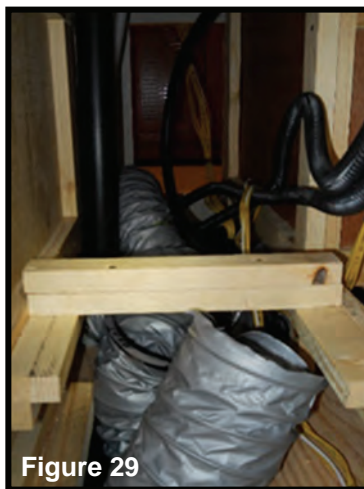
Figure 29

16. Place provided lumber pieces into opening as shown. Insert cage and adjust lumber pieces as needed to provide correct support to furnace, Figures 29 - 30. Remove cage and screw lumber pieces in place using screws from kit.

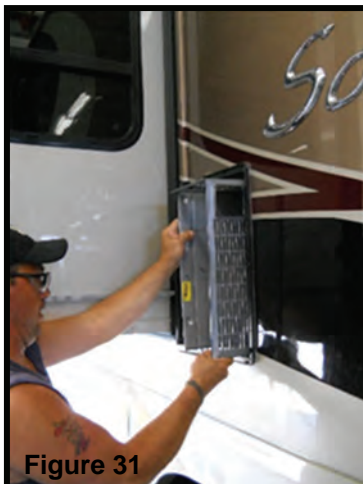
Figure 31

17. Insert cage and attach ductwork to bottom, Figures 31 - 32. Secure cage on left side with 2 screws, Figure 33.

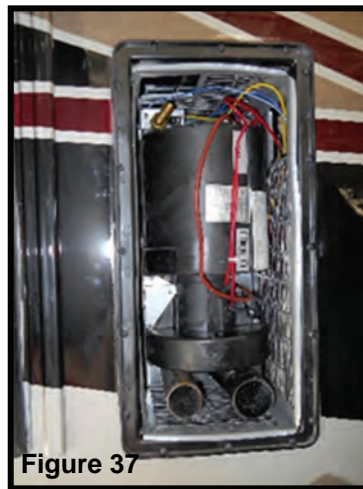
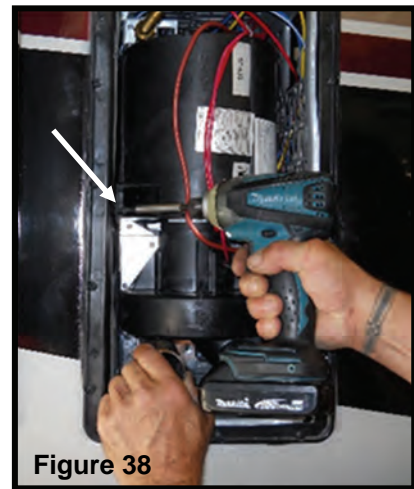
19. Insert furnace in cage as shown, Figures 36 - 37. Attach with 1 screw on left side, Figure 38.

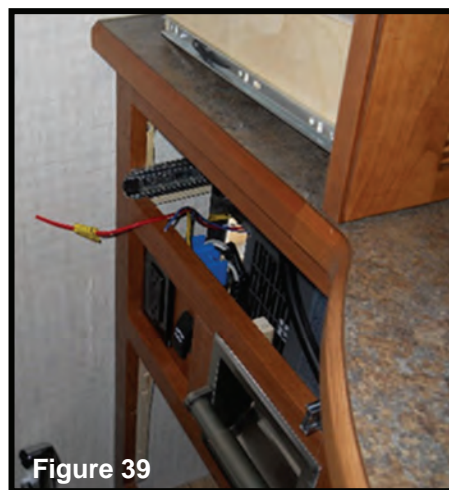
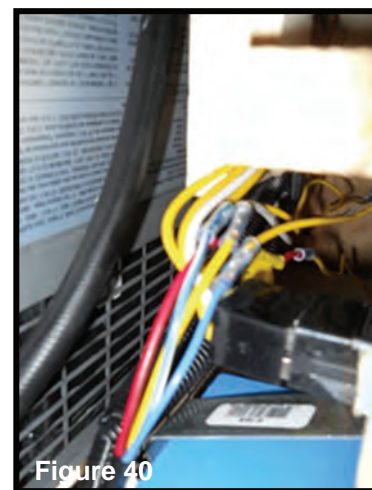
20. In bathroom where magazine rack was removed, reattach wiring to furnace, Figures 39 - 40.

- Blue - JJ
- Yellow - JM1
- Red - JB1
- Blue w/white - JH3

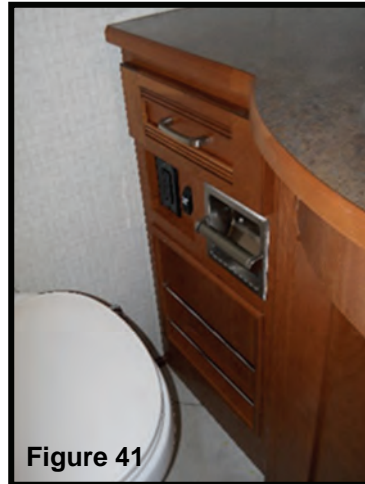
21. Reattach magazine rack and reinstall drawer, Figure 41.

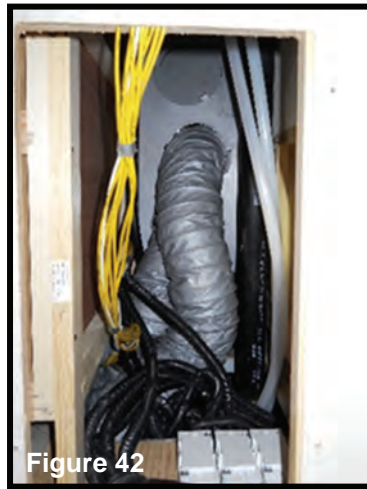
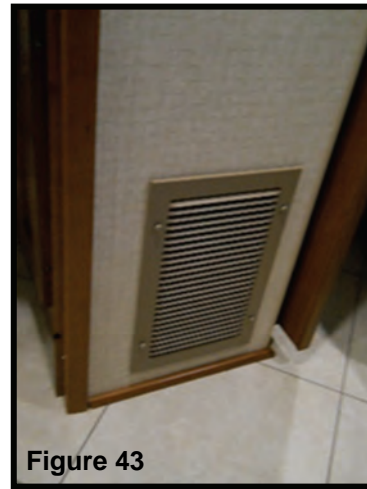
22. Attach ductwork to rear of furnace in hallway access, Figure 42. Reattach vent cover, Figure 43.

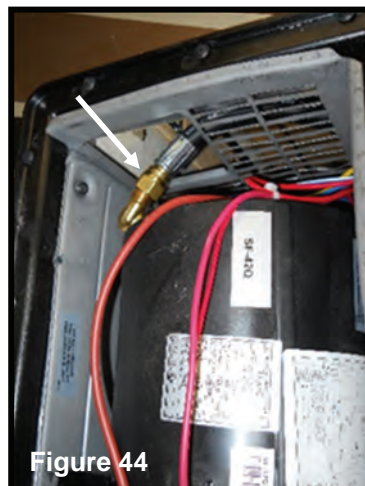
23. Attach LP line to furnace, Figure 44.

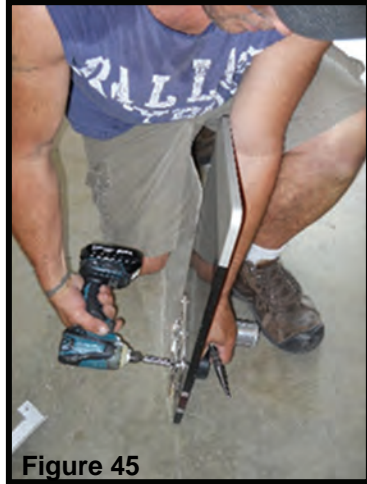
Figure 45

24. Install vent from Step 3 into new furnace access door, Figures 45 - 46. Lip of vent should orient towards the top of the door.

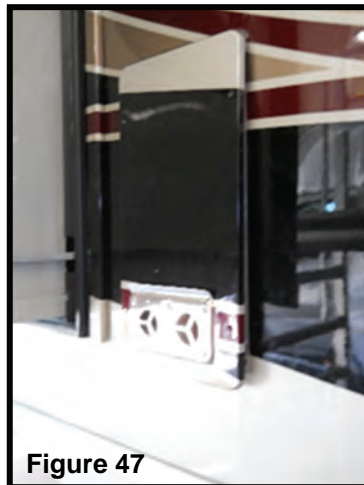
Figure 47

25. Install new furnace access door, Figure 47.
