# CAPACITY TECHNICAL SERVICE BULLETIN

## Sabre 5<sup>th</sup> Wheel Boom Sway

### CAP-TSB-15-013

Capacity has identified boom cylinder failures on select Sabre Units.

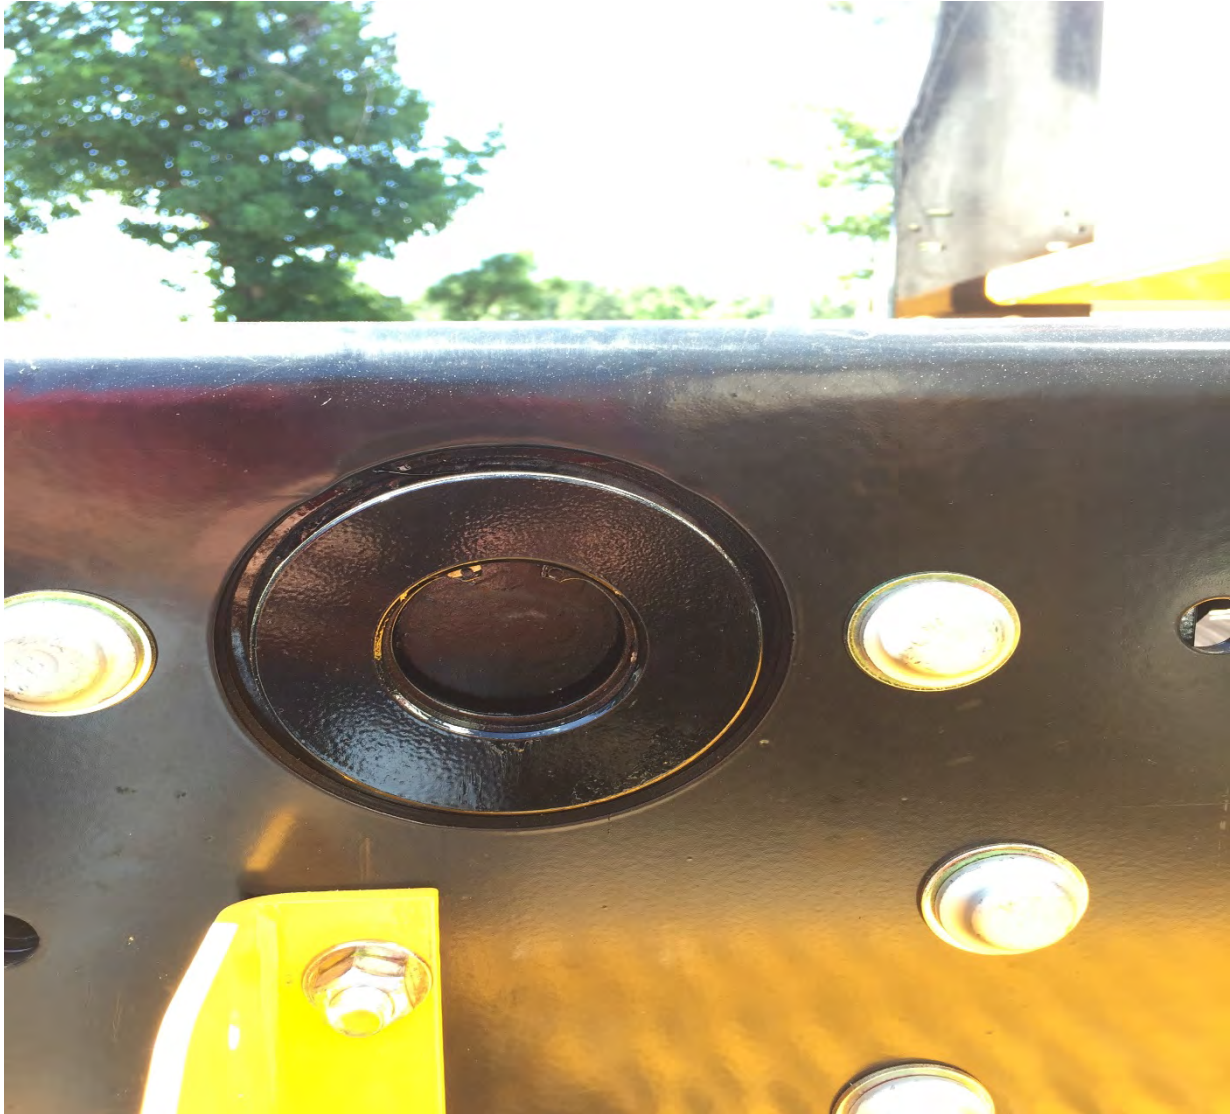
1. Identify that boom boss has a boss pin and not a snap ring. If there is a snap ring on the outside of the boom boss do not proceed with the TSB.

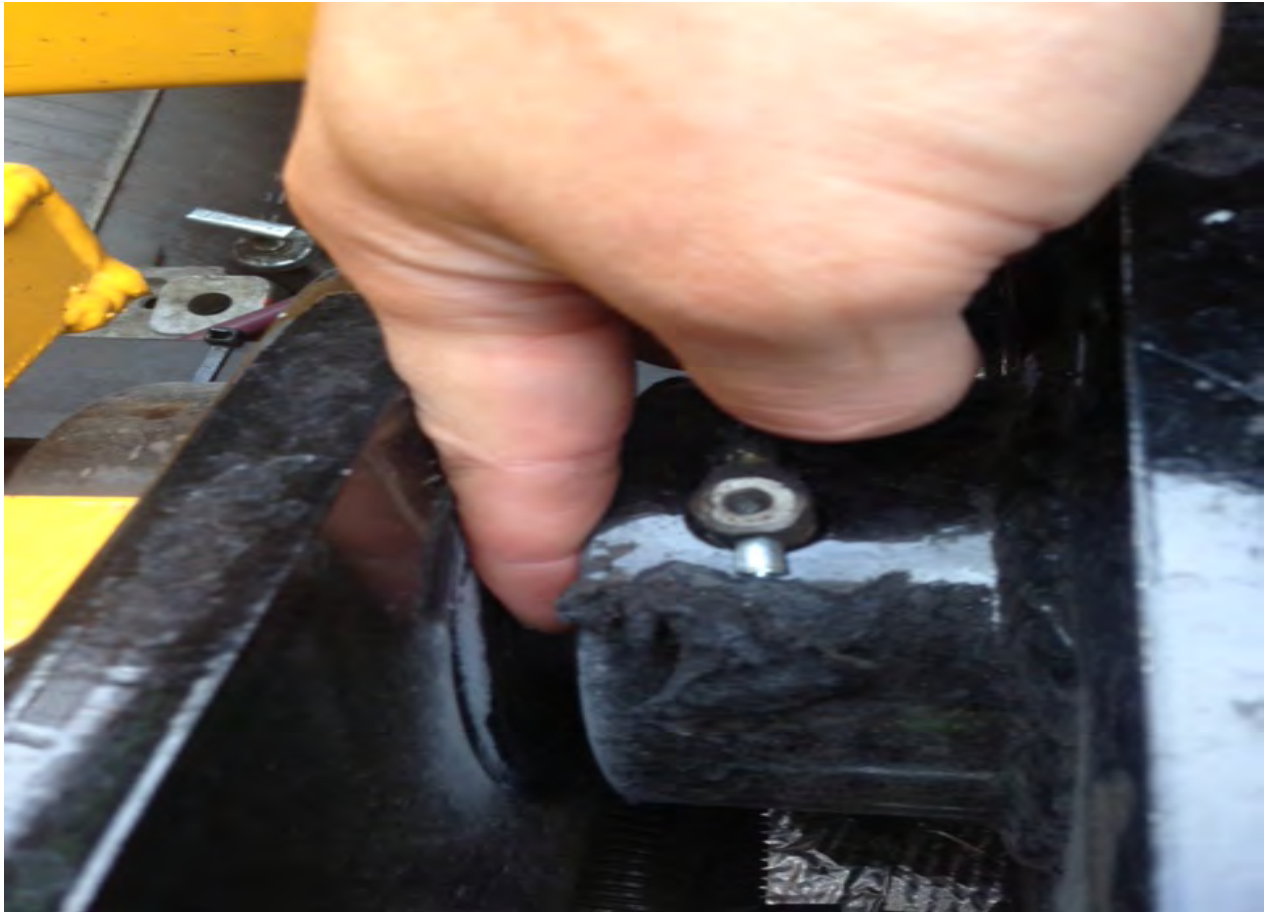
2. Once verified that there is no snap ring on the boom boss inspect for the boom boss pin. If boom boss is present check for gap.
3. Inspect for gap in between boom and boss

4. Once gap has been verified shims must be installed
5. Cut the shims directly in half making 2 pieces per shim
6. Place the 2 pieces of the shim around the boom boss pin
7. Weld the 2 pieces of the shim together making one.
8. Place 2 welded shims on each side of the boom which will center the boom between both bosses.
