122SD and Coronado  
Business Class M2  
> Cascadia  
108SD/114SD

Freightliner  
Service Bulletin

## General information

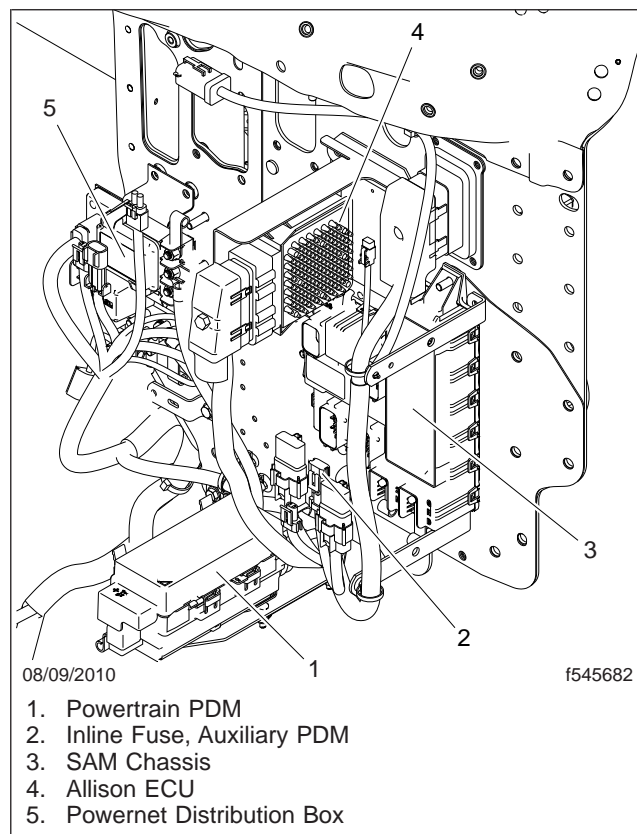
**Fig. 1, Cascadia Power Distribution**

It is important to make sure that proper care is observed when working on or around the SAM Chassis. See [Fig. 1](#). Failure to follow the guidelines in this bulletin could result in water intrusion, which will damage SAM Chassis electrical components.

If a procedure requires opening the SAM Chassis cover, close the cover immediately after the procedure is completed and make sure that it snaps shut securely at both the top and the bottom. If the cover is not shut securely, it may swing open and allow water or other foreign materials to come in contact with SAM Chassis electrical components. Such exposure could cause corrosion, leading to failure of the SAM Chassis.

**Do not power wash or steam clean the engine bay in the area of the SAM Chassis, unless specified by vehicle manuals or service literature. Power washing/steam cleaning near the SAM Chassis can permanently damage it, which could result in fire, personal injury, or property damage.**
