SERVICE BULLETIN

SB1261A

ADDRESSEES	: Owners and users of vehicles mentioned under "Application"
VEHICLE TYPE	: T2100, C2045, CX, TX, TD925US, TDX25US, A300K, A300L, A330, AG300
CONFIGURATION GROUP	: 7.06 Steering – front-axle steering
BULLETIN TYPE	: Service Information
DATE	: June 16 th , 2015
SUBJECT	: Bevel gear of front axle steering system
TERMS & CONDITIONS	: Refer to the warranty section further in this Bulletin.

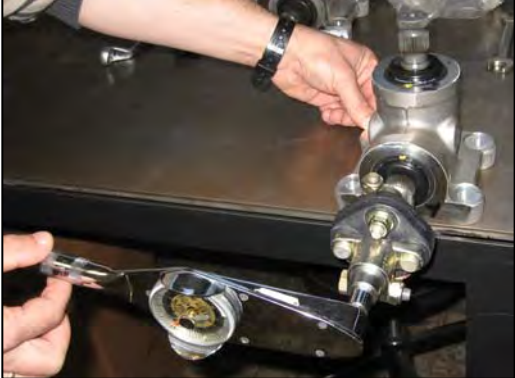
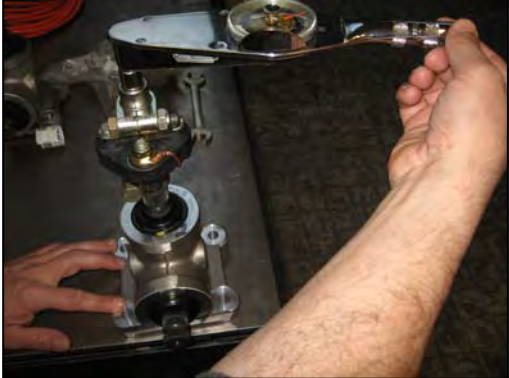
Step	Action
1	Position the bevel gear on a work bench.
2	Position a torque tester suitable for measuring small torques at the input or output shaft of the bevel gear. Check the bevel gear rotating torque by progressively increasing the force on the arm of the tester. The bevel gear must be replaced when the reading on the torque meter exceeds 0,7 Nm (0.52 ft.lbf).
