BULLETIN NUMBER:  
**CB15-X-001**

## VOLUNTARY EMISSION RECALL INCORRECT VIN AND WEIGHT RATING/GHG LABEL #V1502

- 2015MY Isuzu NPR Vehicles (See Attached VIN List)  
Equipped with 3.0L (4JJ1) Diesel Engines

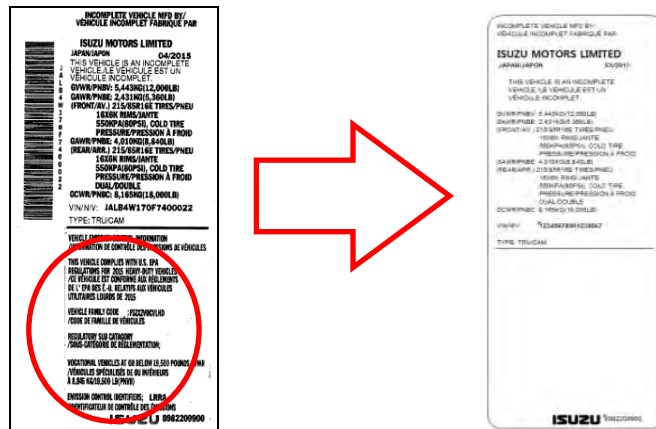
Figure 1

- 1) Verify new and old labels have matching VIN numbers. Note that the correct VIN and Weight Rating label will not include the GHG information on the lower half of the label titled, "Vehicle Emission Control Information" (Figure 1).

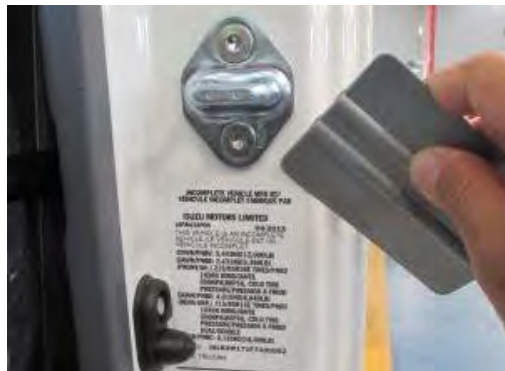
Figure 2

- Carefully remove old label from B-pillar door jamb (driver's side door) using the 3M™ Scotchcal™ application squeegee to avoid paint damage (Figure 2).

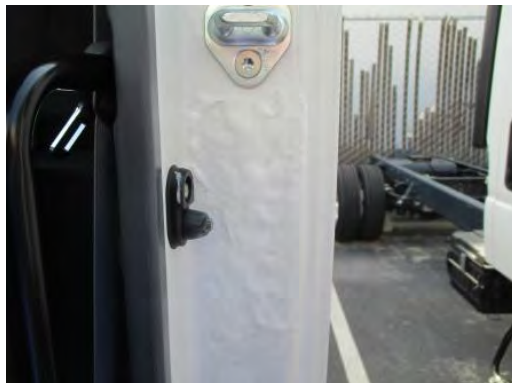
Figure 3a

- Remove old label glue residue by applying a light coat of CRC™ gasket remover (Figure 3a) and letting it soak for no more than two (2) minutes before wiping it off with a clean cloth (Figure 3b).

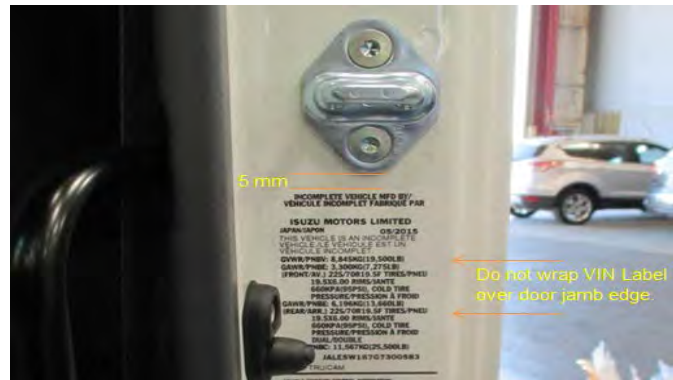
Figure 4

- 4) Apply new VIN and Weight Rating label in area shown (Figure 4), located **5mm below striker** in driver's door jamb. Be careful **not to wrap label over door jamb edge**.

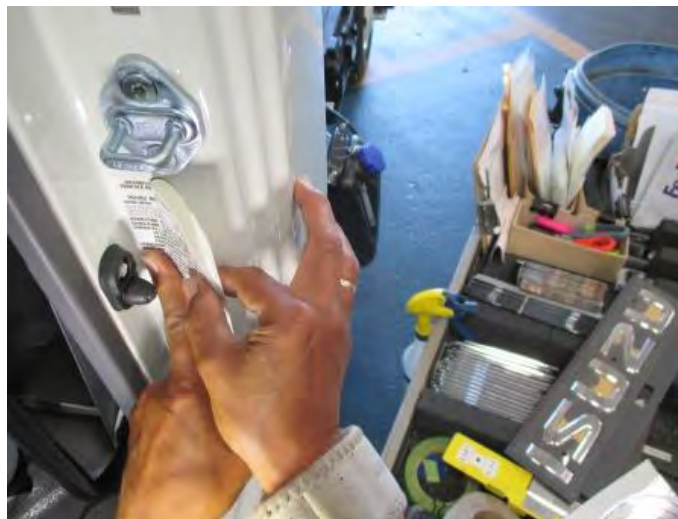
Figure 5

- 5) Apply label starting from the inboard edge using the back of the label to keep it straight avoiding air pockets and wrinkles (Figure 5).

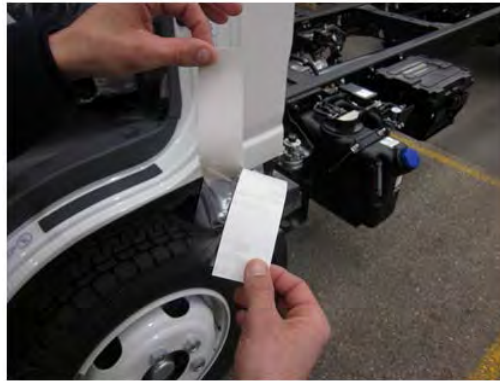
Figure 6

- 6) To apply protective film over the VIN and Weight Rating label, peel half of the backing away from protective film. (Figure 6)

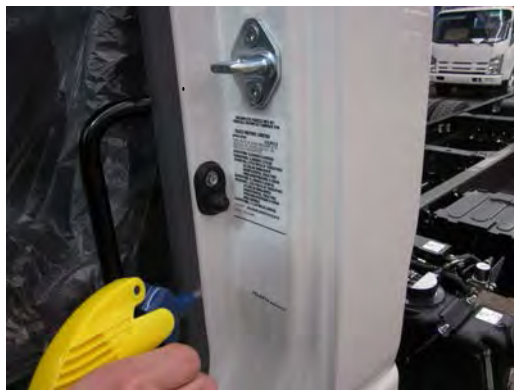
Figure 7a

- 7) Apply water/soap solution (5 drops of Dawn® dishwashing liquid per 32 fl. oz. of distilled water) to the new installed label (Figure 7a) and to the application side of protective film (Figure 7b) to ease film installation.

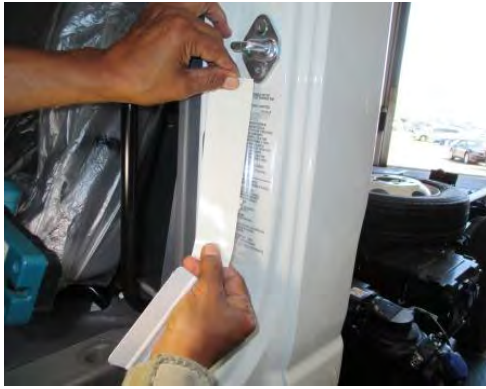
Figure 8a

- 8) Apply protective film to label starting with the outboard edge (Figure 8a). Use squeegee to hold film in place (Figure 8b).

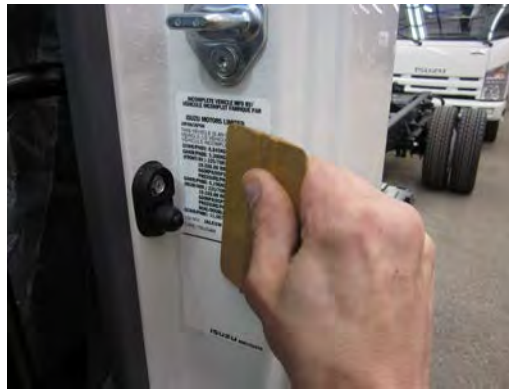
Figure 9

- 9) Peel the second half of the film backing, apply water/soap solution to protective film as needed and remove excess with 3M™ Scotchcal™ application squeegee (Figure 9).

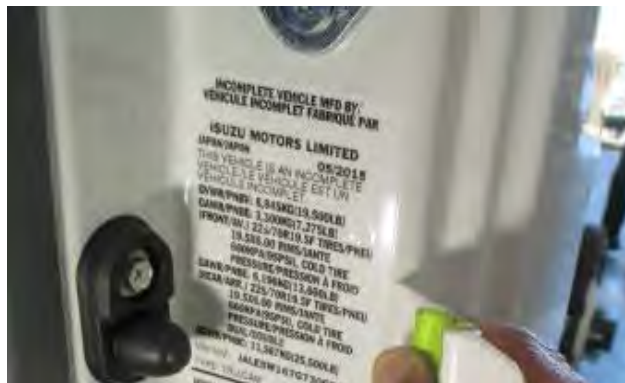
Figure 10

- 10) Carefully finish the edge around label removing any water/soap residue. (Figure 10)
