# Service Bulletin

## SB-10059109-2149

**SUBJECT:** Service Update for Inventory and Customer Vehicles  
Rear Brake Line Bracket Bolt to Rear Axle Loose  
Expires with Base Warranty

**MODELS:** 2014-2015 Chevrolet Silverado LD  
2015 Chevrolet Silverado HD  
2014-2015 GMC Sierra LD  
2015 GMC Sierra HD  
2015 GMC Sierra Denali LD

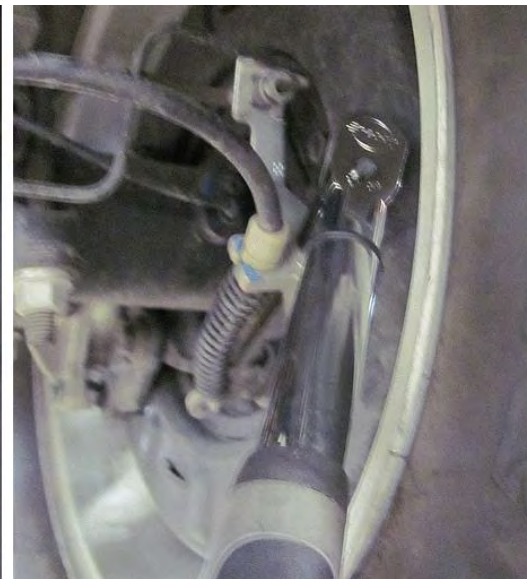
4204740

This bulletin provides a service procedure to inspect and, if required, retighten the torque on the right-rear-brake-line-bracket bolt to the rear-axle on **certain** Fort Wayne assembly plant built 2014-2015 Chevrolet Silverado LD, 2015 Chevrolet Silverado HD, 2014-2015 GMC Sierra LD, 2015 GMC Sierra HD and 2015 GMC Sierra Denali LD vehicles. These vehicles may have been assembled with an incorrectly torqued right-rear-brake-line-bracket bolt to the rear axle. This condition could allow the brake line to wear against the rear-axle housing and cause a brake-fluid leak.

1. Raise and support the vehicle. Refer to *Lifting and Jacking the Vehicle* in SI.
2. Locate right rear brake line bracket. The bracket is located on the rear axle.

**Caution:** If the brake line bracket bolt is damaged or missing, replace it with a new bolt to avoid damaging the brake line or brake line bracket.

3. Inspect right rear brake line bracket bolt (1) to rear axle for proper torque. Ensure bolt is tightened to 25 Nm (18 lb ft).
4. Lower the vehicle. Refer to *Lifting and Jacking the Vehicle* in SI.
