Service Bulletin

Bulletin No.: PI1203B

Subject: Steam/Vapor Coming from Front Grille or Radiator Area, Engine Runs Rough or Stalls, DTC P0506 Set

Models: 2014 Chevrolet Impala (VIN 1)

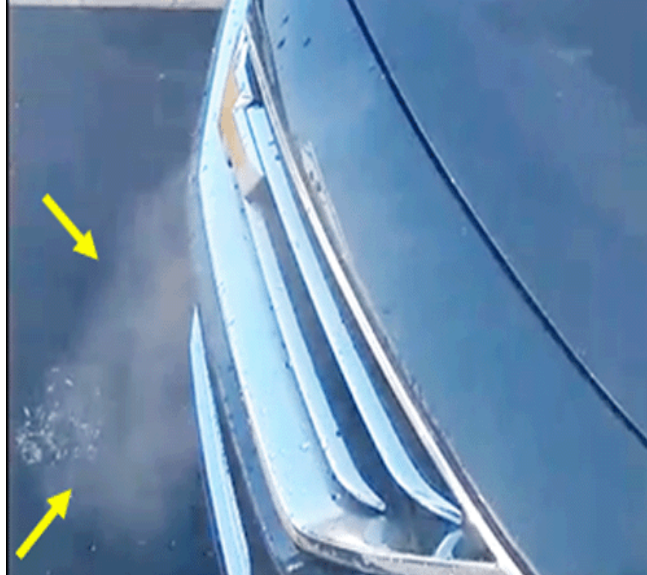
3770252

Some customers may comment that steam is coming from the front grille at idle, or on seeing vapor coming from the radiator after car washes.

The cause of this condition may be the result of rain or car wash runoff water reaching the condenser, radiator and fan module (CRFM) where it can be vaporized and, with the right weather, can become visible condensate.

Apply BRS tape to the front compartment front sight shield front lip and replace the radiator air upper baffle and deflector following the procedure below.
