POWER STEERING HOSE REPLACEMENT

Prevost vehicles

On the vehicles affected by this bulletin, replace the power steering supply hose.

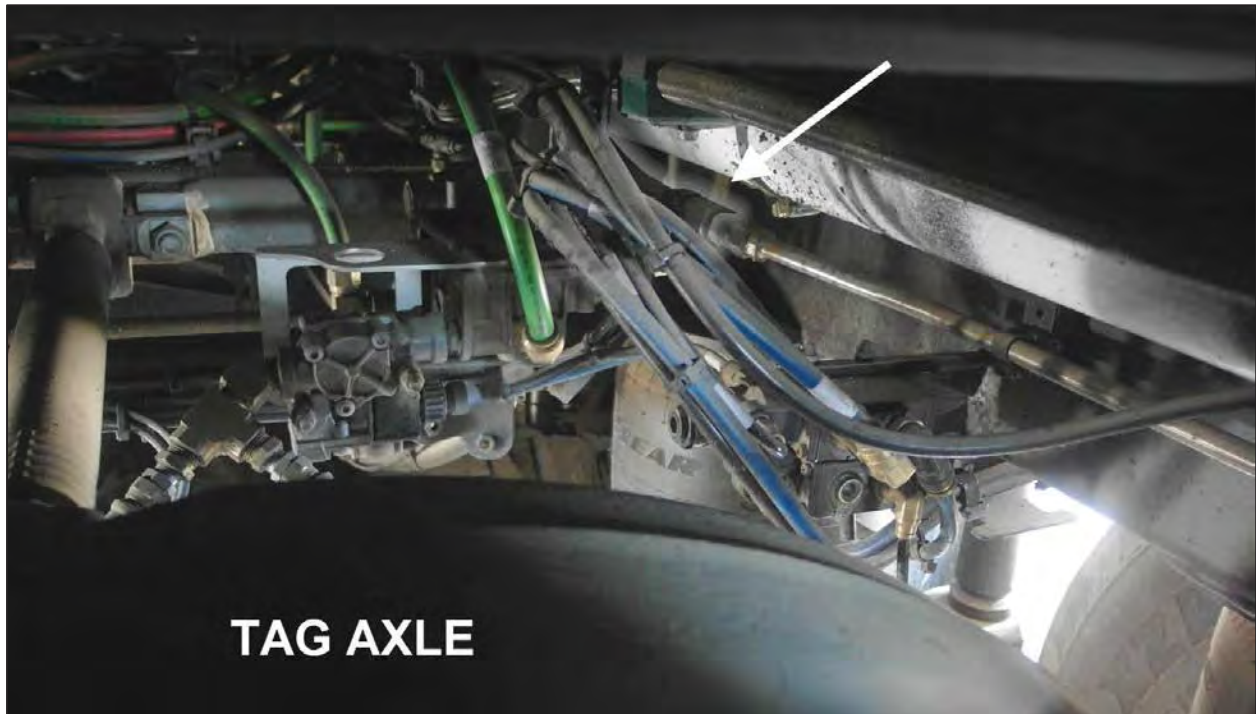
Figure 1

1. Prepare a suitable container and absorbent medium for hydraulic oil.
2. Locate the power steering hose above drive axle, curb side,. It is connected to a steel tube. (Fig. 1)
Loosen the hose fitting while supporting the steel line fitting with a wrench. Collect any oil dripping.

12. Connection above rear axles (Fig. 1).

- a. Inspect sealing surfaces. Clean and dry fitting threads.

- b. Hand-tighten.

- c. Tighten fitting with 7/8" open wrench to **1 1/2 FFWR or 42 lbf-ft (dry)** while holding the mating fitting with a wrench.

- d. Apply a torque seal mark across mating fittings.

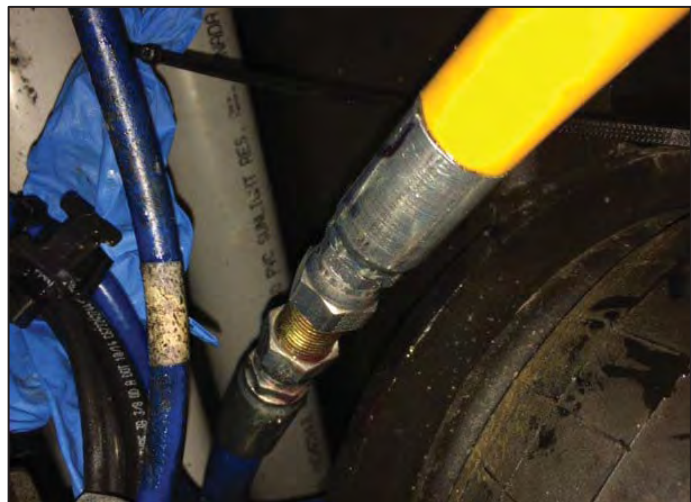
Figure 2

3. Join the old and new hose #161335P together with a #8 brass union fitting. (Fig. 2)

This will help guide the new hose into position while removing the old hose.

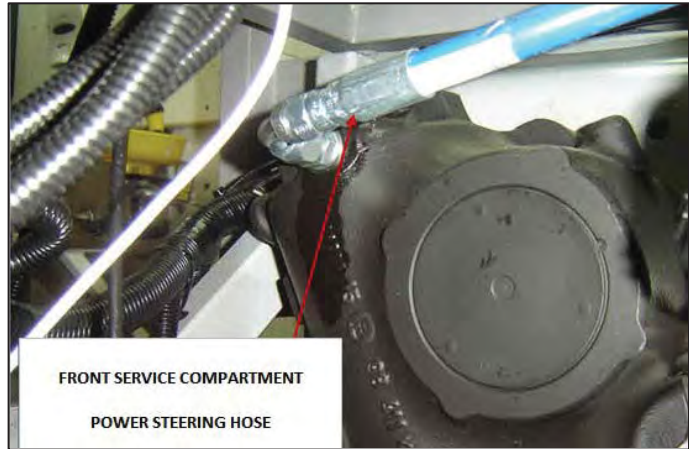
Figure 3

4. In front service compartment, locate the straight fitting on the upper hose. (Fig. 3)

Loosen the hose fitting while supporting the steering gear fitting with a wrench. Collect any oil dripping.

11. Steering gear connection.

- a. Inspect sealing surfaces. Clean and dry fitting threads.

- b. Hand-tighten.

- c. Tighten fitting with 7/8" open wrench to **1 1/2 Flats From Wrench Resistance FFWR¹ or 42 lbf-ft (dry)** while holding the mating fitting with a wrench.

- d. Apply a torque seal mark across mating fittings.

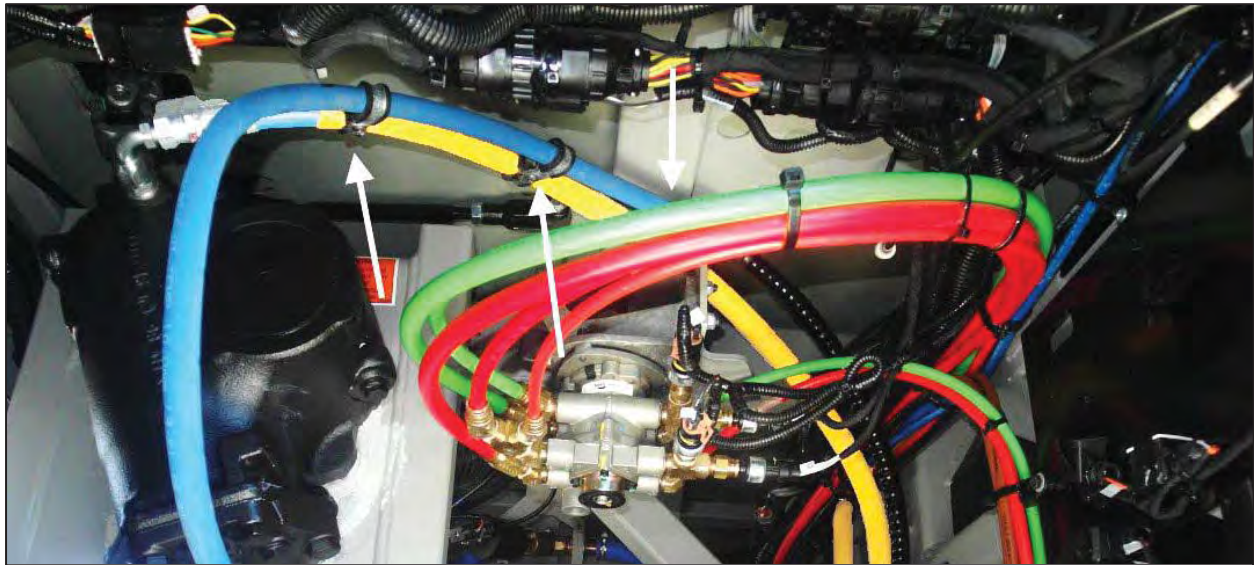
From the spare tire compartment, the following hose routing hardware is accessible: three (3) P-clamps (Fig 4), three (3) hose guides (Fig. 5) and one (1) block clamp (Fig. 6)

Figure 4: P-clamps in front service compartment.

13. Re-attach the hose and clamps all along hose routing in same location as they were removed.

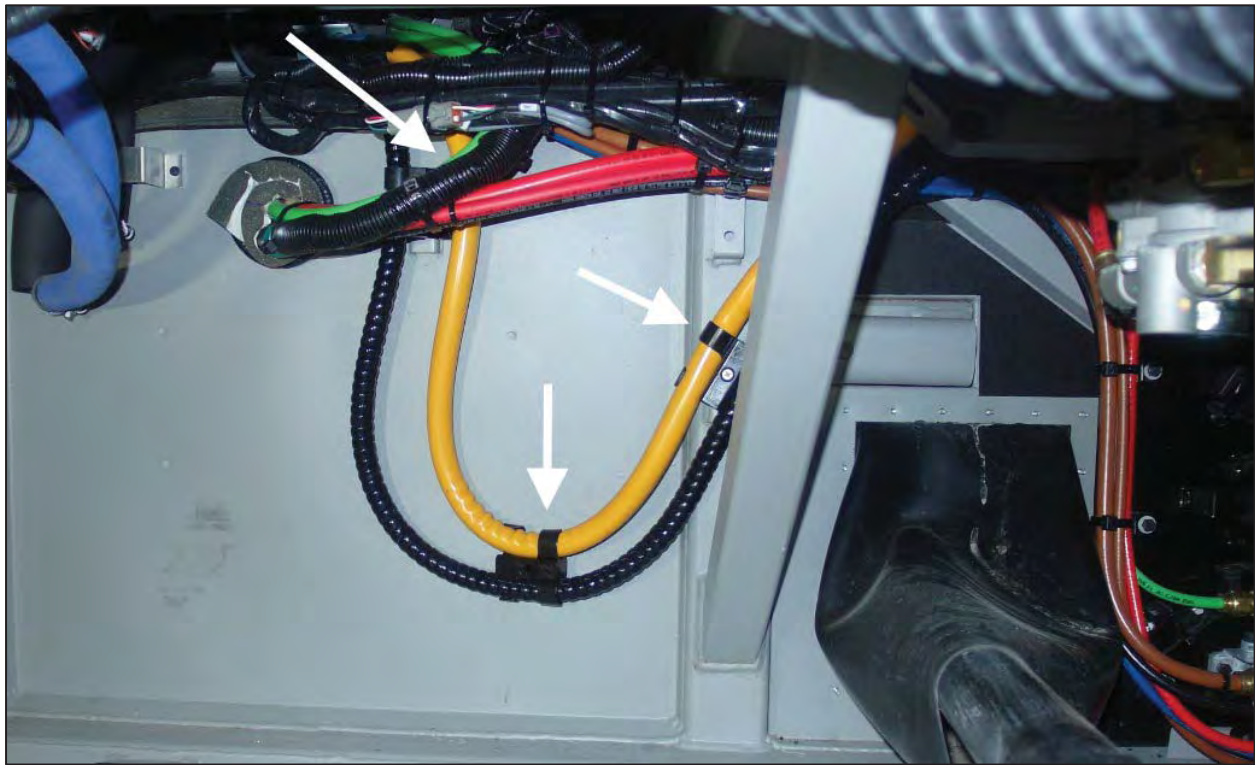
Figure 5: Hose guides on fore wall of front axle well

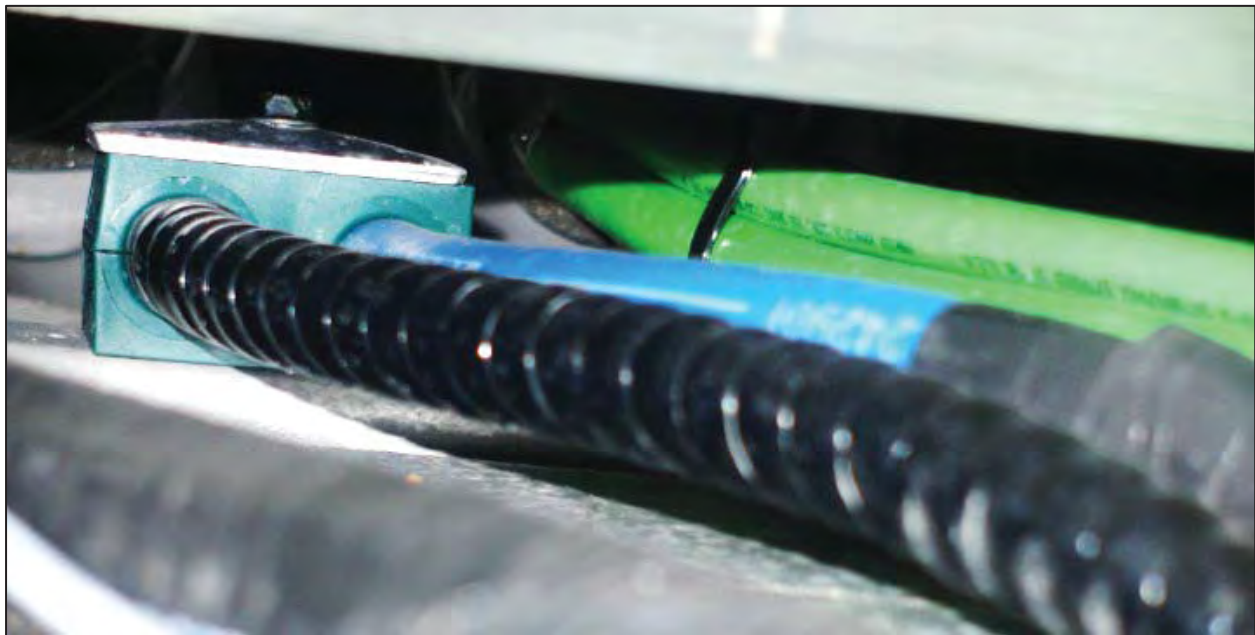
Figure 6: Block clamp in the tunnel leading to the first luggage bay.

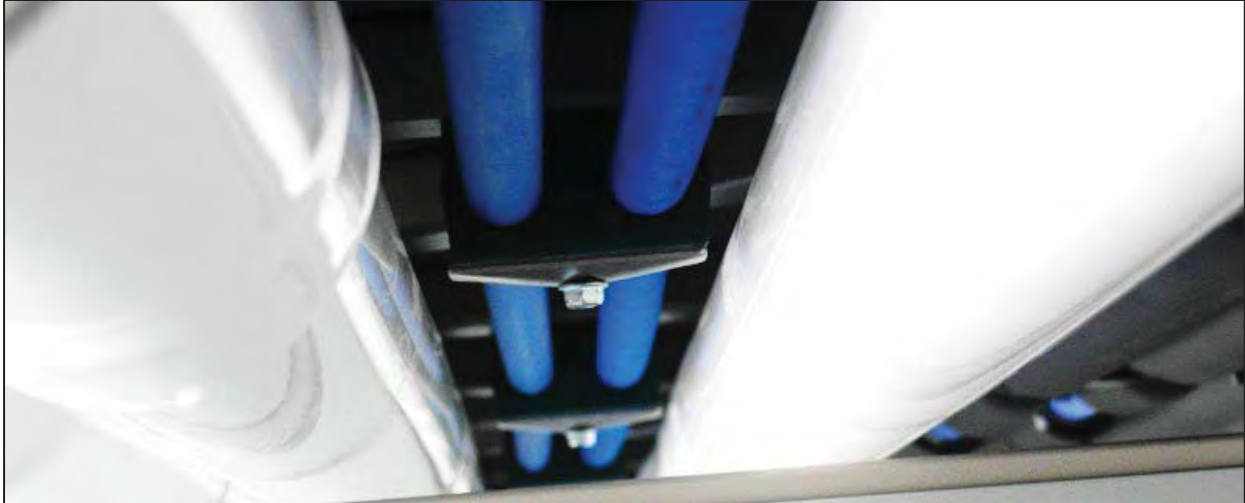
6. Remove the nine (9) block clamps on the luggage bay ceiling. (Fig. 7)

Figure 7: Inside Luggage bays

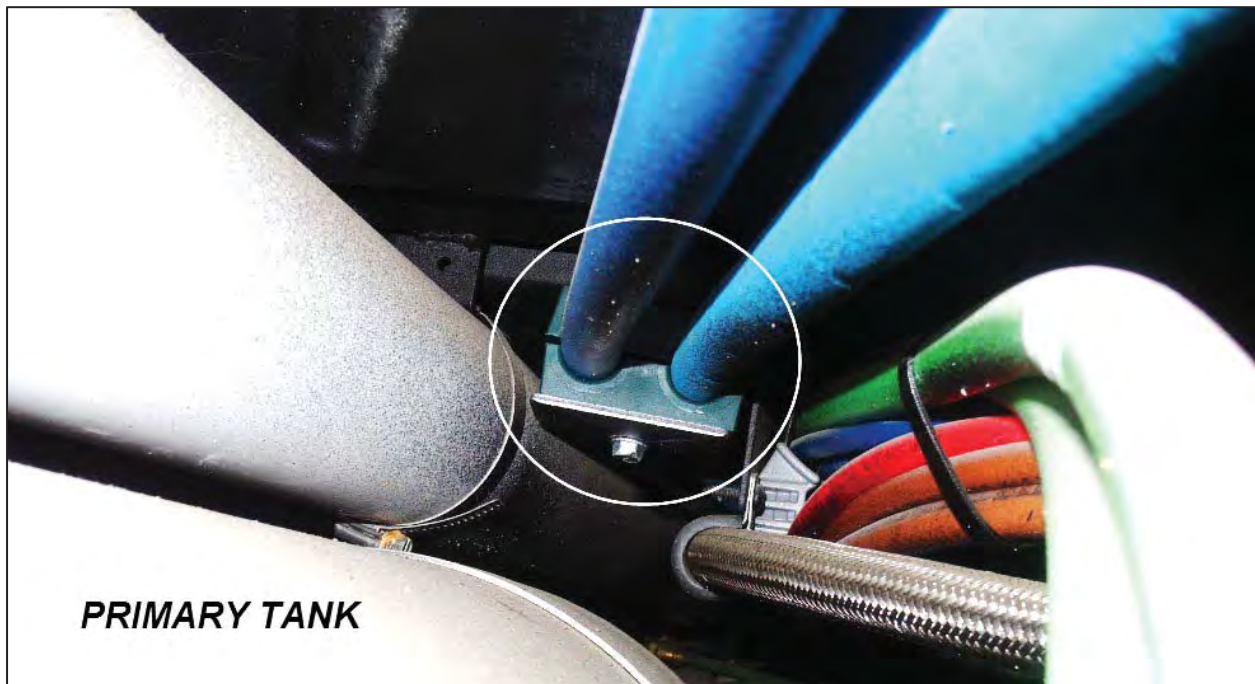
7. Remove three (3) block clamps accessed from above drive axle. (Fig. 8)

Figure 8: Above Primary Tank Looking Towards the Rear.

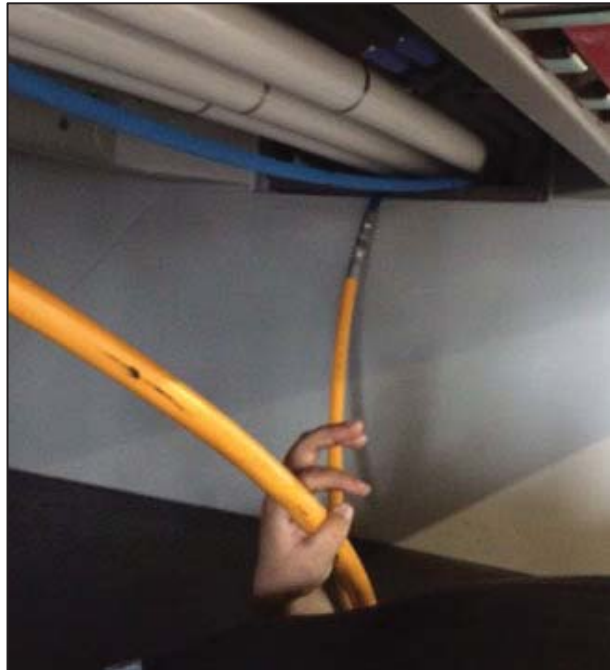
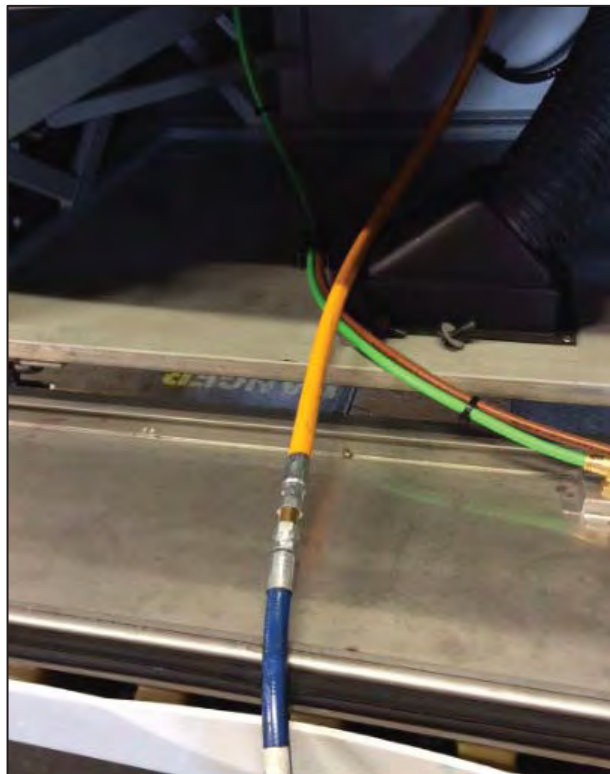
9. Still from the first luggage bay, assist a colleague by guiding the new hose into the spare tire compartment while he continues removing the existing hose. (Fig. 9, 10)
