# Service Action

## Code: 19L2

<b>Subject</b>	<b>Coolant Pump</b>
<b>Release Date</b>	August 06, 2015
<b>Revision Summary</b>	<b>Additional inspection steps added to the work procedure.</b>
<b>Affected Vehicles</b>	<b>U.S.A. : 2010-2013 Audi A3</b> <b>CANADA: 2012-2013 Audi A3</b>  <i>Check Campaigns/Actions screen in Elsa on the day of repair to verify that a VIN qualifies for repair under this action. Elsa is the <u>only</u> valid campaign inquiry &amp; verification source.</i> <ul style="list-style-type: none"><li>✓ Campaign status must show "open."</li><li>✓ If Elsa shows other open action(s), inform your customer so that the work can also be completed at the same time the vehicle is in the workshop for this campaign.</li></ul>
<b>Problem Description</b>	The coolant pump may develop a small leak over time.
<b>Corrective Action</b>	Inspect and, if necessary, replace the coolant pump.
<b>Parts Information</b>	Parts will be allocated prior to owner notification. If allocated parts have been used and your dealership is at the weekly Upper Order Limit, submit requests for additional parts via email to <a href="mailto:upperorderlimits@vw.com">upperorderlimits@vw.com</a> .

**Subjec

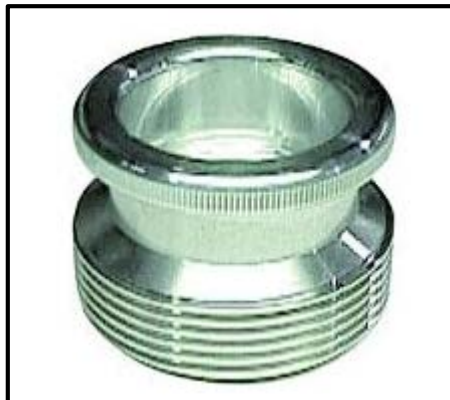
- Cooling System Tester - Adapter-VAG1274/8

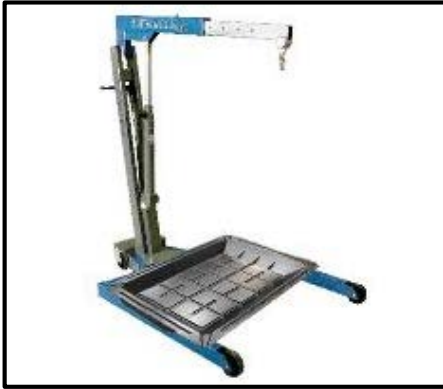
- Shop Crane – Drip Tray - VAS6208 (or equivalent)

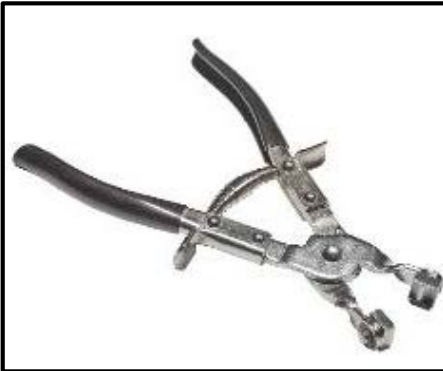
- Hose Clip Pliers - VAS6362 (or equivalent)

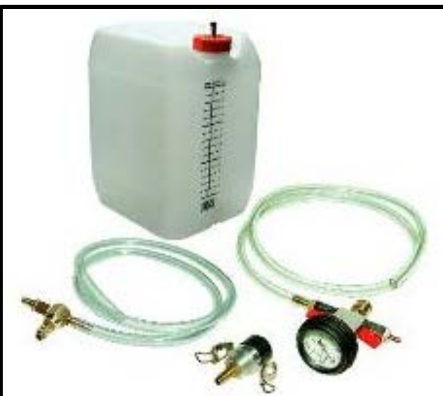
- Cooling System Charge Kit -VAS6096-

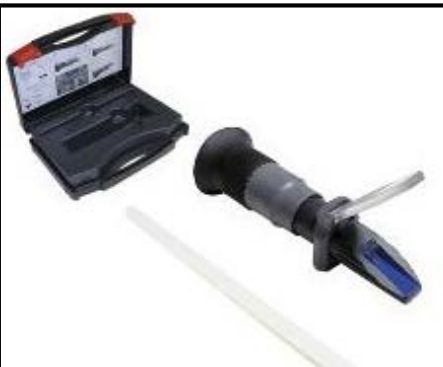
- Refractometer -T10007A-

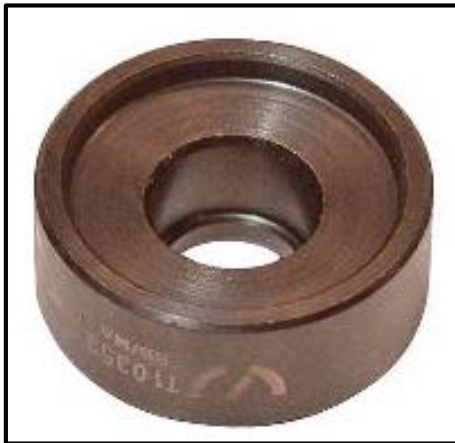
- Seal Installer - Intermediate Shaft - T10353

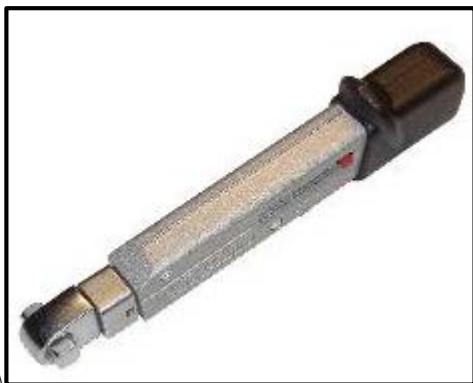
- Torque Wrench - VAG1410 (or equivalent)

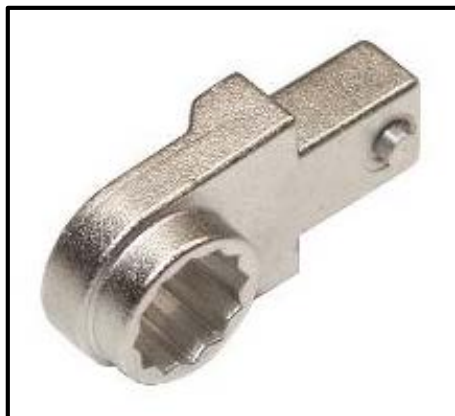
- Torque Wrench 1331 Insert – Ring Wrench – 12mm – T10360

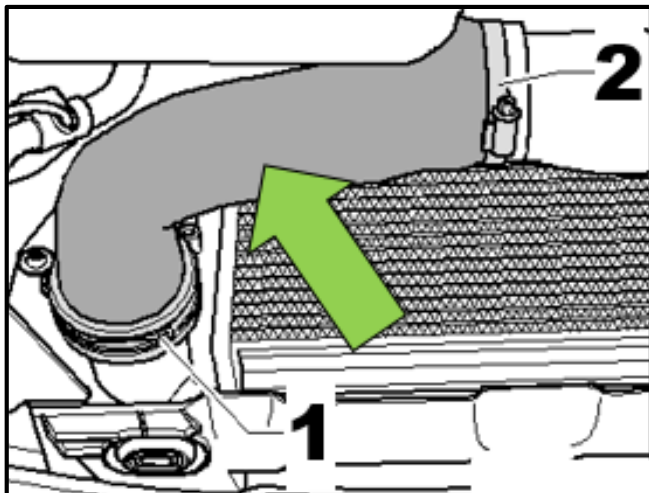
- Raise the vehicle on an appropriate hoist.
- Remove the underbody shield.
- Loosen the air guide hose clamps <1 and 2>.
- Disconnect and remove the air guide hose <arrow>.

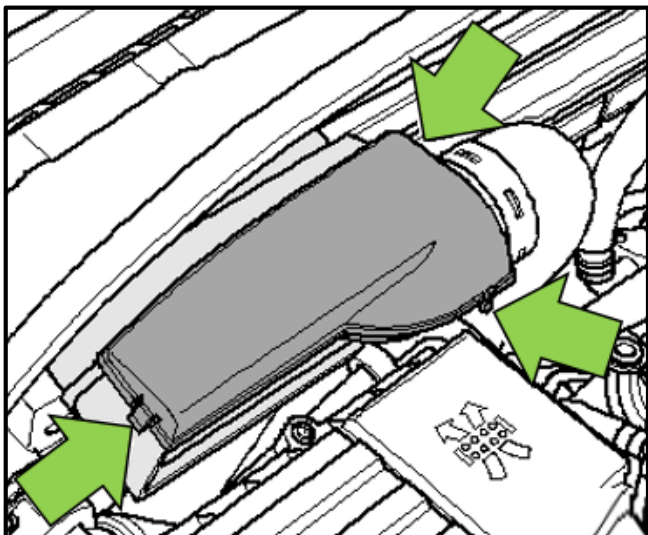
- Lower hoist.
- Disengage the side clips <arrows> and remove the air duct cover.

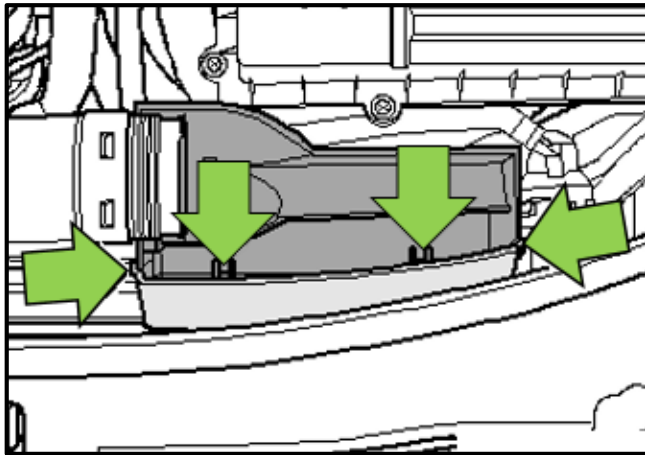
- Disengage the wire retainers <arrows> to unfasten the lower air duct.
- Remove the lower air guide and lower air guide hose.

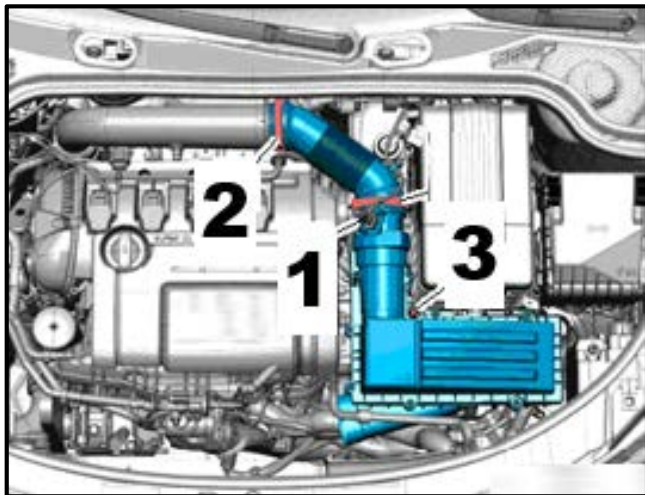
- Disconnect the Secondary Air Injection hose from the air filter housing.
- Disconnect the wiring harness from the Mass Air Flow Sensor <1>.
- Loosen the clamp <2> and remove the air guide hose.
- Loosen the mounting bolt <3>.
- Lift the air filter housing straight upward out of the mounting bracket.
- Remove the air filter housing together with the mass air flow sensor and connecting pipe.

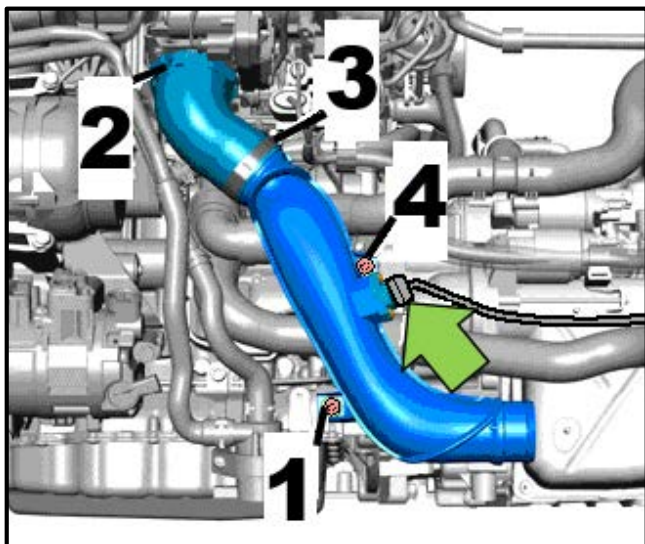
- Loosen the clamp <2>.
- If necessary, loosen the clamp <3>.
- Remove the mounting bolt <4>.
- Disconnect the electrical connector <arrow>.
- Remove the mounting bolt <1> and remove the air guide pipe.

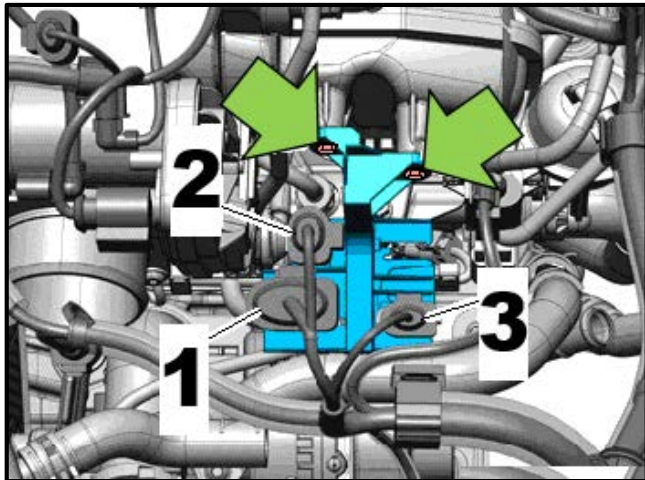
- Remove the connectors <1, 2, and 3> from the mounting bracket.
- Remove the mounting bolts <arrows>.
- Remove the mounting bracket.

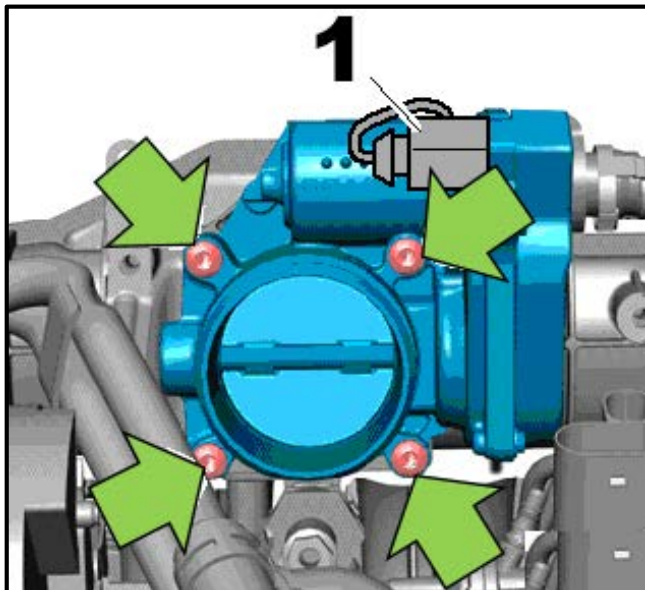
- Disconnect the connector <1> at the Throttle Valve Control Motor (J338).
- Remove the J338 mounting bolts <arrows> and remove the J338.

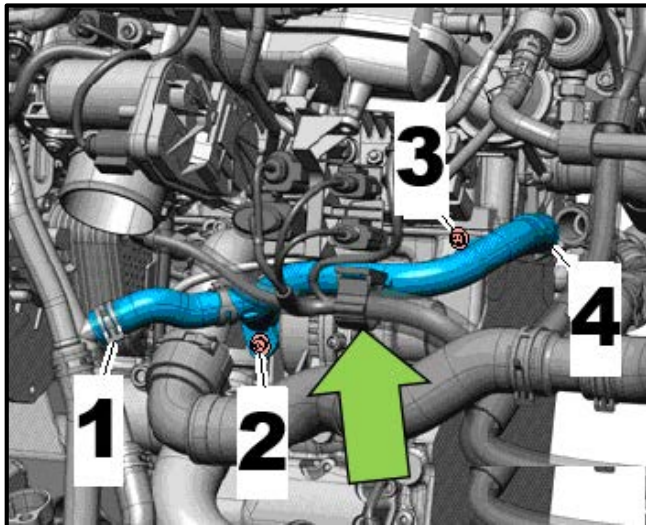
- Release the wiring harness retainer <arrow> and free up the wiring harness.
- Remove the coolant pipe mounting bolts <2 and 3>.
- Release the clamps <1 and 4> and remove the small coolant pipe.

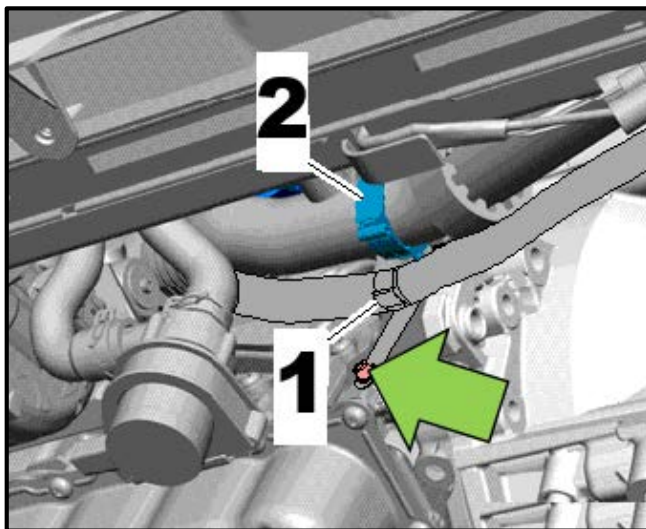
- Release the coolant hose and wiring harness retainers <1 and 2>.
- Remove the mounting bolt <arrow>.

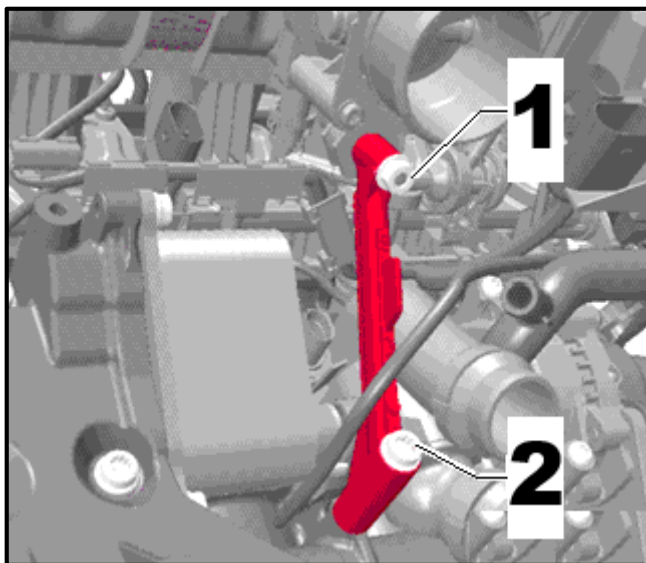
- Remove the nut <1> and mounting bolt <2>.
- Remove the intake manifold support.
- Remove the bonded rubber bushing for the intake manifold support on the intake manifold.

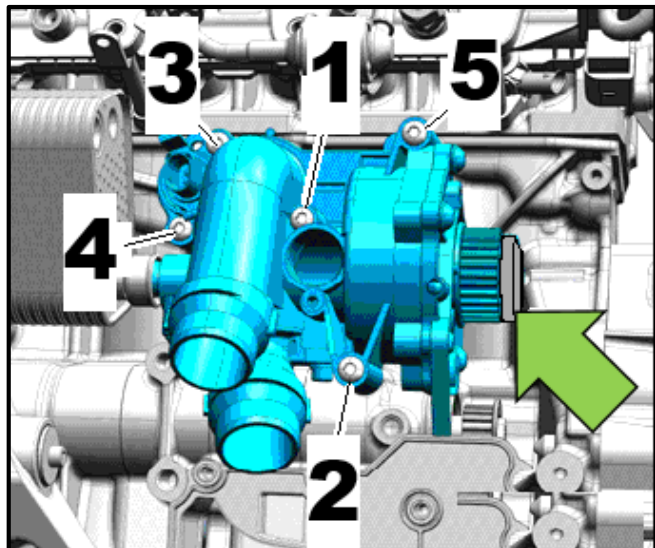
Do not discard the coolant pump mounting bolts. The three longer length bolts are re-used during reassembly.

- Remove the coolant pump mounting bolts <1 through 5>.
- Remove the coolant pump from the centering pin and disconnect it from the engine oil cooler.

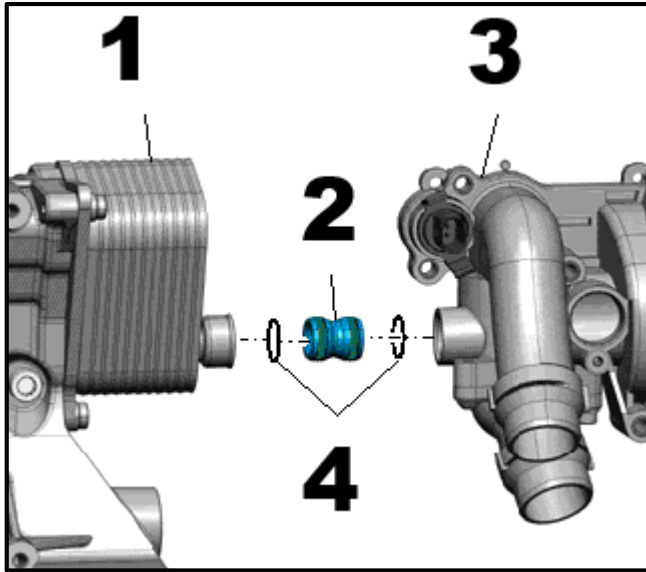
- Remove the O-rings from the connecting pipe <2>.
- Install replacement O-rings, P/N: WHT002001 onto the connecting pipe <2>.
- Coat the O-rings <4> with coolant.
- Inspect both centering pins and insert them into the cylinder block if necessary.

- Install the connecting pipe <2> into the engine oil cooler <1>.
- Position the replacement coolant pump, P/N: 06J 121 026 BG <3> onto the connecting pipe, then onto the centering pins in the cylinder block.
- Inspect the coolant pump and connecting pipe using a mirror to verify the pump is seated properly on the centering pins.

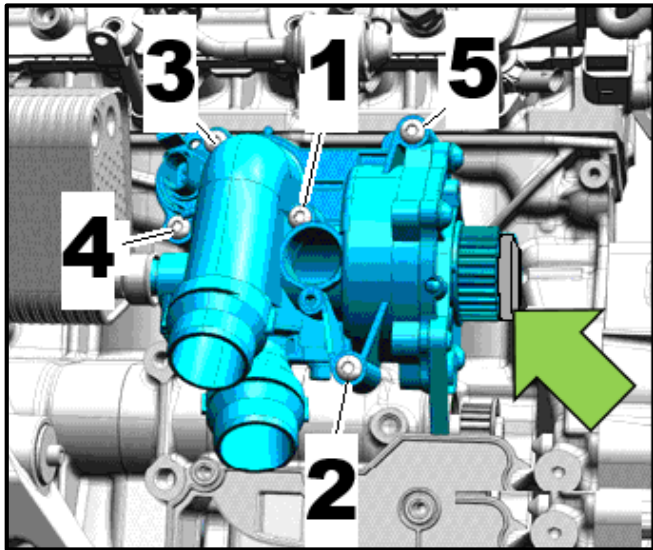
- Install the two new coolant pump mounting bolts, P/N: N91068001 <3 and 4>.
- Reinstall the three longer coolant pump mounting bolts <1, 2, and 5>.
- Tighten all the mounting bolts to **9 Nm** in the sequence shown (1 to 5).
- Remove the protective cap <arrow> from the new coolant pump drive wheel.
- Install the Engine Coolant Temp Sensor (G62).

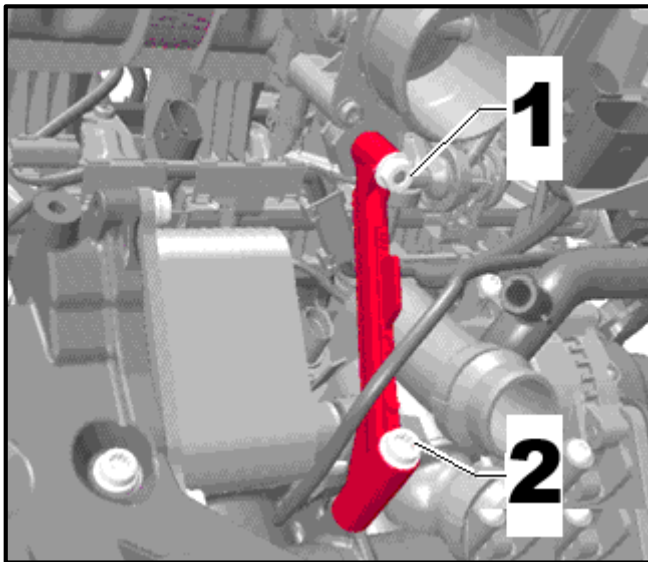
- Reinstall the bonded rubber bushing for the intake manifold support on the intake manifold.
- Reinstall the intake manifold support <as shown>.
- Install then tighten the nut <1> and mounting bolt <2>.

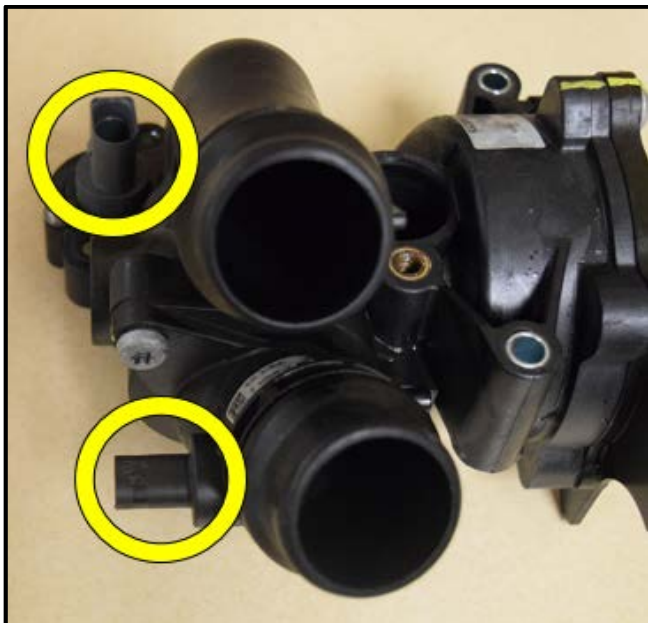
- Reconnect both electrical connectors <circles> on the coolant pump housing.

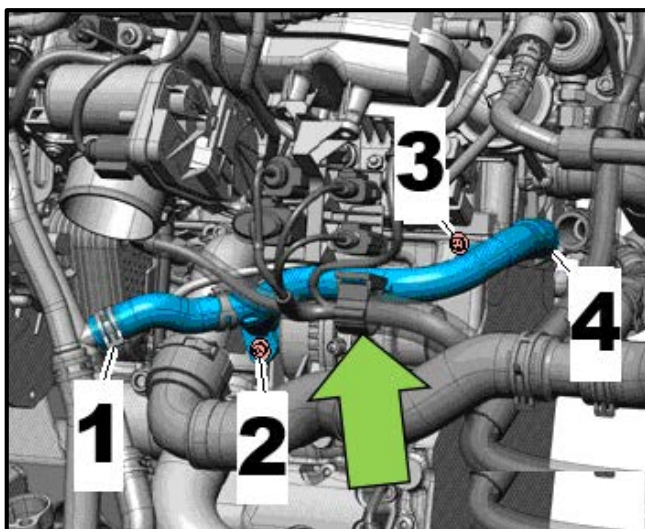
- Replace the seal, P/N: WHT 006 407, on the small coolant pipe at the coolant pump connection.
- Reinstall the small coolant pipe and refasten the clamps <1 and 4>.
- Reinstall then tighten the coolant pipe mounting bolts <2 and 3>.
- Refasten the wiring harness retainer <arrow> and secure the wiring harness.

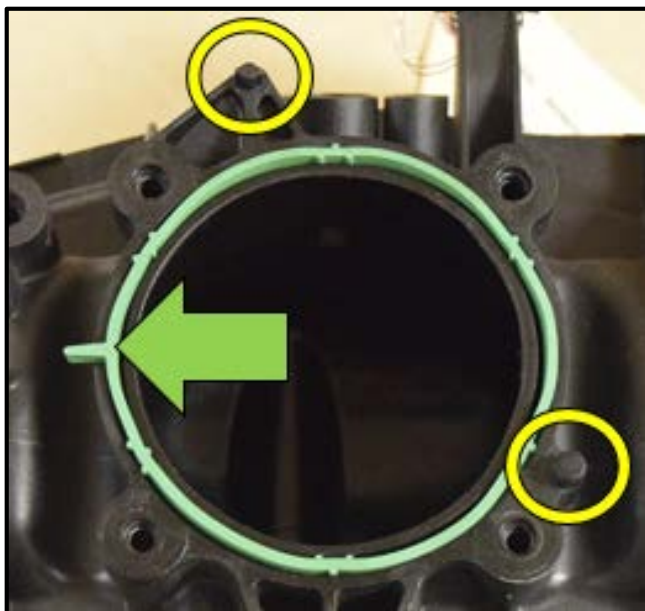
- Clean the Throttle Valve J338 sealing surface with a clean shop towel and acetone (or equivalent).
- Insert the replacement throttle valve seal, P/N: 06F133073D, into the intake manifold opening <as shown>.
- Align the tab <arrow> with the cut-out in the intake manifold.
- Position the J338 into place on the alignment pins <circles>, and install the mounting bolts by hand.

The rim of the seal must fit into the groove provided for it inside the intake manifold.

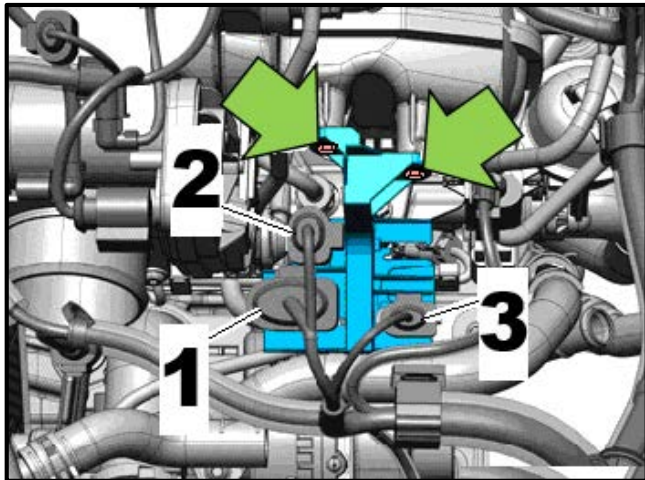
- Reinstall the mounting bracket and retaining bolts <arrows>.
- Reinstall the connectors <1, 2, and 3> into the mounting bracket.

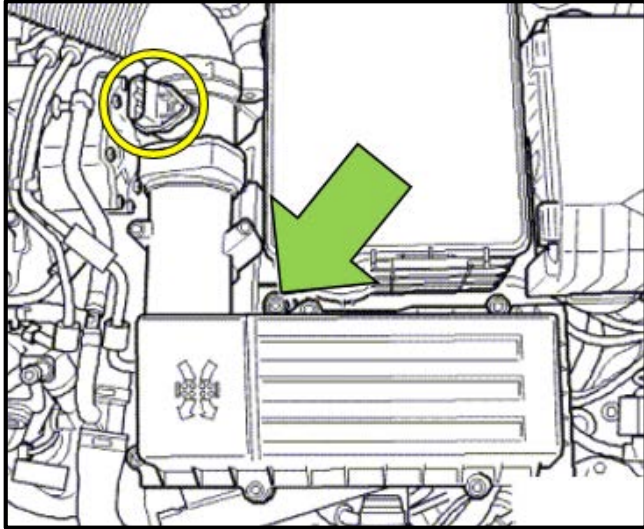
- Reinstall the air filter housing together with the mass air flow sensor and connecting pipe.
- Reconnect the Secondary Air Injection hose onto the air filter housing.
- Reconnect the wiring harness from the Mass Air Flow Sensor <circle>.
- Tighten the mounting bolt <arrow>.

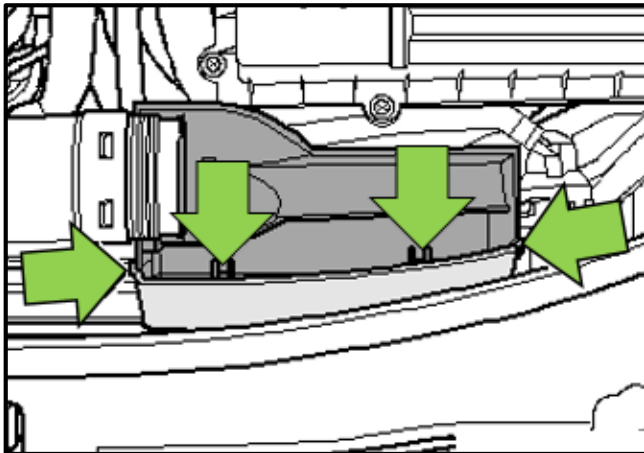
- Reinstall the lower air guide and lower air guide hose.
- Refasten the wire retainers <arrows> to secure the lower air duct.

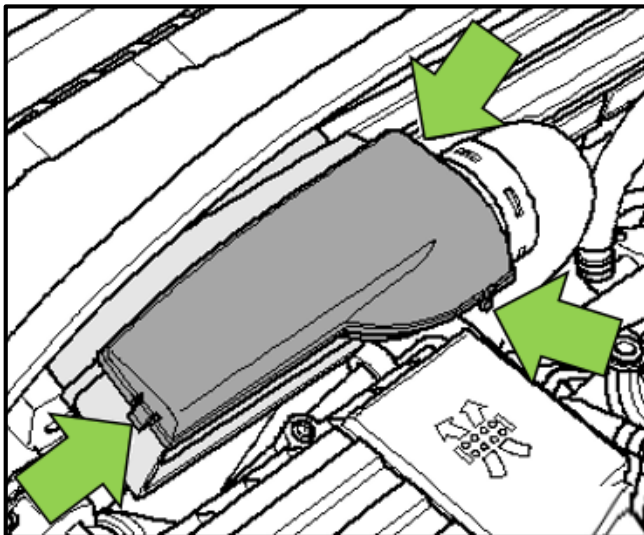
- Reinstall the air duct cover and refasten the side clips <arrows>.

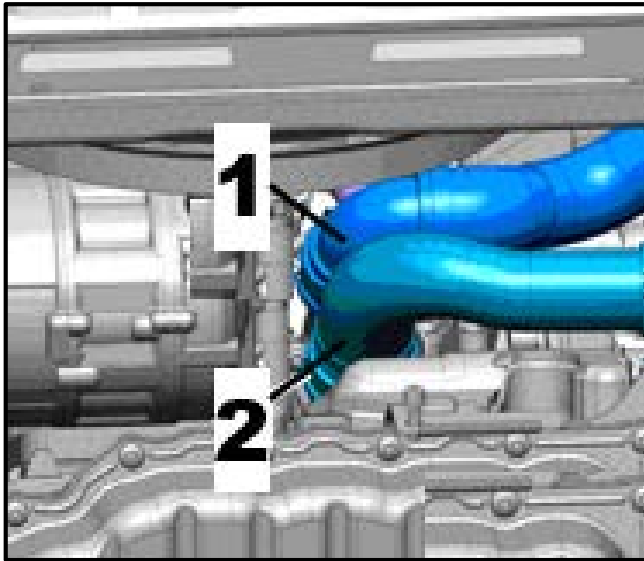
- Reinstall the coolant hoses <1 and 2>.

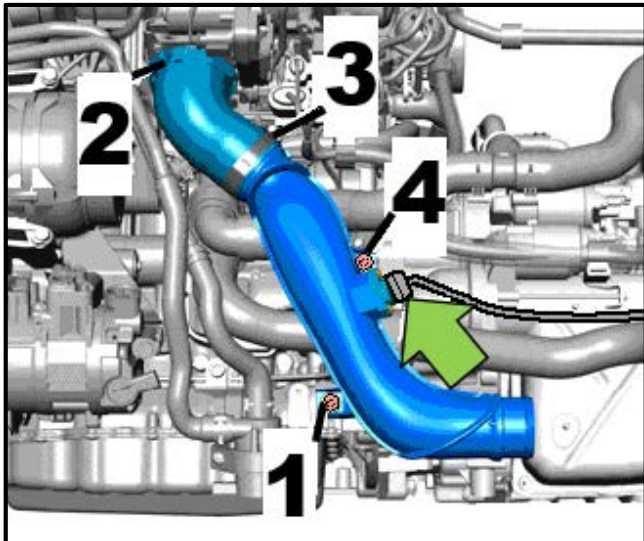
- Reinstall the air guide pipe.
- Tighten the clamp <2>.
- If necessary, tighten the clamp <3>.
- Reinstall and tighten the mounting bolts <1 and 4>.
- Reconnect the electrical connector <arrow>.

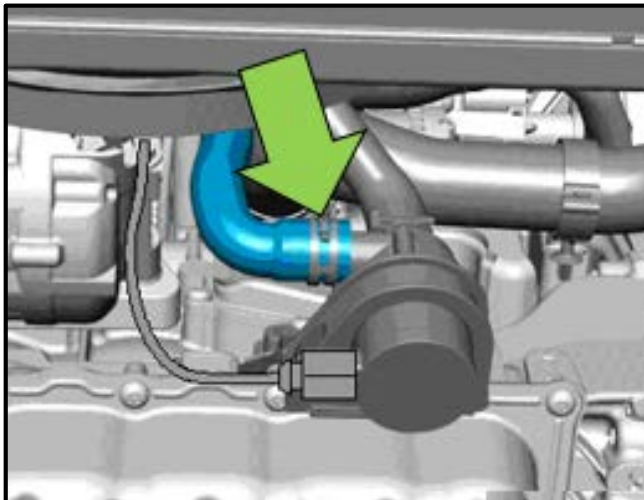
- Reinstall the lower coolant hose onto the After-Run Coolant Pump V51 <arrow> and fasten the clamp.

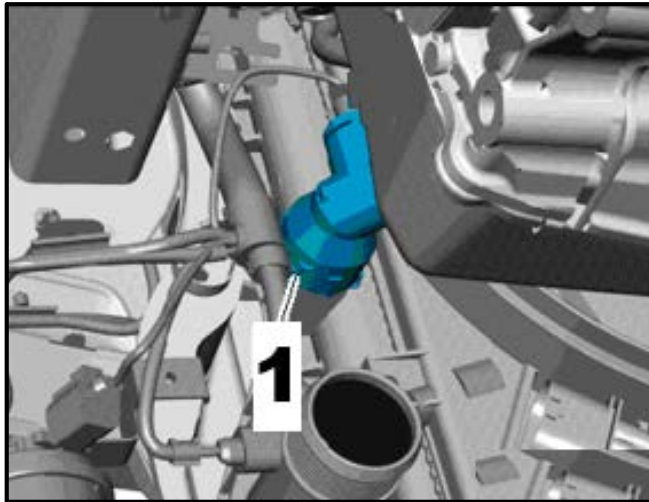
- Reconnect the lower coolant hose <1> to the radiator.

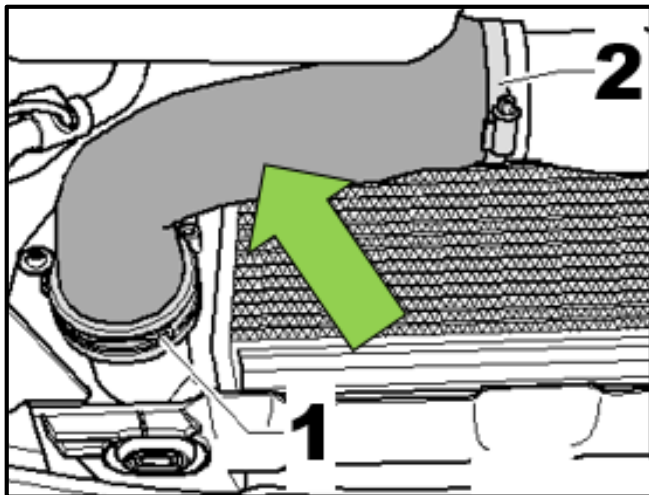
- Reinstall the air guide hose <arrow>, and fasten the clamps <1 and 2>.

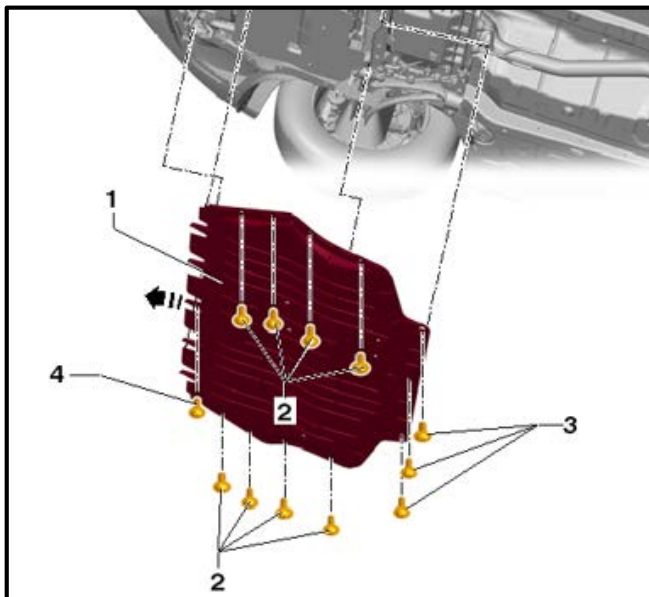
- Reinstall the underbody shield.
- Install the mounting bolts by hand.
- Torque the mounting bolts <2 and 4> to **2 Nm**.
- Torque the mounting bolts <3> to **6 Nm**.

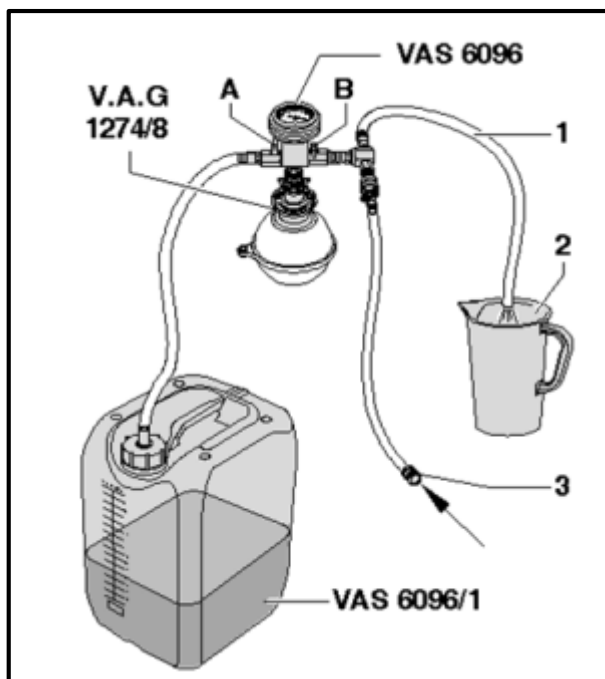
- Fill the Cooling System Charge Kit - VAS6096-Cooling System Charge Kit - Reservoir -VAS6096/1- with at least 10 liters of premixed coolant with the proper mixture ratio.
- Install the Cooling System Tester - Adapter -VAG1274/8- onto the coolant expansion tank <as shown>.
- Disconnect the hose between the Cooling System Charge Kit - VAS 6090 and the VAG 1274/8.
- Place the air outlet hose <1> in a separate container <2> to catch any residual coolant in the system.
- Close the valves <A and B> on the VAG 1274/8.
- Connect the inlet hose <3> to a compressed air source.

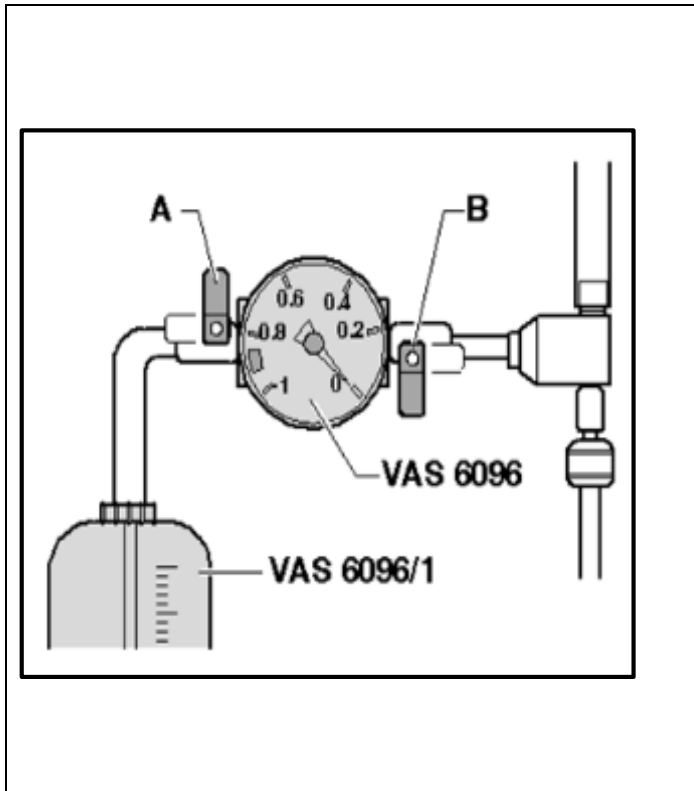
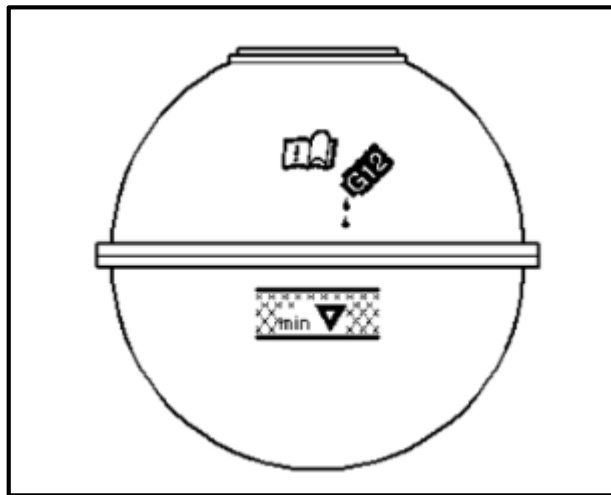
- Open the valve <B>.
- Allow the VAS 1274/8 to pull the cooling system into a vacuum until the needle reaches the green section on the dial (about .9 bar).

- Reconnect the hose between the Coolant System Charge Kit – VAS 6090 and the VAS 1274/8.
- Open the valve <A> briefly and allow the hose from the VAS 6096 to fill with coolant.

- Close the valve <A> as soon as it fills with coolant.
- Re-open the valve <B> and allow air to flow for at least 2 minutes.
- The needle must remain in the green section of the dial.

- Close the valve <B>.
- Open the valve <A>.
- Allow the cooling system to fill until the needle on the VAS6096 has reached “0” and coolant flow into the reservoir has stopped.
