SERVICE BULLETIN

Classification: AT15-015a	Reference: NTB15-086a	Date: November 11, 2015
------------------------------	--------------------------	----------------------------

2013-2015 ALTIMA AND 2014-2016 ROGUE; MIL ON WITH DTC P0776

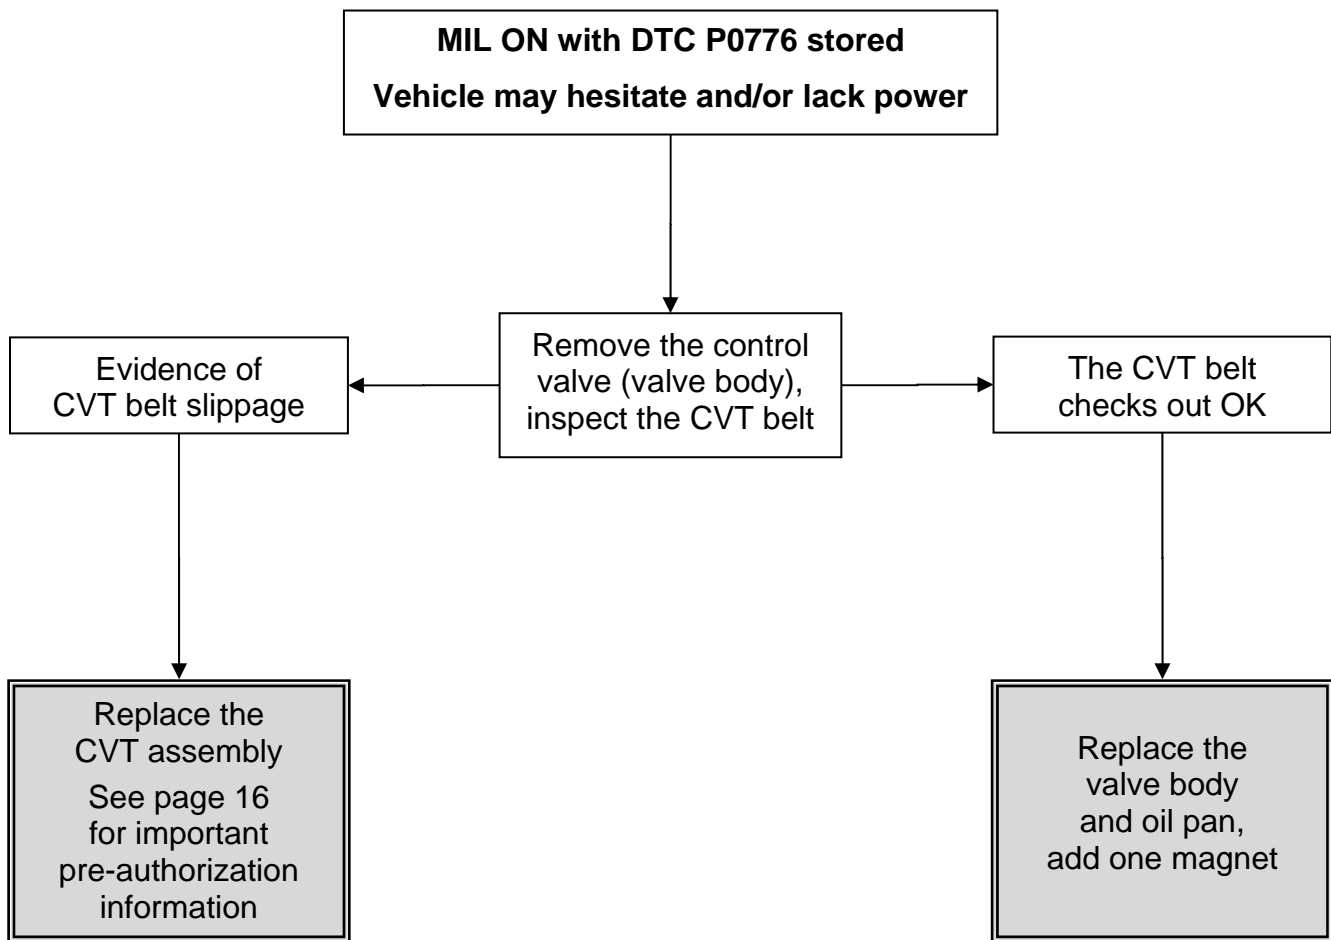
Repair Flow Chart

Refer to the **Repair Flow Chart** on page 2.

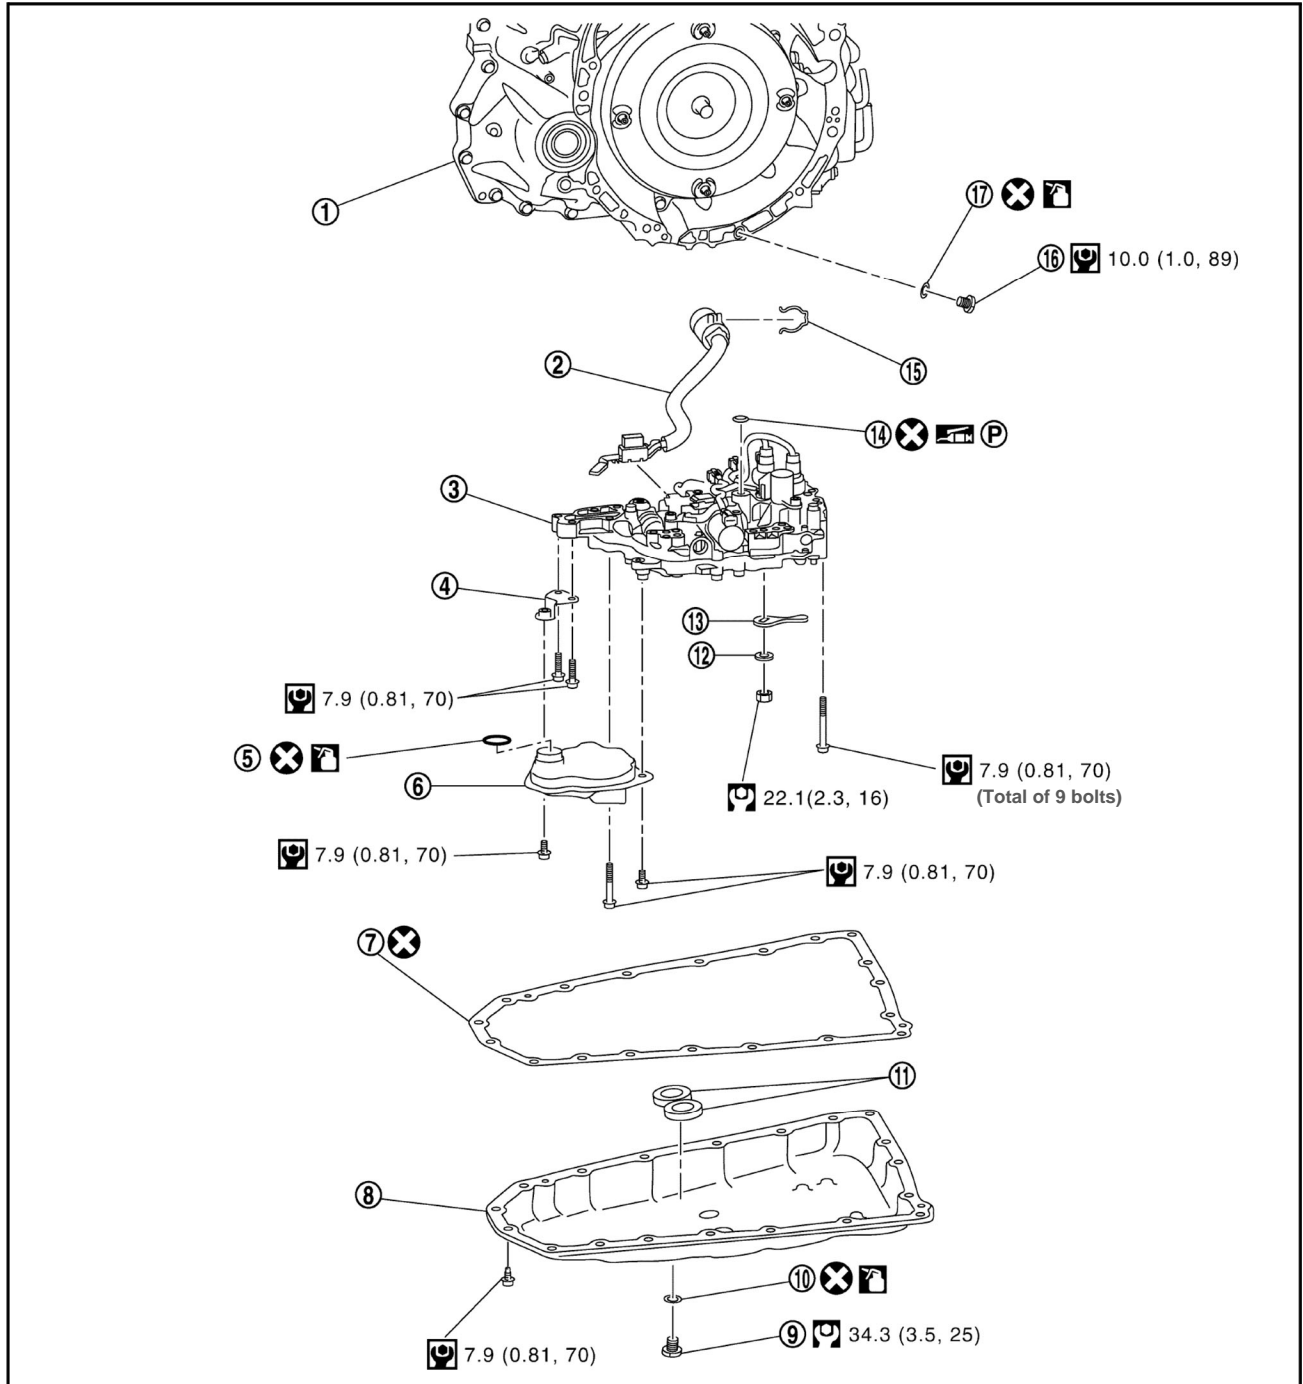
Figure 1

Exploded View

| ① | Transaxle (CVT) assembly | ② | Terminal cord assembly | ③ | Control valve (valve body) |
| ④ | Bracket | ⑤ | O-ring | ⑥ | Oil strainer assembly |
| ⑦ | Oil pan gasket | ⑧ | Oil pan | ⑨ | Drain plug |
| ⑩ | Drain plug gasket | ⑪ | Two original magnets | ⑫ | Spring washer |
| ⑬ | Manual plate | ⑭ | Lip seal | ⑮ | Snap ring |
| ⑯ | Overflow plug | ⑰ | O-ring | | |

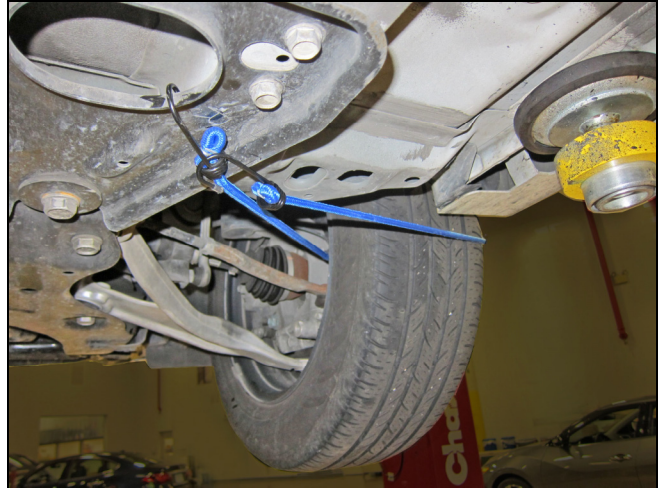
Figure 2

2. Secure the front right tire with a suitable strap.
 - This will assist in making the belt turn.
3. Mark the front left tire with a suitable marking.
 - This will assure all 360° of the belt is inspected.

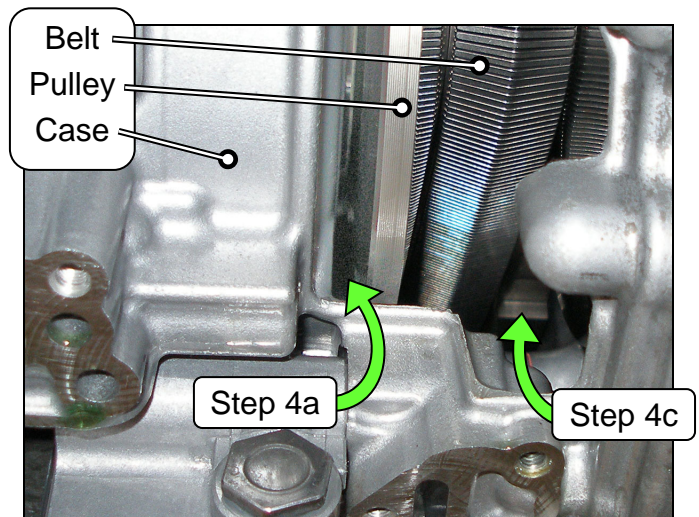
- a. Insert the camera lens between the CVT case and pulley where shown in Figures 3 and 4.
 - Insert the lens approximately seven (7) inches, and then view the side of the belt that contacts the pulley.

- c. If the inspection result is OK, inspect the other side of the belt.
- Insert the the camera lens in the second location where shown in Figure 3 and 6, and then perform step 4b again.
- d. If the inspection result is OK 360° on both sides of the belt, skip to step 5 on the next page.
- If any evidence of belt slippage is found, go to step 4e, and then step 6.
 - For additional information, see video # 544: “CVT Belt Inspection”. This video is located under the TECH TRAINING GARAGE VIDEOS tab in Virtual Academy.

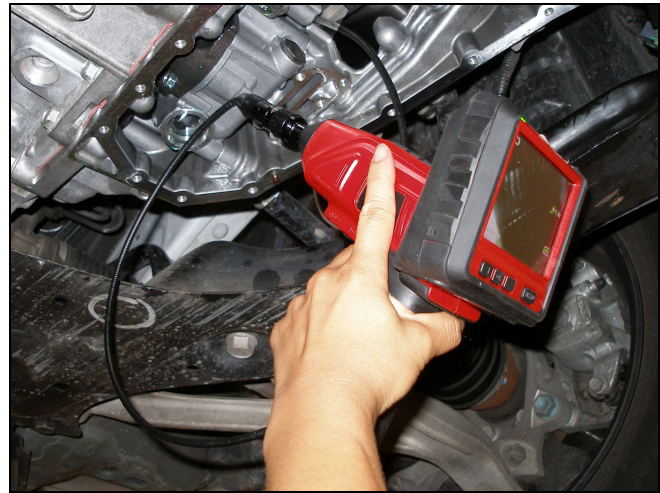
Figure 5

- Holding the borescope with one hand allows for turning the tire with the other hand (see Figure 5).

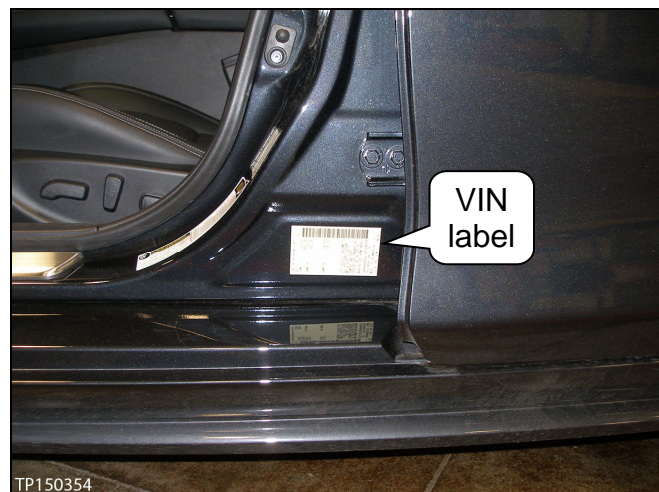
Figure 7

- e. Once CVT replacement is determined as required, use borescope J-51951 to record a 15 second or less continuous video of the most severe evidence of belt slip and the VIN on the F.M.V.S.S. certification label (VIN label). See Figure 7.

NOTE: This required video must be attached to the Powertrain Call Center CVT Preauthorization Form (in ASIST) prior to calling for authorization. Failure to submit a continuous video will cause immediate denial of request for replacement.

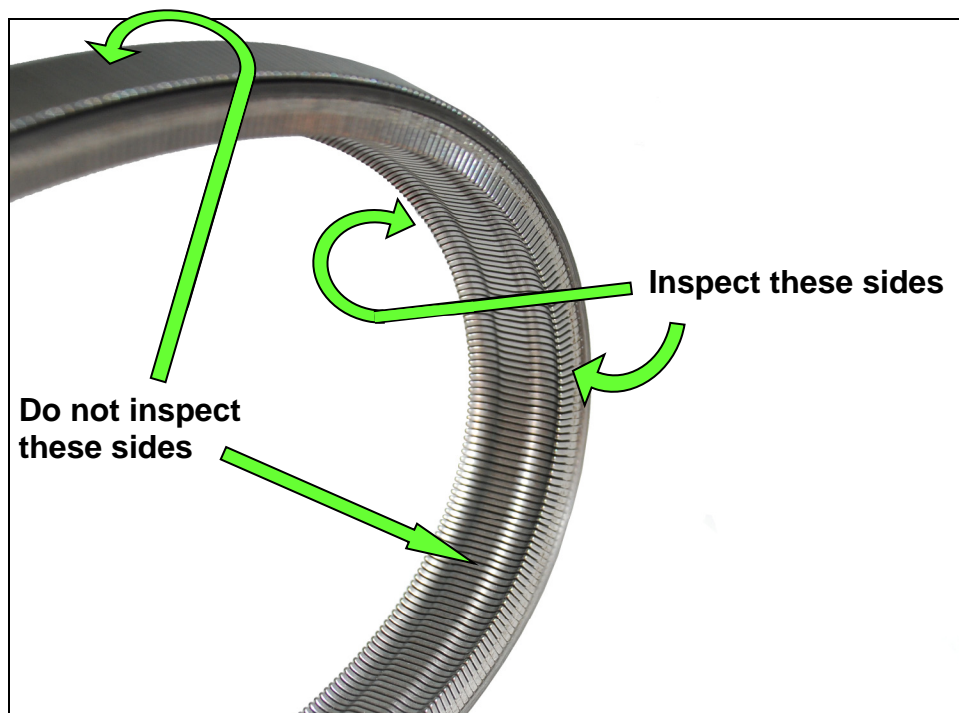
Figure 8

4. Using borescope J-51951 with mirror attachment, inspect the entirety of the two sides of the belt that come in contact with the pulleys (see page 7, Figure 8). Reference the pictures on pages 7 through 11 for comparison.

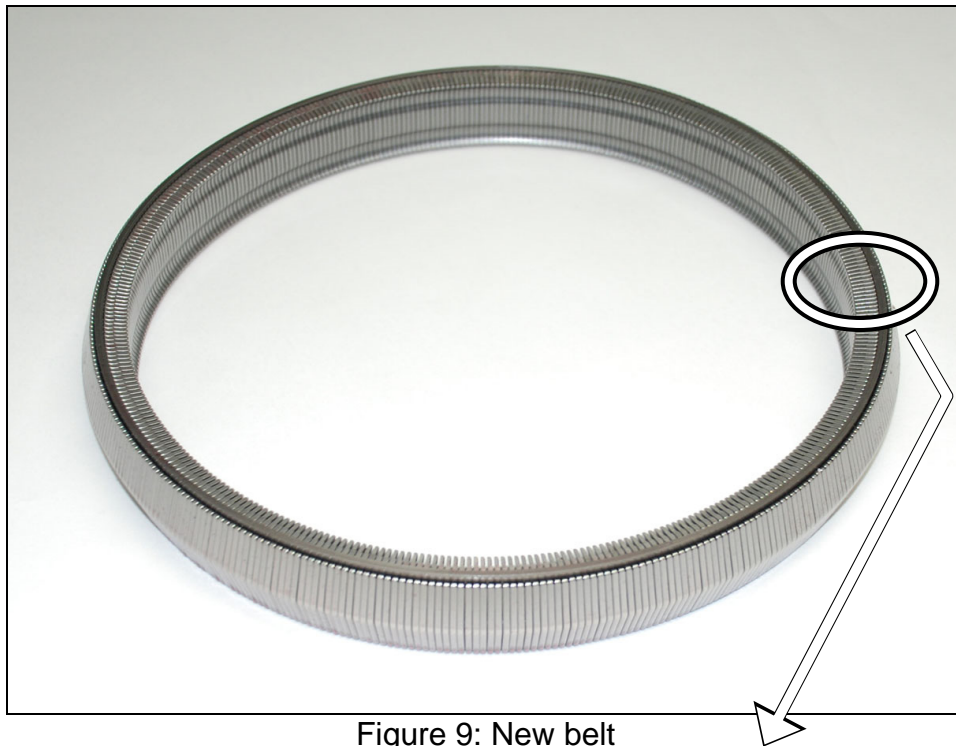
Figure 9: New belt

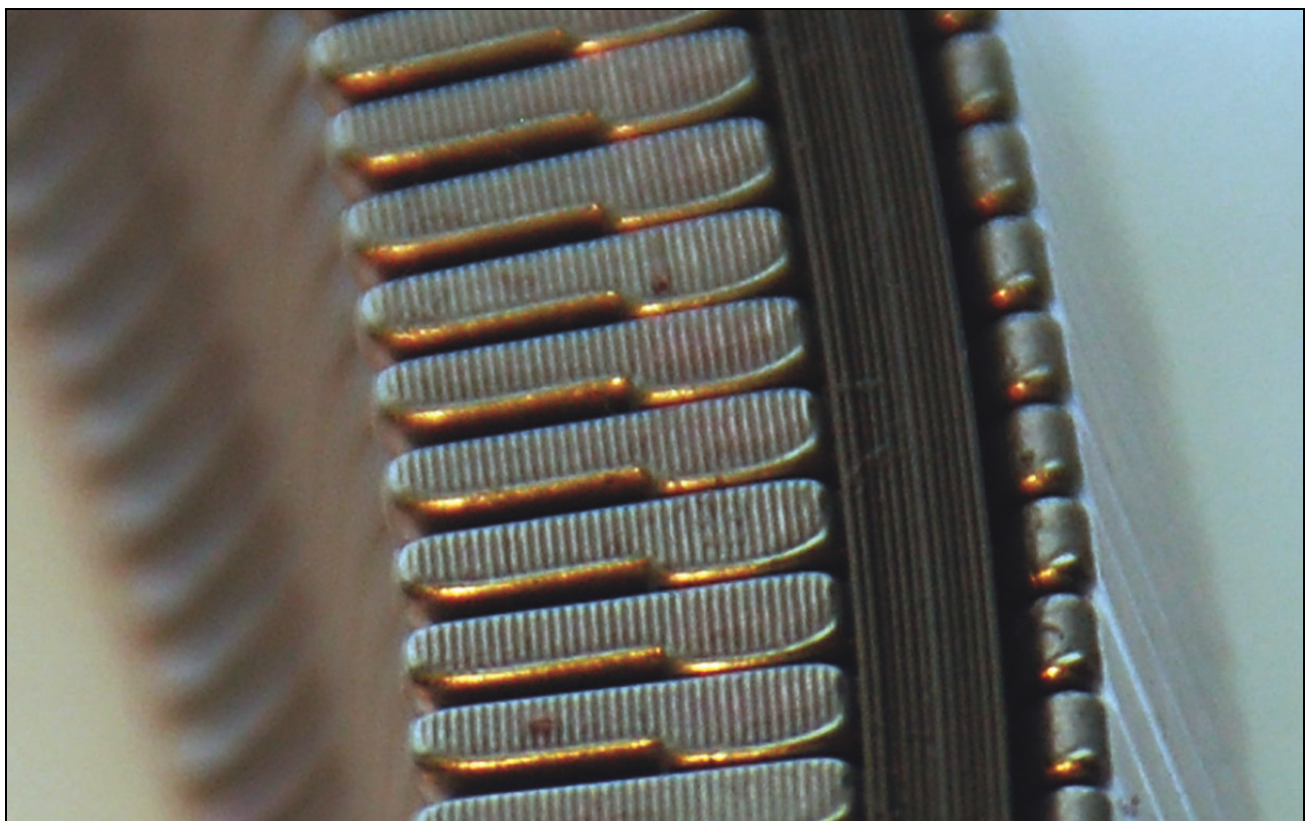
Figure 10: Close-up of section to be inspected

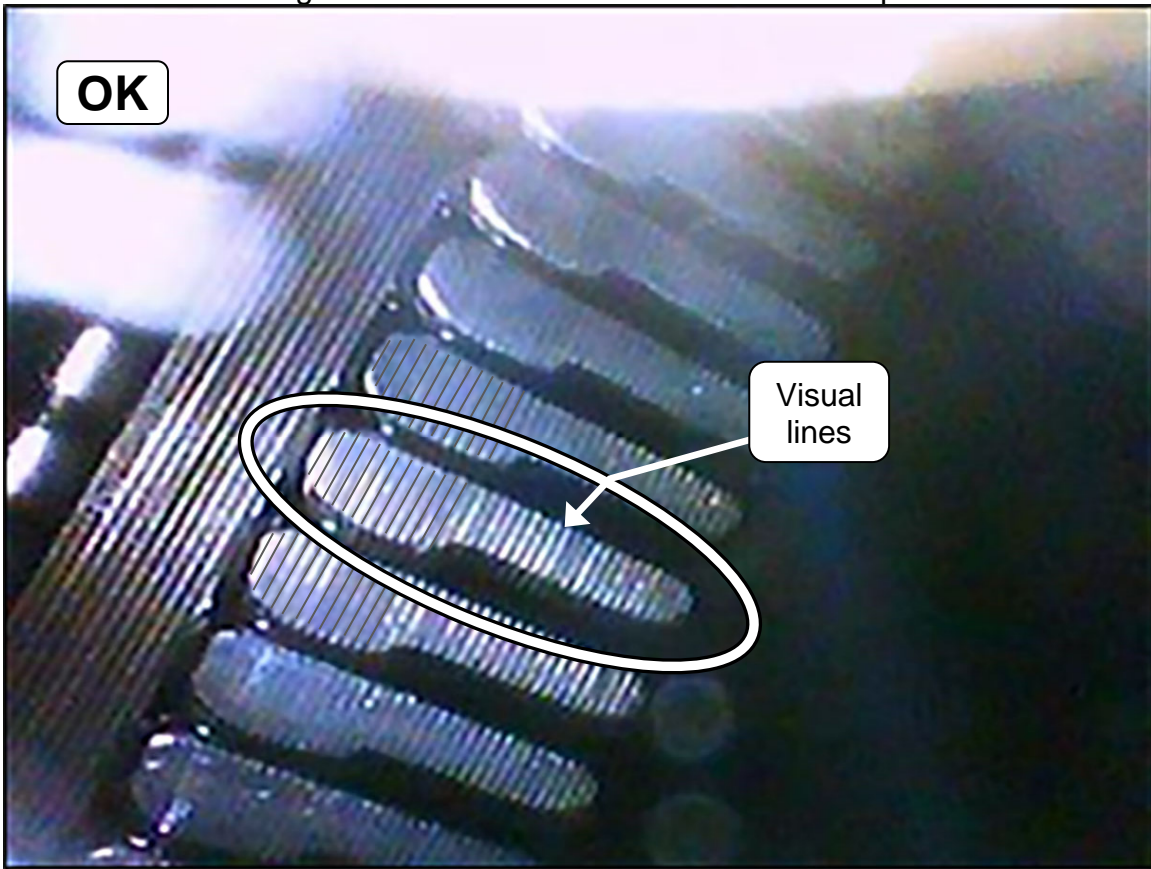
Pictures in Figures 11 and 12 were taken with borescope J-51951.

Figure 11: Belt is OK

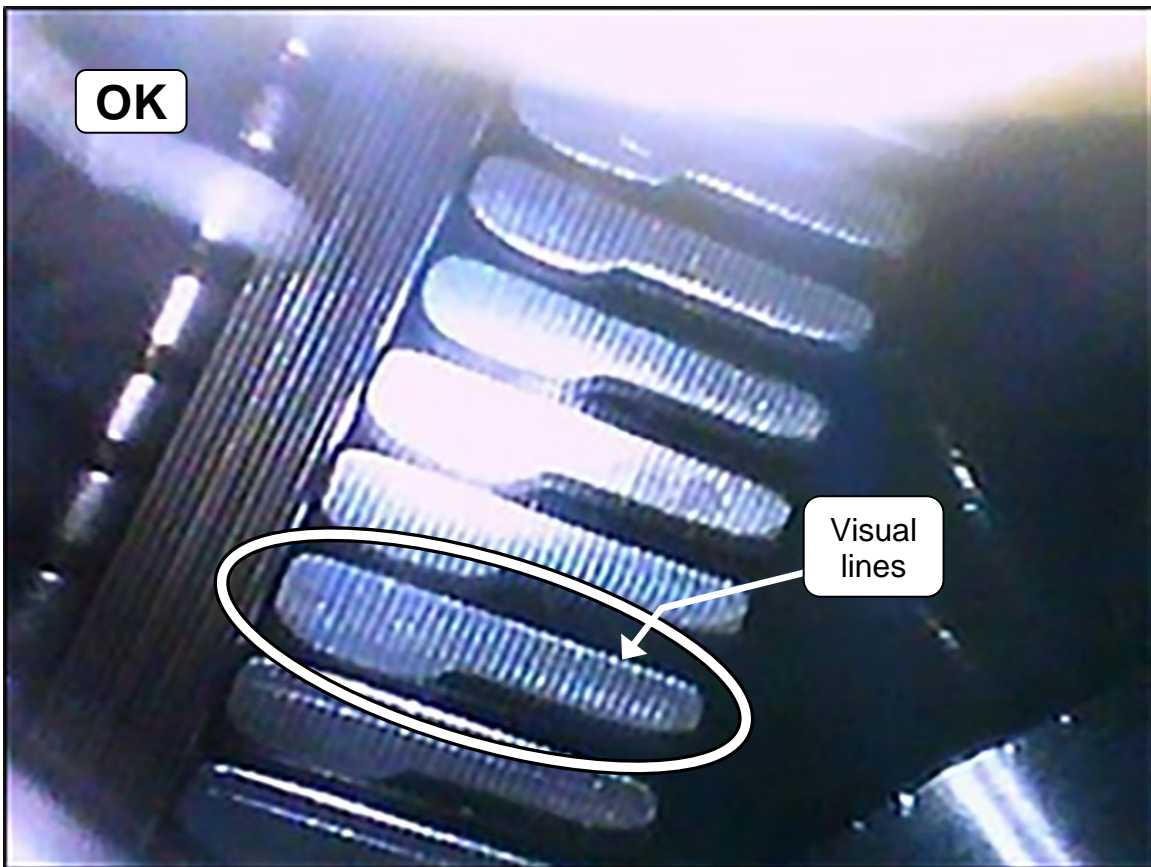
Figure 12: Belt is OK

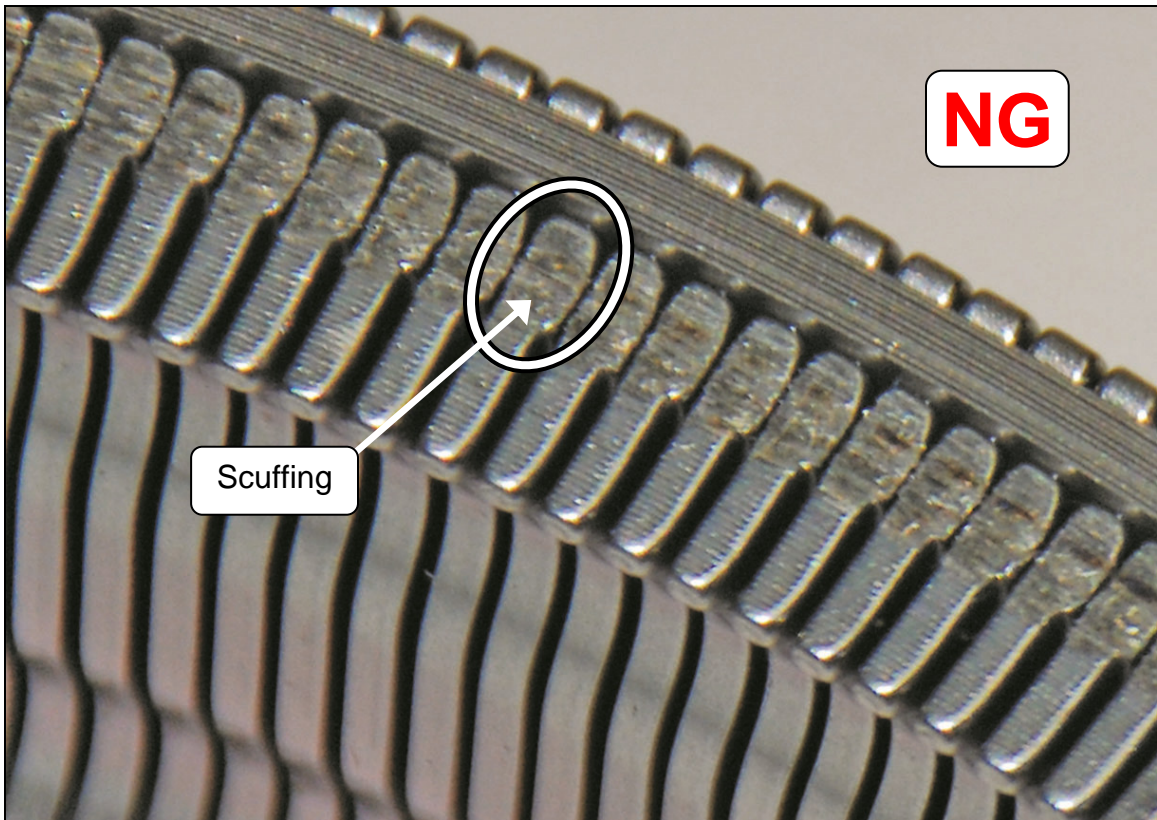
Figure 13: Example of NG belt

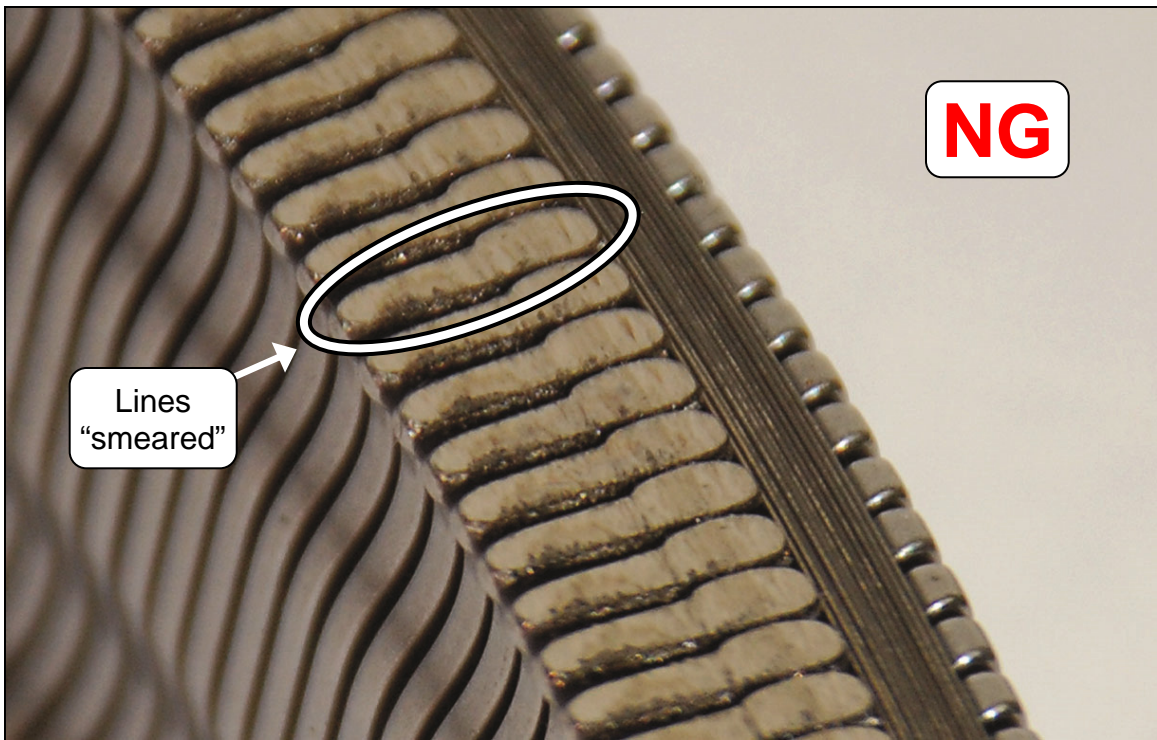
Figure 14: Example of NG belt

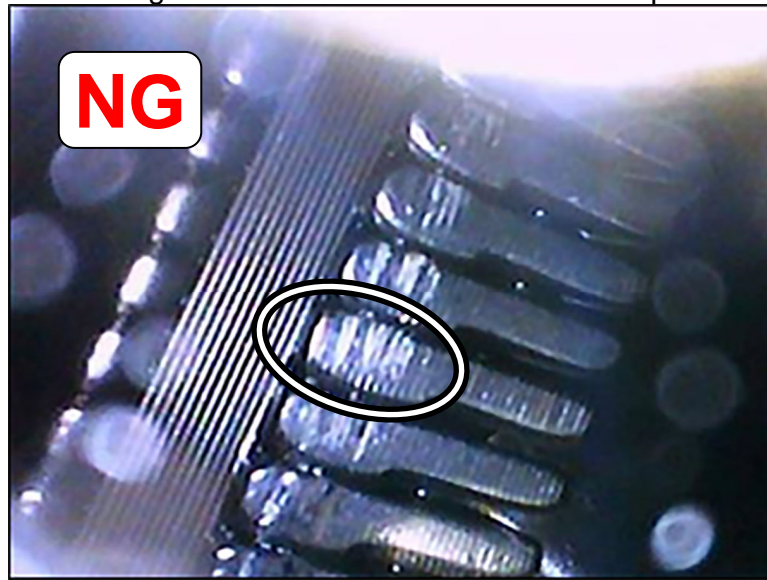
Pictures in Figures 15-17 were taken with borescope J-51951.

Figure 15: Example of NG belt

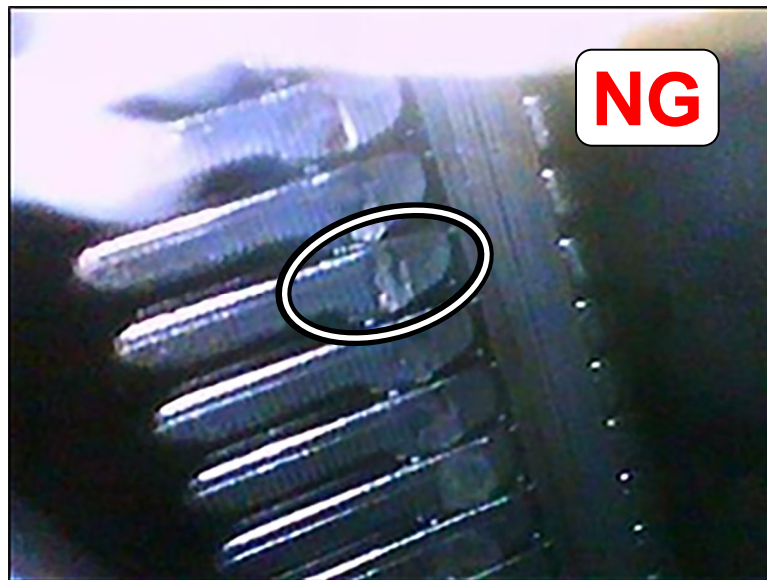
Figure 16: Example of NG belt

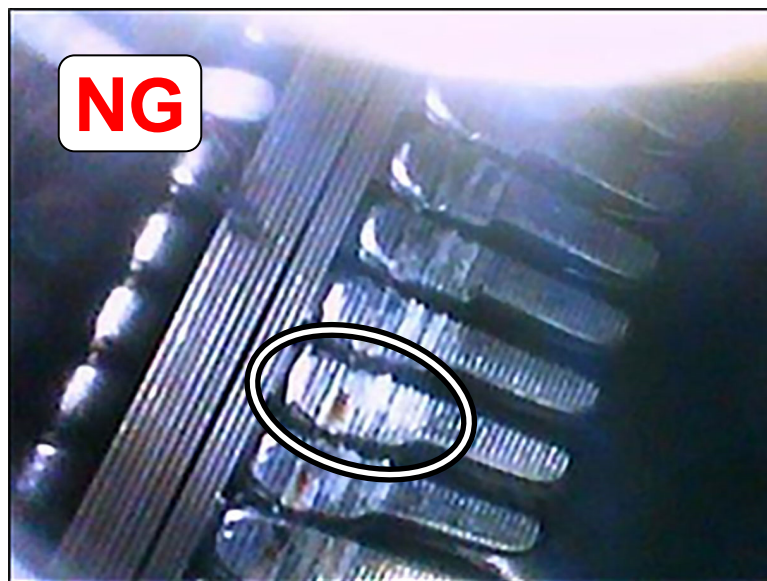
Figure 17: Example of NG belt

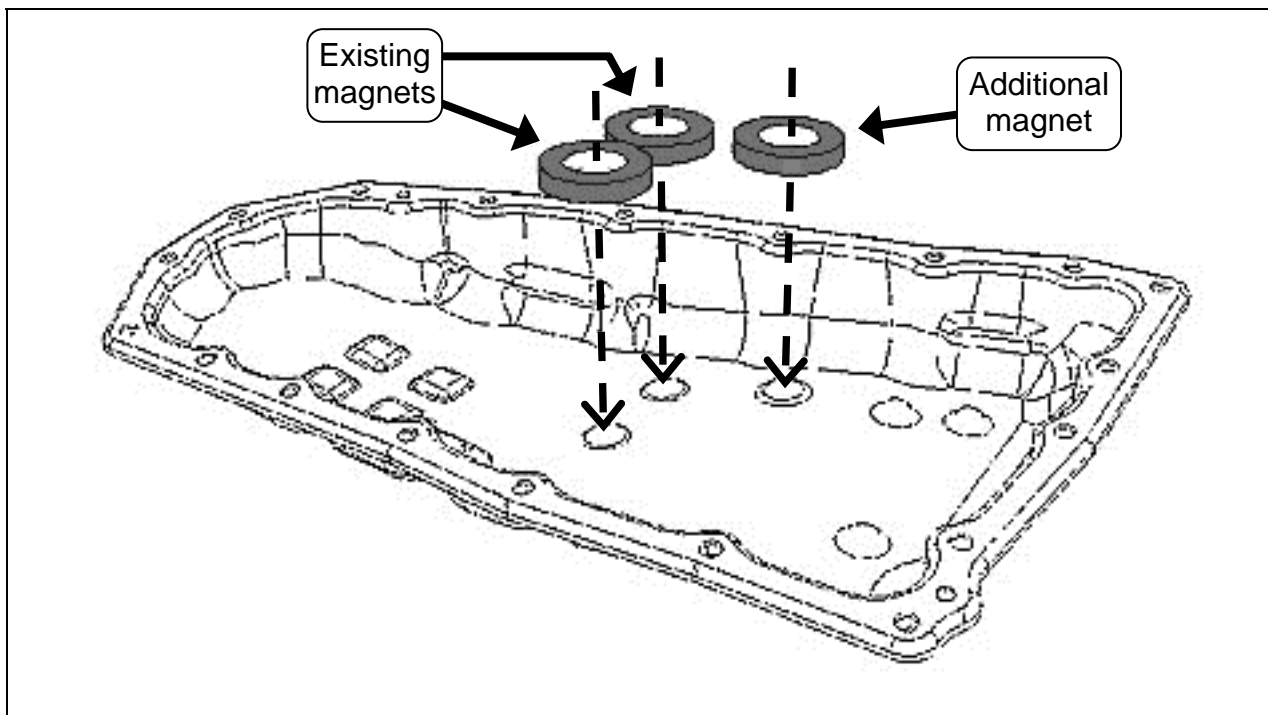
Figure 18

- Install the one additional magnet and two existing magnets where shown in Figure 18.
- Make sure the new oil pan and magnets are thoroughly clean before installing.

2. Install a new style oil pan with the addition of a third magnet.

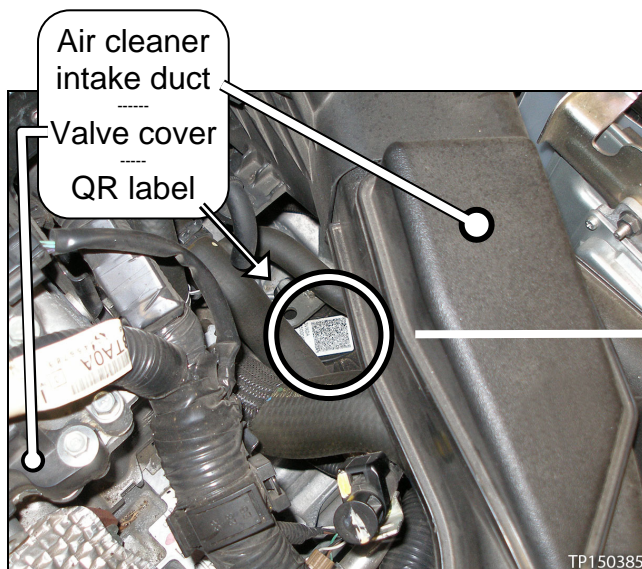
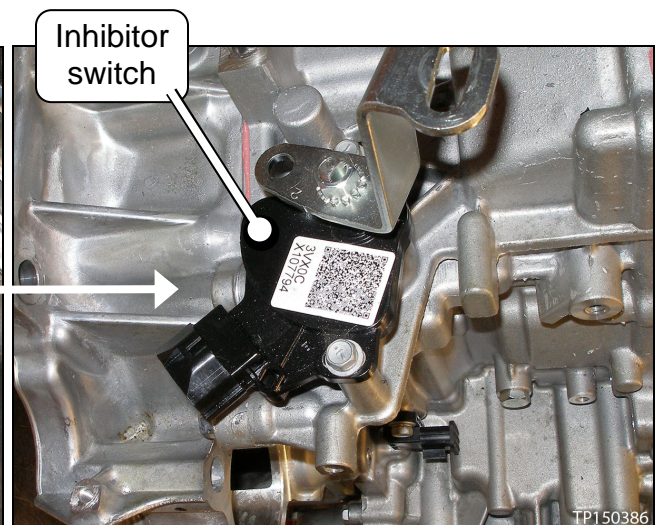
- Refer to **TM – Transaxle & Transmission / RE0F10D / BASIC INSPECTION**, and perform **ADDITIONAL SERVICE WHEN REPLACING TRANSAXLE ASSEMBLY**.
 - Check for fluid leakage.
 - Attach the QR label with the new calibration data onto the transmission range switch (inhibitor switch).
 - See Figure 19 and 20 below.
 - A QR Label and CD-R are included with the replacement valve body.
