# SERVICE BULLETIN

Classification: EC15-016	Reference: NTB15-111	Date: December 22, 2015
-----------------------------	-------------------------	----------------------------

## 2013-2015 ALTIMA; LOW POWER / STOP LAMPS STAY ON

**APPLIED VEHICLE:** 2013-2015 Altima (L33)

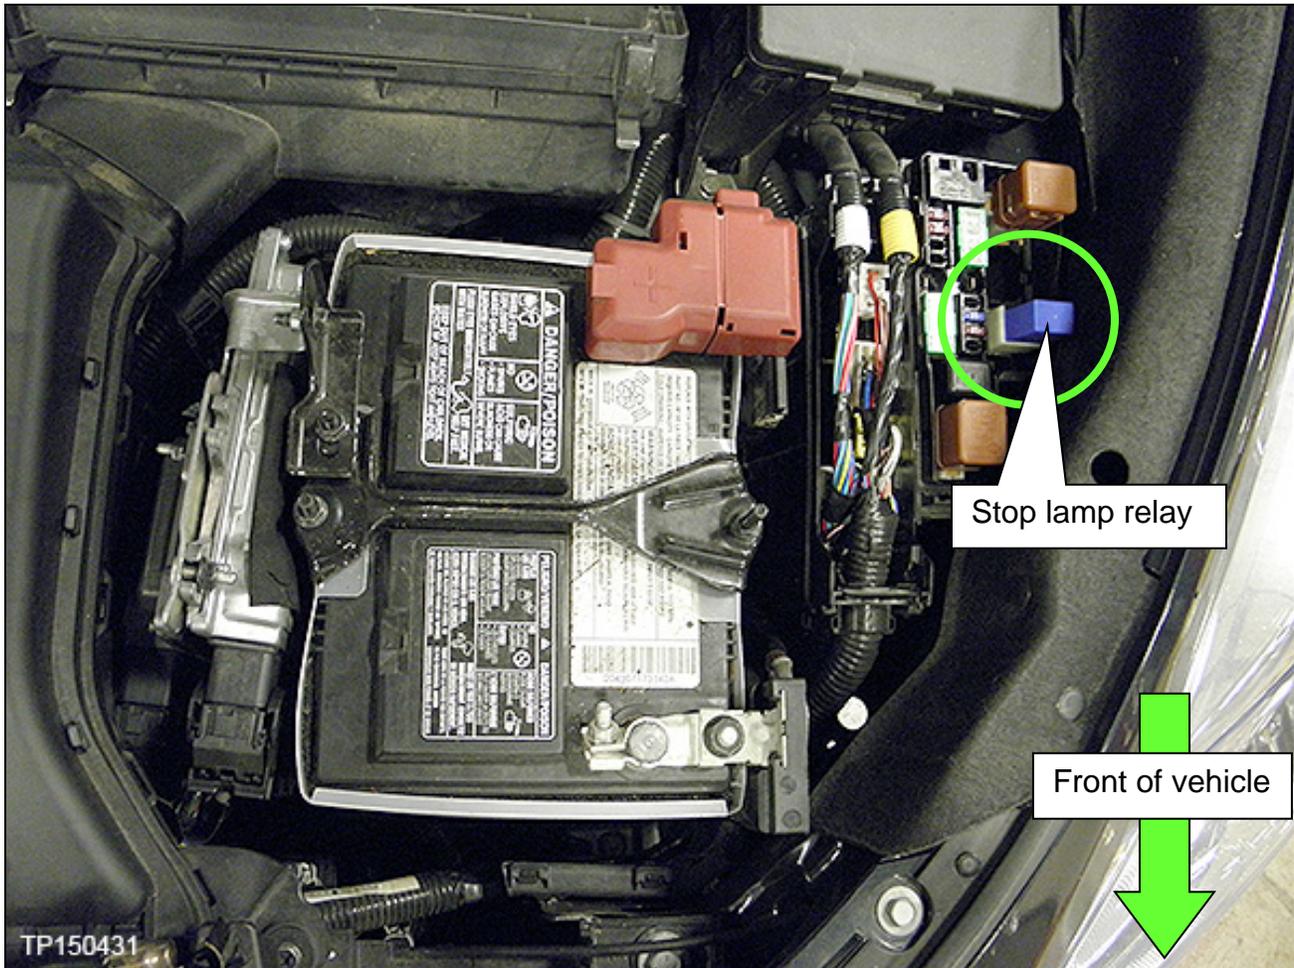
Figure 1

1. Remove the stop lamp fuse (#10) from the “junction box” fuse block in the Instrument panel.
2. Remove “fuse and fusible link box” (fuse box) cover and locate stop lamp relay (Figure 1).
  - Fuse box located next to the 12 volt battery.

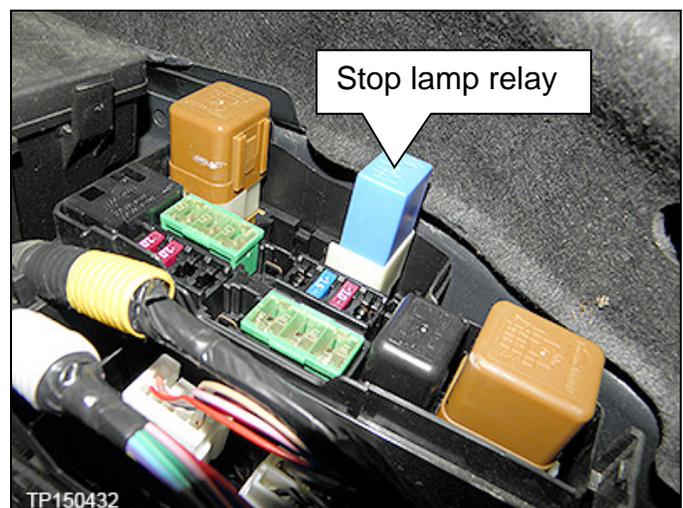
Figure 2

3. Remove the stop lamp relay (Figure 2).

**NOTE:** This relay will not be reinstalled.

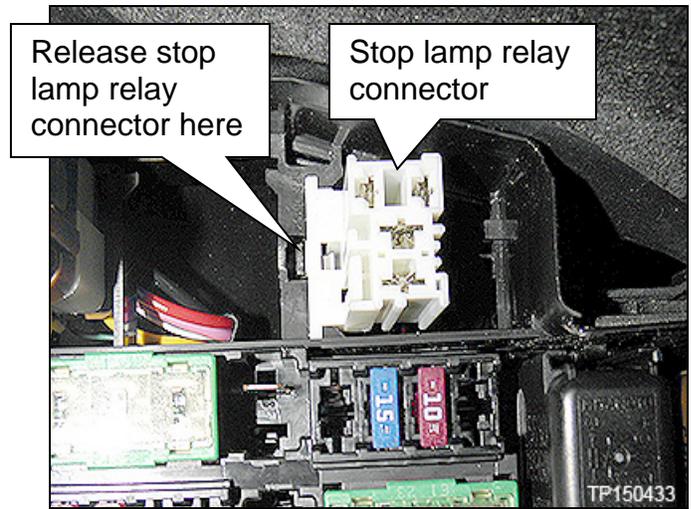
Figure 3

4. Release the stop lamp relay connector (Figure 3).

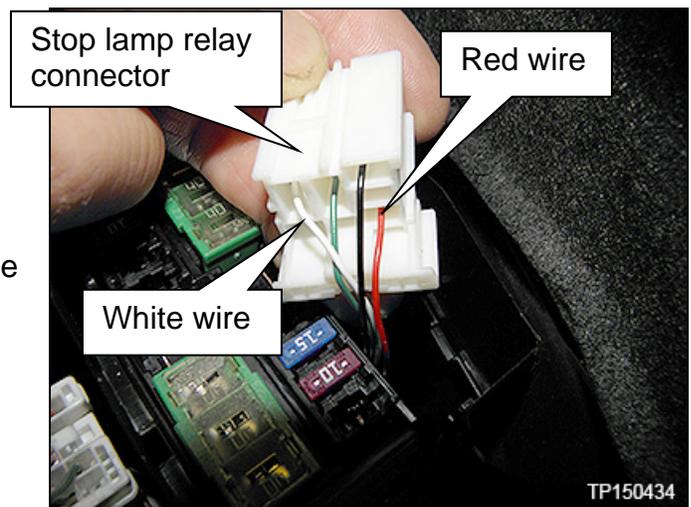
Figure 4

5. Locate the red and the white wires on the bottom of the stop lamp relay connector (Figure 4).

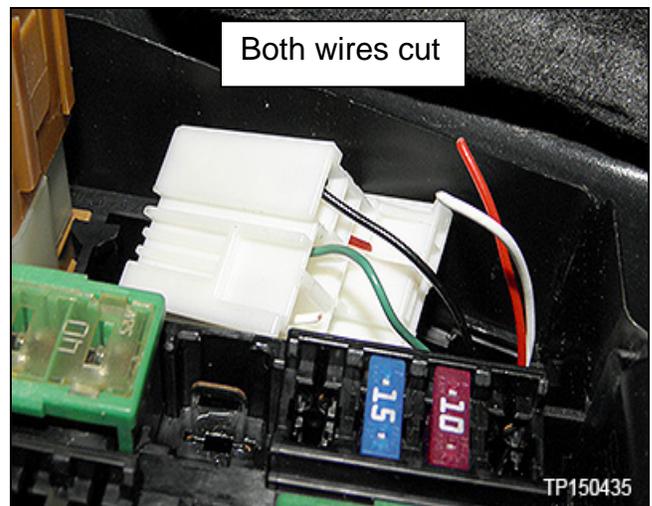
Figure 5

6. Cut the red and white wires flush with the bottom of the stop lamp relay connector (Figure 5).

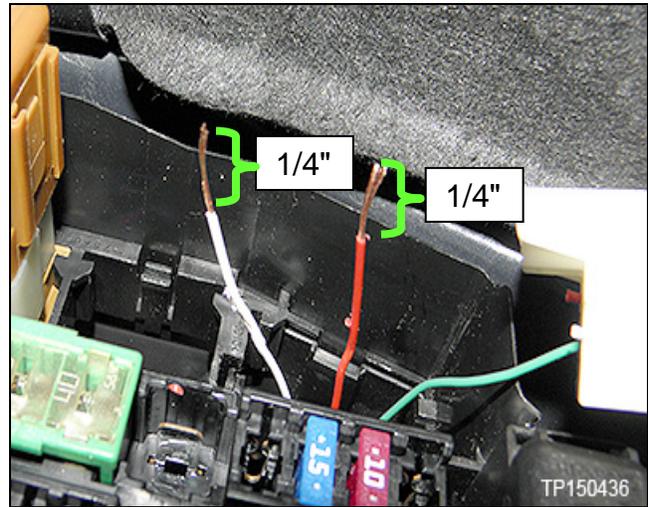
Figure 6

7. Strip approximately 1/4" from the ends of both the red and the white wires (Figure 6).

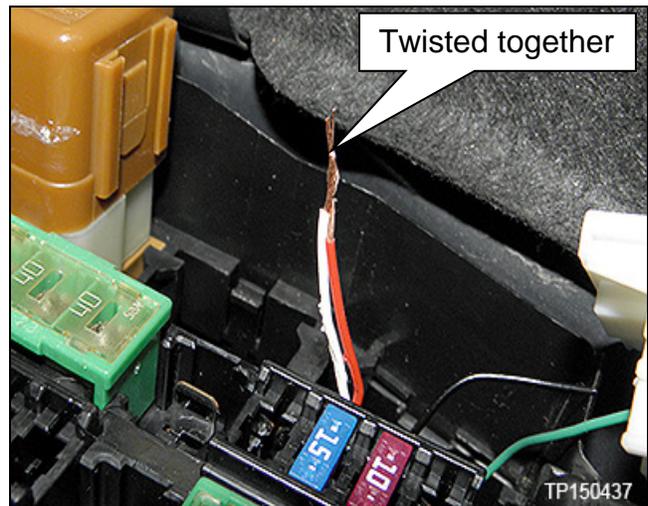
Figure 7

8. Twist the red and white wires together (Figure 7).

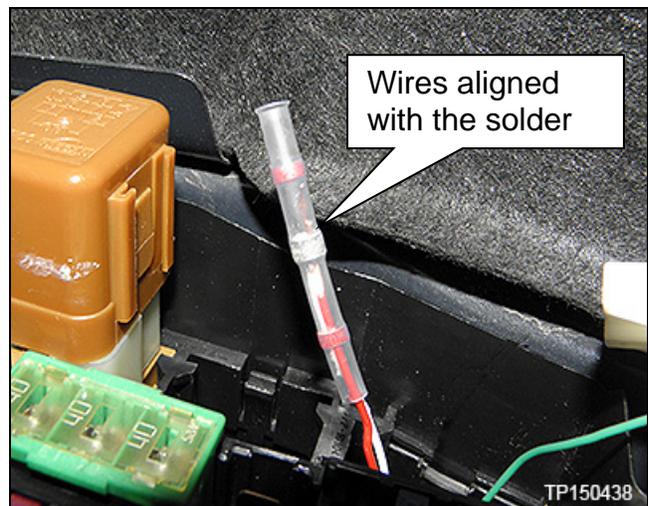
Figure 8

9. Slide a solder sleeve connector (#J-47003-2) over the twisted pair (Figure 8).
- Confirm that the bare wires are aligned with the solder in the center of the connector.

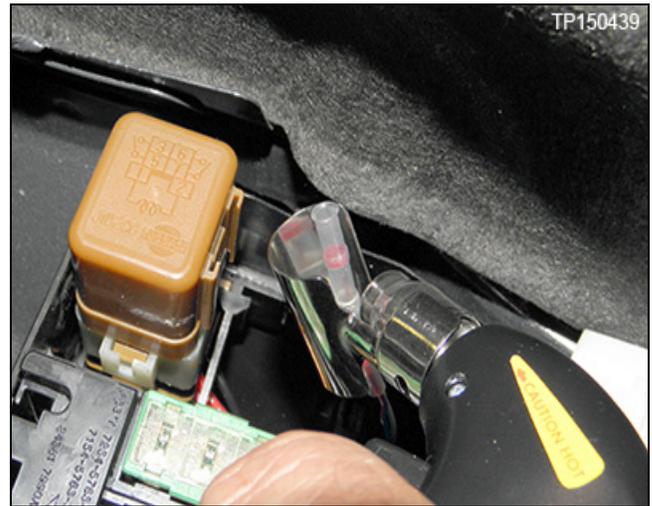
Figure 9

10. Apply heat (Figure 9) with a Flameless Heat Gun (#J-46538) until:

- The solder completely melts

And

- Both ends of the shrink tube have been sealed.

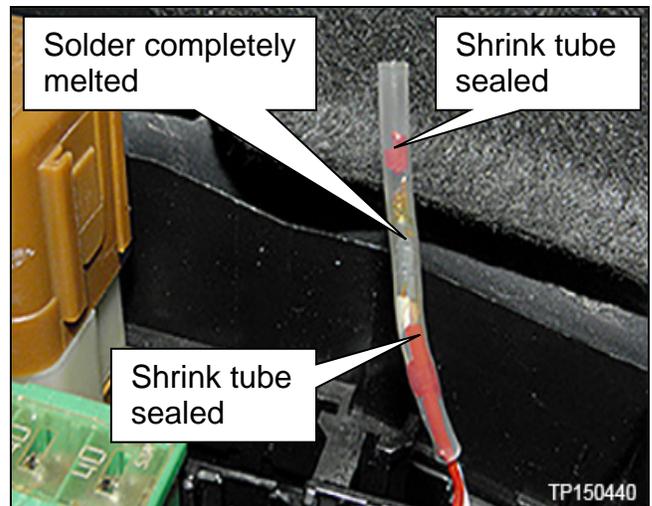
- Figure 10 shows completed solder connection.

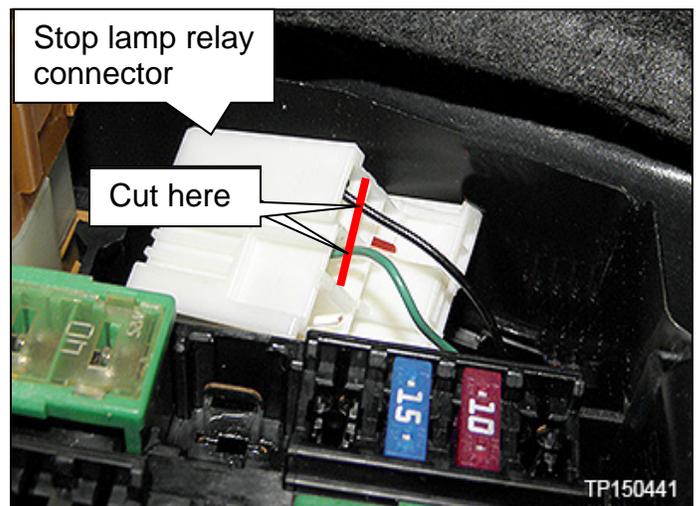
Figure 11

11. Cut the remaining two wires (green and black; Figure 11) to the stop lamp relay connector, and discard the connector.

- Tape the ends of the green and black wires.
- Tuck all wires from stop lamp relay out of the way back into connector cavity.
