NUMBER: 08-109-15

Cannot Complete Restore Vehicle Configuration Or Proxi Alignment

This bulletin involves inspecting and replacing the Comfort Seat and Wheel Module (CSWM), if required.

2015 (BU) Jeep Renegade

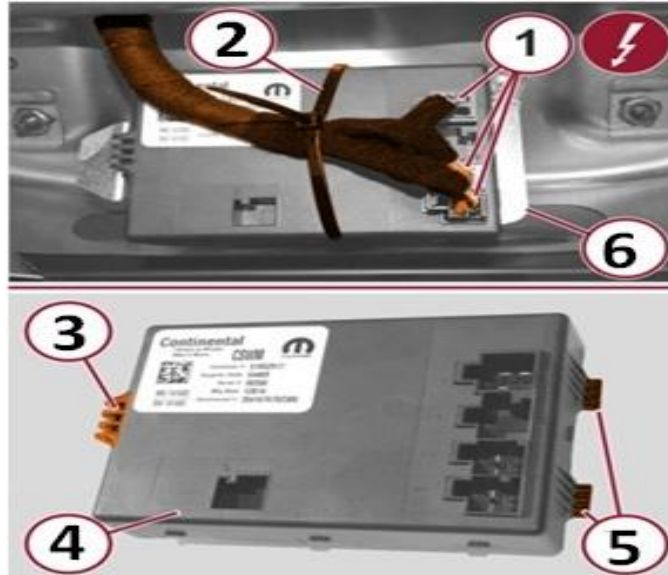
Fig. 1 CSWM Location

- 1 - Electrical connector
- 2 - Tie
- 3 - Retaining tab
- 4- CSWM
- 5- Alignment tabs
- 6- Base of seat

-
3. Cut the tie (2) and press retaining tab (3) to release the CSWM from the bracket, see (Fig. 1).
 4. Remove the CSWM (4) from the base of the seat (6), see (Fig. 1).
 5. Position the alignment tabs (5) of CSWM to the base of the seat and install the module, see (Fig. 1).
 6. Using a new tie strap, secure the CSWM to the base of the seat (6), see (Fig. 1).

NOTE: Make sure to properly secure to harness using the tie strap.
