# Program Bulletin

## CUSTOMER SATISFACTION PROGRAM

**SUBJECT:** Undersized Generator

**MODELS:** 2015 Chevrolet Silverado Crew Cab  
Equipped with Special Service Package (RPO 5W4)  
and 170 amp Generator (RPO KW7)

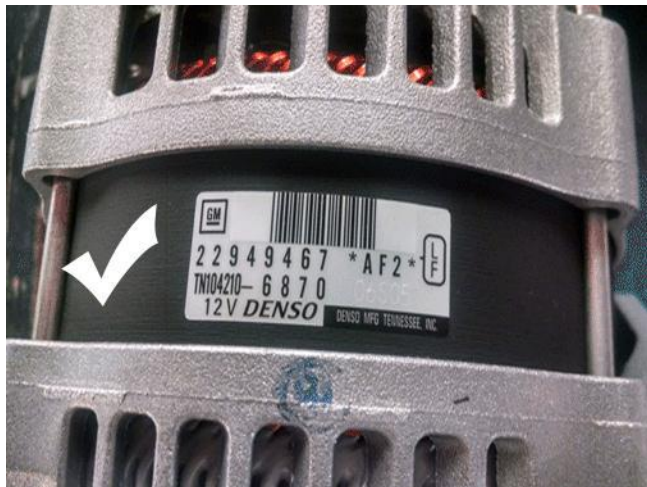
4261270

- If generator part number 22949467 AF2 is installed, no further action is required.

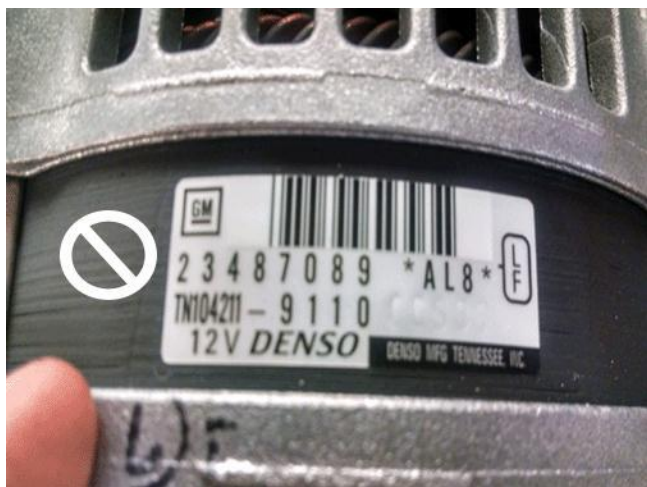
4261276

- If generator part number 23487089 AL8 is installed, remove and replace the generator. Continue to step 2.

2. Remove the generator. Refer to *Generator Replacement* in SI.

3. Install the generator. Refer to *Generator Replacement* in SI.
