## REAR JCT BOX COVER UPGRADE

### DESCRIPTION

On the vehicles affected by this bulletin, to prevent premature corrosion of the rear junction box components, replace the junction box cover with a late model "central mount" cover.

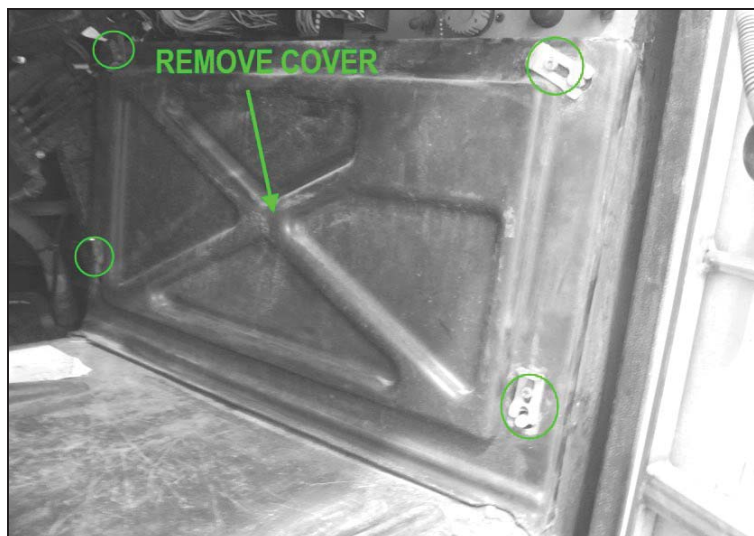
- 1) Open the right side engine compartment to access the rear junction box and remove the junction box cover.

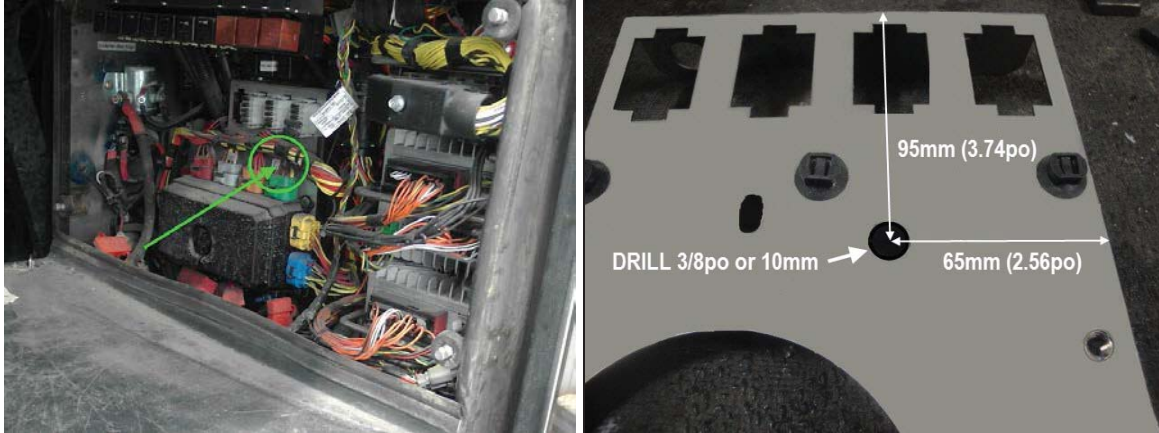
- 2) On the fuse box back plate, drill a 3/8" (10mm) hole following the template and image below (move away wires and harness as required).

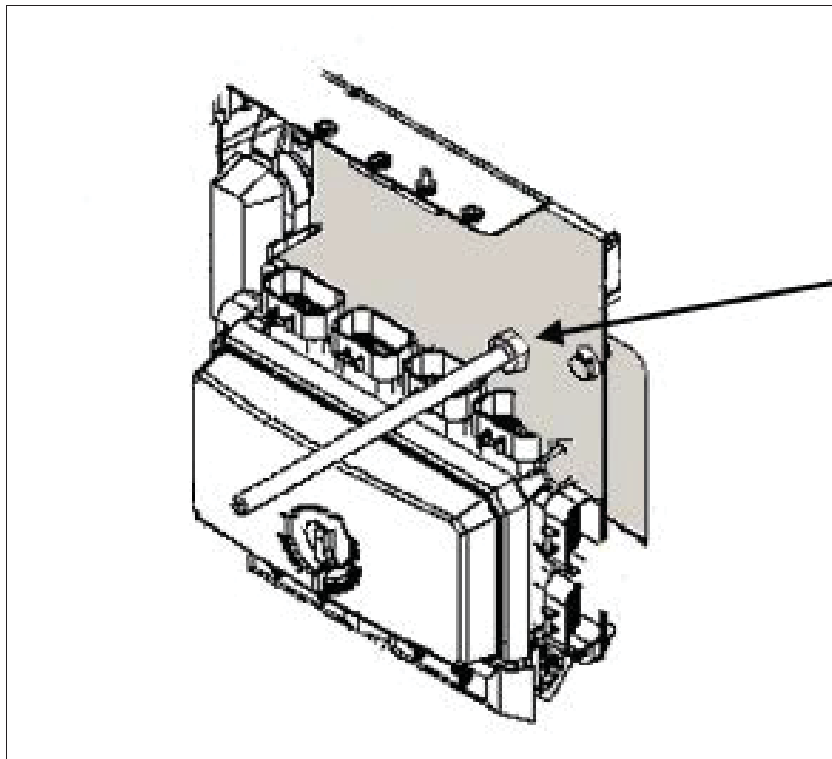
- 3) Insert a 3/8" stainless steel threaded rod of the correct length in the previously drilled hole (rod must stick out of the new central mount cover about 1/2" min), secure the rod to the back plate using two #500102 3/8 SS nuts, one on each side of the plate.

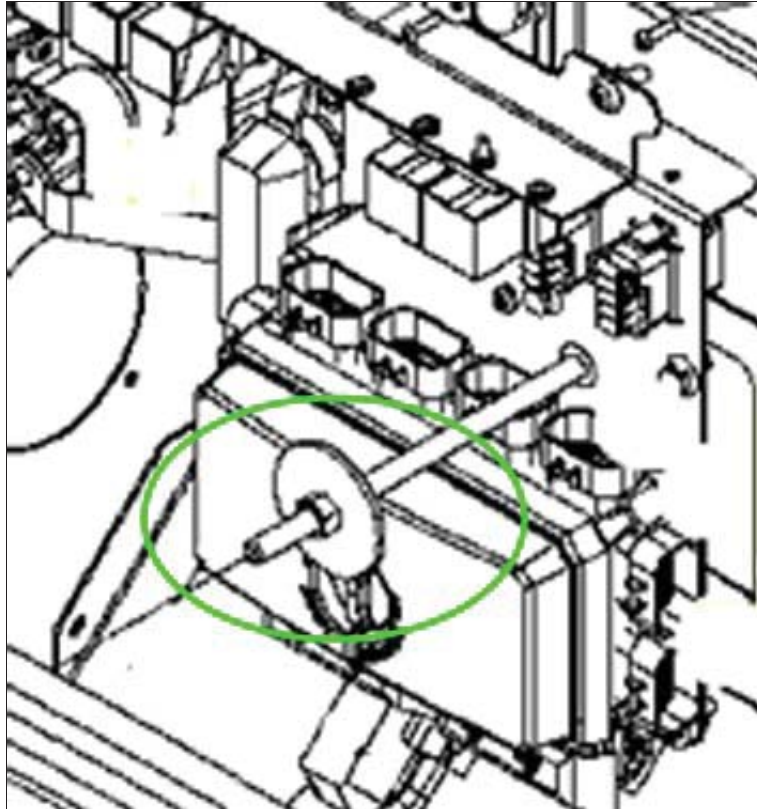
- 4) Install the #068704 washer on the rod (secured with a #500102 3/8 SS nut on both sides) at about one inch below the cover wing nut flange.

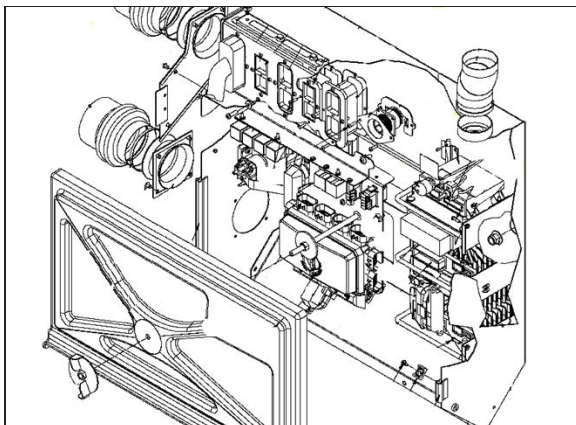
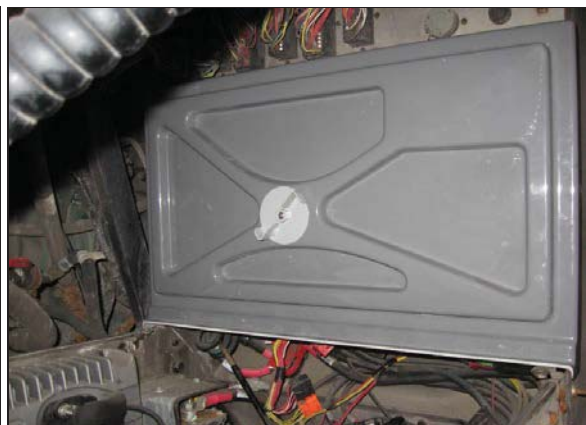
- 5) Install the old cover rubber seal on the new central mount cover and discard the old cover.
- 6) Install the new cover on the rear junction box and tighten it in place using the #068765 wing nut until the cover bottom-out on the rod flat washer.
