NORGREN VALVE AIR LEAK Prevost vehicles

DESCRIPTION

On the vehicles affected by this bulletin, the entrance door may open inadvertently or not open at all when door open button is pressed.

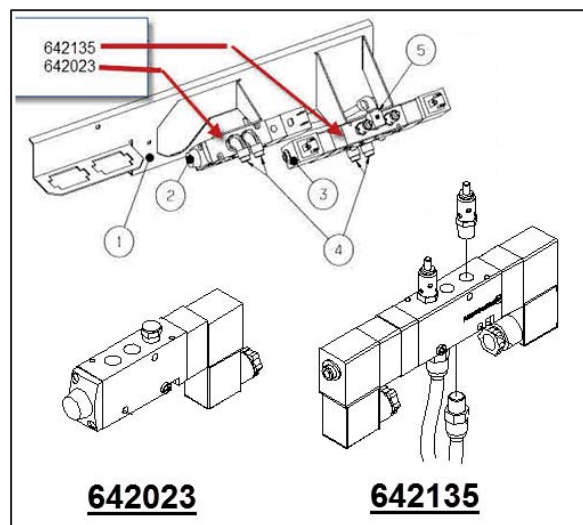
Figure 1

- 1) Open the right hand access panel next to the entrance door. Locate the door valves. (Fig.1)
- 2) Inspect the production date code on valves 642023 & 642135 (Fig. 1).

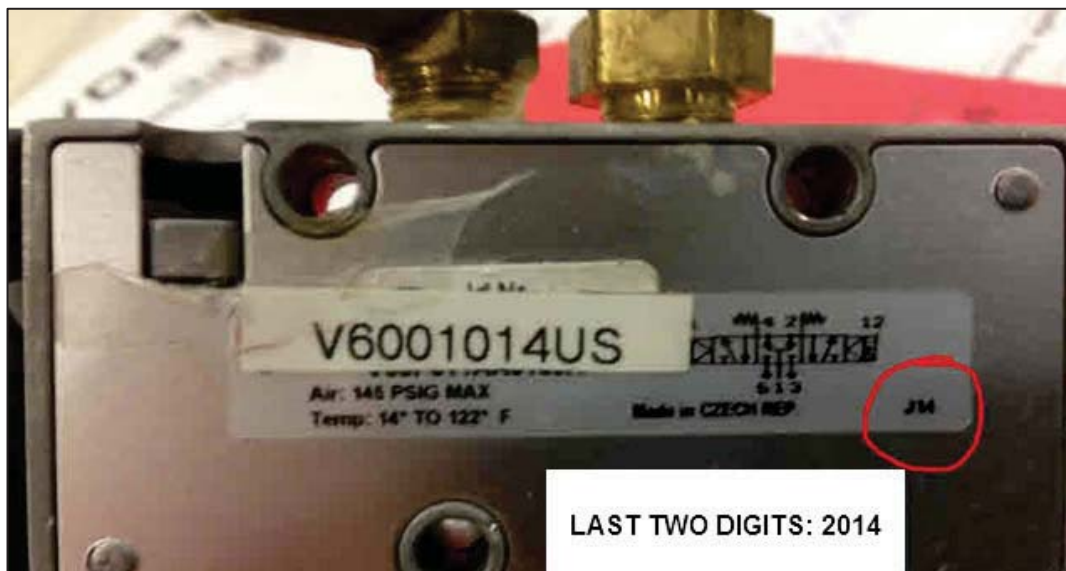
Figure 2: Date code example

(Date code is found in the lower right hand corner of the valve specifications label.) (Fig. 2)

The last two digits indicate year and must be 15 or more. (fig. 2)

- 3) If year is less than 2015, Valve must be replaced.
- 4) If year is 2015, inspect further to visually confirm a vertical stamp mark behind the valve (fig. 3)
