Technical Bulletin

Model	Year	Eng. Code	Trans. Code	VIN Range From	VIN Range To
Passat	2012-2014	2.0L TDI (CKRA)	ALL	ALL	ALL

21 15 07 August 21, 2015 2036110 Supersedes Technical Bulletin V211505 dated June 15, 2015 to update turbocharger part number.

Engine Lacks Performance, Shaft of Turbine Fan of Turbo Charger Broken or Seized

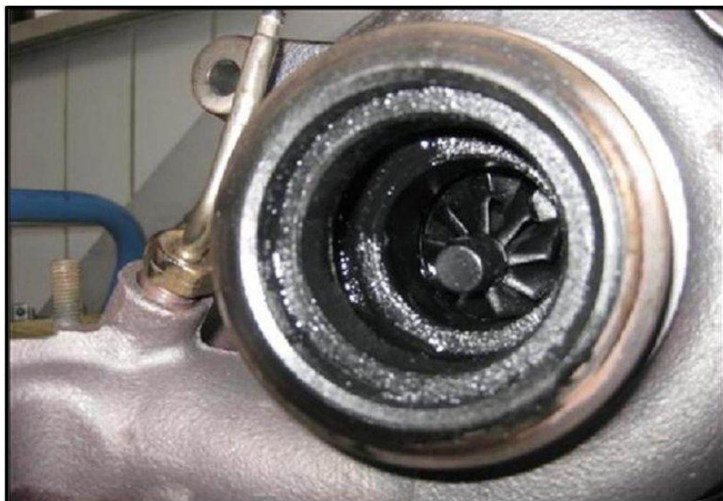
To confirm a broken shaft on the turbocharger the diesel particulate filter (DPF) must be detached on the turbocharger. This is the only way to check the turbocharger for damage and engine oil ingress on the exhaust side (figure 1).

Figure 1 (broken turbocharger shaft, engine oil ingress on exhaust side)

- If turbocharger is found to be damaged, the DPF must be reattached at the turbocharger before proceeding to the following steps:

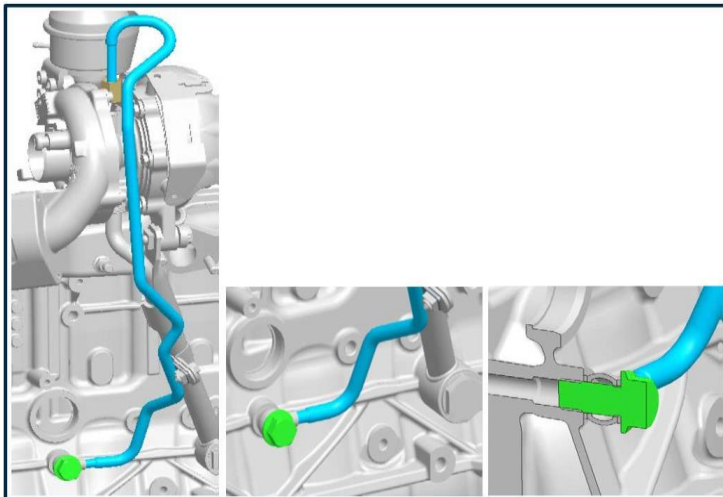
Figure 2

- Replace the oil filter according to the repair manual and thoroughly clean the inside of the oil filter housing.
- Drain the engine oil according to the repair manual.
- Unscrew the banjo bolt for the oil supply pipe on the cylinder block. Replace the banjo bolt with the hex head bolt with part number WHT 005 747 (figure 2, in green) and tighten it according to the repair manual to block oil supply to the damaged turbocharger.

Flush out the oil circuit while the faulty turbocharger/particulate filter is installed and the intake hose removed from the turbocharger.

- Fill up the engine oil according to the manufacturer guidelines.
- Run the engine at idle speed for about 15-20 minutes.
- Replace the oil filter according to the repair manual and thoroughly clean the inside of the oil filter housing.
- Replace the oil filter housing cap (03L 115 433).
