FL685AB

NHTSA #15V-432 (School Bus)

Subject: TBB Emergency Door Handles

Models Affected: Specific Thomas Built Buses Vista, TL-960, Saf-T-Liner Conventional, ER, MVP-EF, EFX, MVP-ER, FS65, C2, and HDX Buses manufactured February 5, 2001, through May 29, 2012.

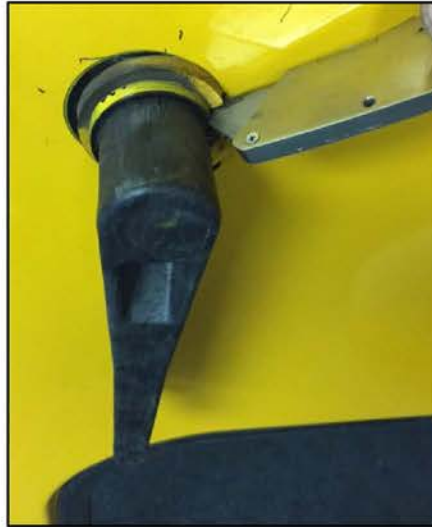
Figure 1, Cutting Washers

1. Chock the wheels, set the parking brake, make sure the shifter is in Park or Neutral. Disconnect the battery and the ignition switch is off.
2. Remove the washers between the external door handle and the door facing. Use a razor knife to slice through the large washer and then the smaller diameter plastic washer. Slide something under the washers to keep from damaging the paint on the door. See **Figure 1**.

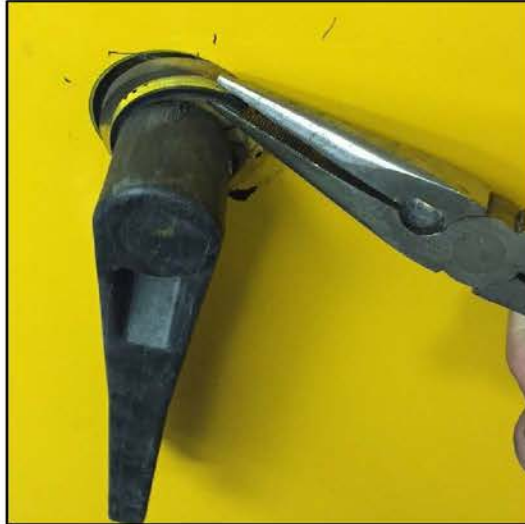
Figure 2, Removing Washers

3. Pull the washers off with needle nose pliers and discard the washers. See **Figure 2**.

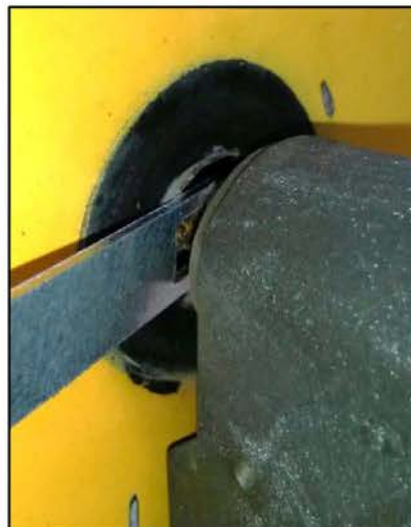
Figure 3, Using the Go/No Go Gauge

4. Once the washers are removed, use the go/no go gauge (TBB 204666 from kit TBB 204971) to verify the stem material is of sufficient thickness for operation. Try to slide the gauge over the smallest thickness of the stem on each of the four sides. See **Figure 3**. If the gauge is able to slide completely on at any point of the stem, go to "Replacement of Interior and Exterior Door Handles." See **Figure 3** for use of the gauge.

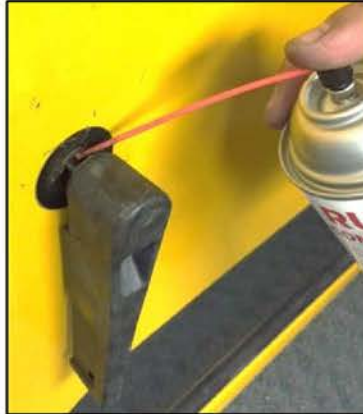
Figure 4, Applying Protectant

5. After verifying the gauge will not slide over the stem, apply a liberal amount of protectant over the entire stem (inside and outside the door cavity). Use an approved corrosion protectant such as WD-40 purchased locally. If any of the protectant liquid gets on the paint or exterior handle, remove it as quickly as possible with an alcohol based wipe. See **Figure 4**.

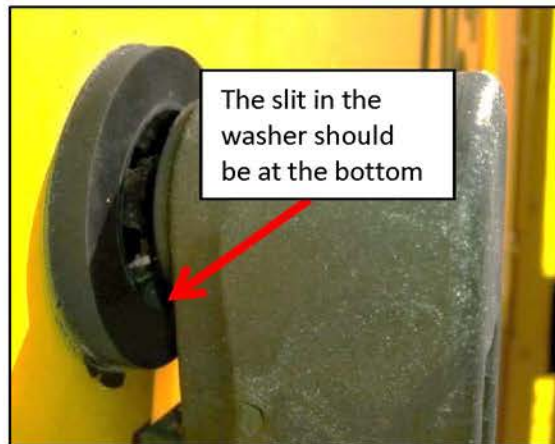
Figure 5, Position of Slit in Washer

6. After spraying the stem, install a new external washer (TBB 204677 from kit TBB 204971).
7. Make sure the painted surface around the stem opening is clean and dry. Remove the paper backing from the washer and place the adhesive side on the door around the external handle. Make sure the washer slit is installed on the bottom side of the opening. There will be an opening between the exterior washer and the door handle. See **Figure 5**.

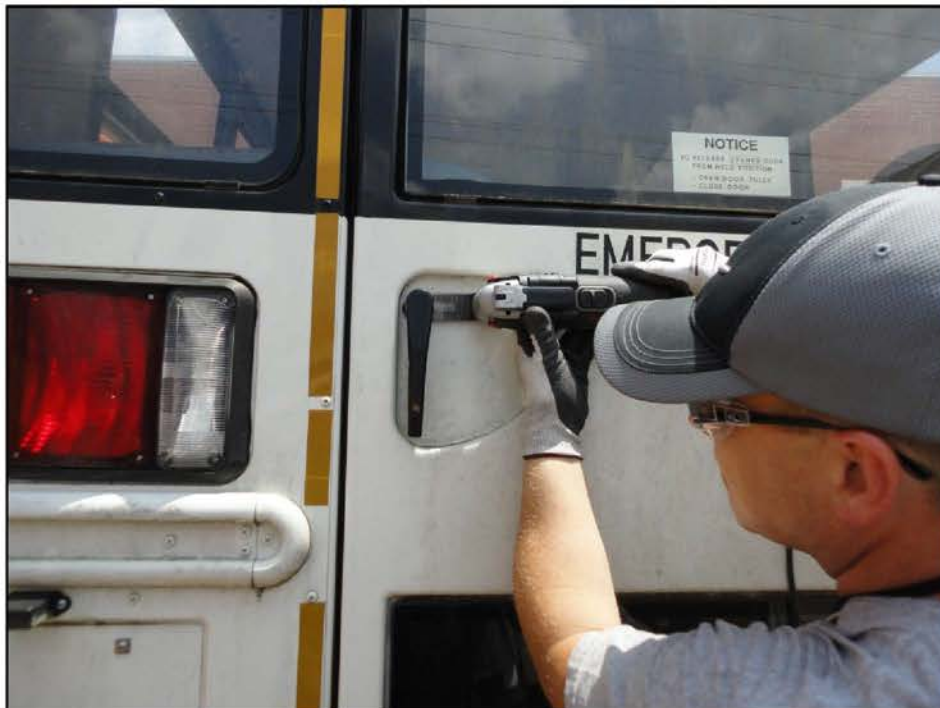
Figure 6, Cutting Off the Stem and Exterior Door Handle

1. Close and lock the door to keep it steady while performing next step.
2. Cut the stem and exterior door handle off. This can be performed with an oscillating tool or similar. See **Figure 6**.

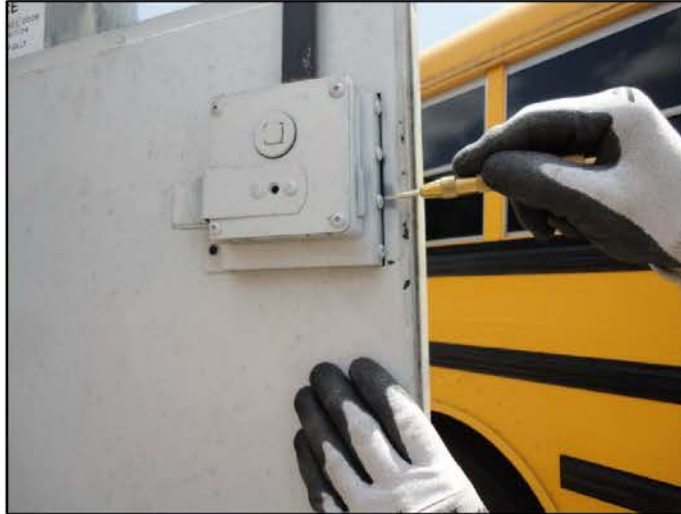
Figure 7, C2 mounting

C2 rear emergency doors will have four (4) rivets used for mounting the mechanism to the door bracket. Included in kit TBB 204987 are four (4) #12 screws to be used as replacement fasteners for the rivets. See **Figure 7**.

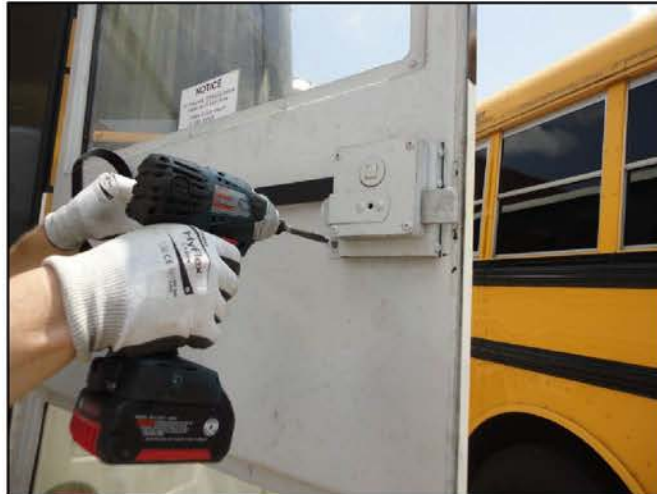
Figure 8, Legacy Mounting

Legacy products will have screws used for mounting the mechanism to the door. Remove and retain these screws for replacement. See **Figure 8**.

5. Remove the two screws on the left side of the locking mechanism and retain them for replacement. See **Figure 8**

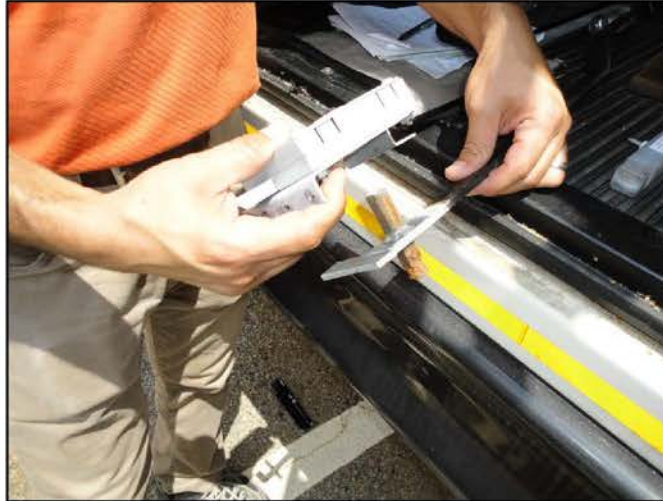
Figure 9, Removing the Locking Mechanism

6. Pull the locking mechanism and handle off the door. Lay the locking mechanism on the side the handle is not on and pull the handle shaft out of the locking mechanism. See **Figure 9**.

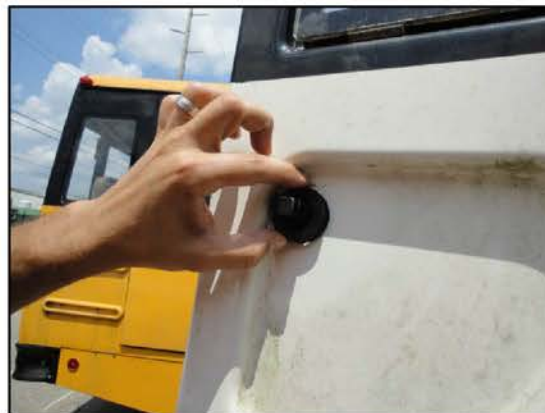
Figure 10, Installing the New Washer

7. Install the new handle with the locking mechanism and new washers from the kit (TBB 204987), using #12 screws in all fastener locations (Two (2) that were already used for mounting and four (4) used to replace the rivets).
8. Wipe the surface clean around the new stem where it exits the door.
9. Remove the paper covering the adhesive off back of the new washer and install it around stem. Make sure the washer slit is installed on the bottom side of opening. See **Figure 10**.

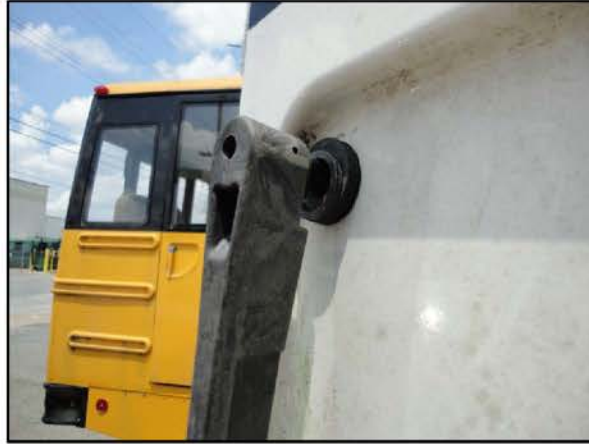
Figure 11, Position of Newly Installed Exterior Handle

10. Close the emergency door using the interior door handle. Make sure the interior handle is in the closed position. The closed position is when the interior handle is pushed all the way down to a horizontal position.
11. The exterior door handle must be installed in a vertical orientation. See **Figure 11**.

12. Using a rubber mallet, hammer the exterior handle (kit TBB 204988) onto the stem. The exterior handle must properly fit on the door stem for installation of the locking pin.
13. Insert the locking pin (TBB151501 from kit TBB 204987) into the side of the exterior handle.
14. Check door operation.
15. Unchock wheels.
