CUSTOMER SATISFACTION PROGRAM

SUBJECT: Sunroof Drain Hose Leaks

MODELS: 2010-2012 Cadillac SRX
Equipped with Sunroof (RPO C3U)
Located in Alabama, Connecticut, Delaware, Florida, Georgia, Kentucky, Louisiana, Maine, Maryland, Massachusetts, Mississippi, New Hampshire, New Jersey, New York, North Carolina, Oregon, Pennsylvania, Rhode Island, South Carolina, Tennessee, Vermont, Virginia, Washington, West Virginia, Puerto Rico, British Columbia, New Brunswick, Newfoundland and Labrador, Nova Scotia, Ontario, Prince Edward Island, Quebec, and export vehicles located only in Europe.

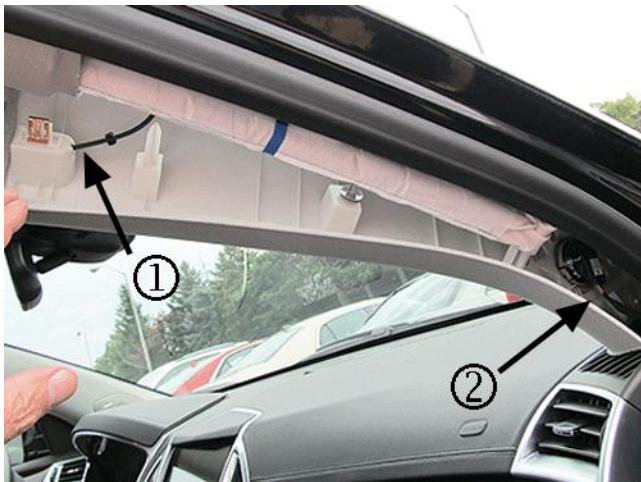
3610902

1. Starting on the left or right side, remove the windshield garnish molding from the A-pillar by pulling gently from the top to disengage the attachment clip. Detach the rubber stop (1) on the tether clip from the molding and disconnect the speaker wiring harness (2).

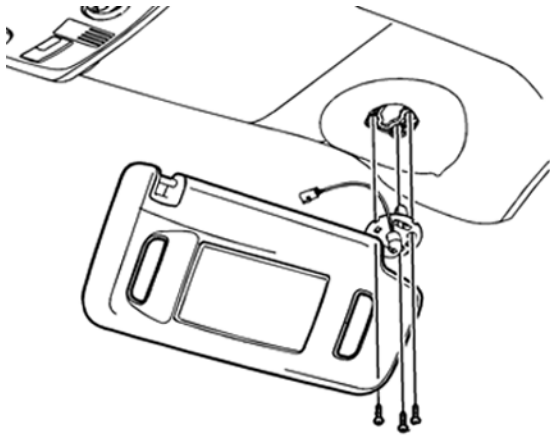
3610903

2. Remove the sunshade. Refer to *Sunshade Replacement* in SI.

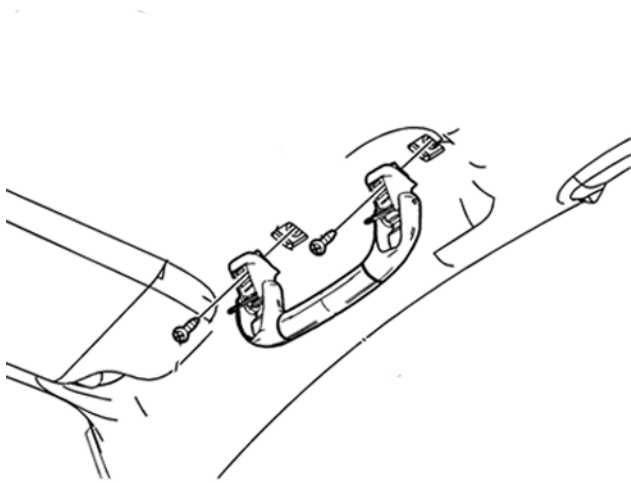
3610906

3. Remove the front assist handle. Refer to *Front Assist Handle Replacement* in SI.

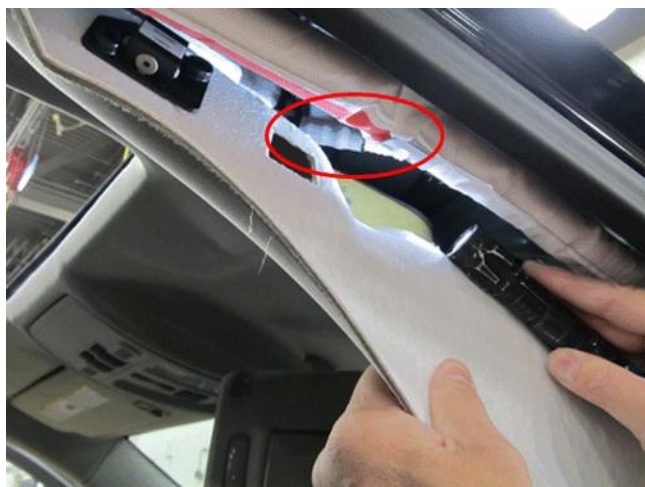
3610910

4. Pull the front corner of the headliner downward to access the drain hose and sunroof drain spigot connection, circled above.

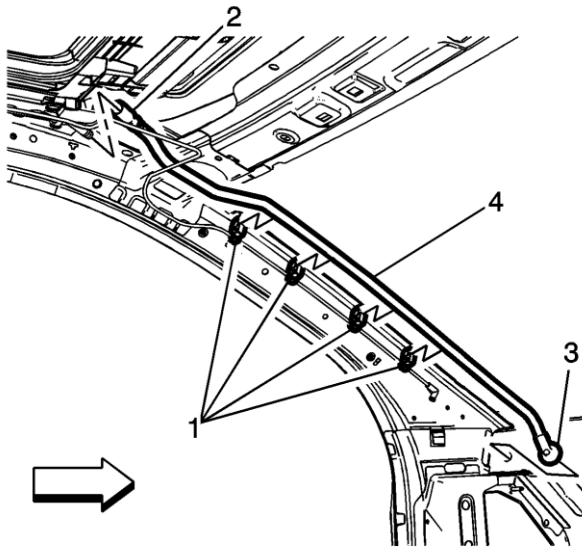
2653136

5. Disengage the sunroof drain hose from the attachment points on the windshield pillar (1).
6. Disconnect the front sunroof drain hose from the sunroof drain spigot (2).
7. Disconnect the drain hose and grommet (3) from the cowl panel.
8. Remove the drain hose (4) from the vehicle.

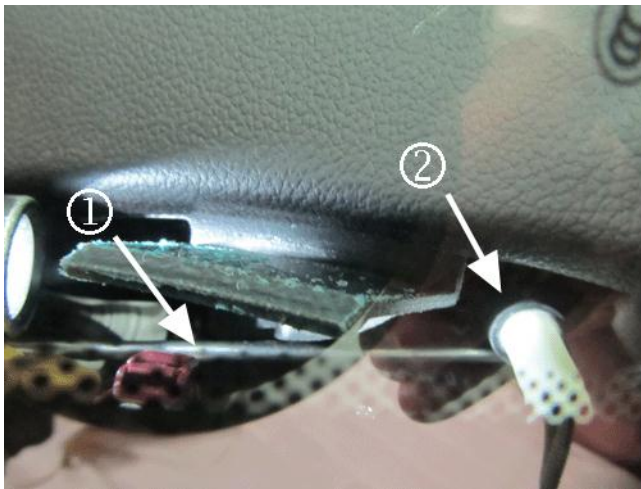
3610909

Note: Verify proper engagement of the grommet to cowl panel to prevent a water leak.

9. Using a long, thin suitable tool (1), connect the grommet end of the hose (2) to the cowl panel by pushing the grommet into its hole.

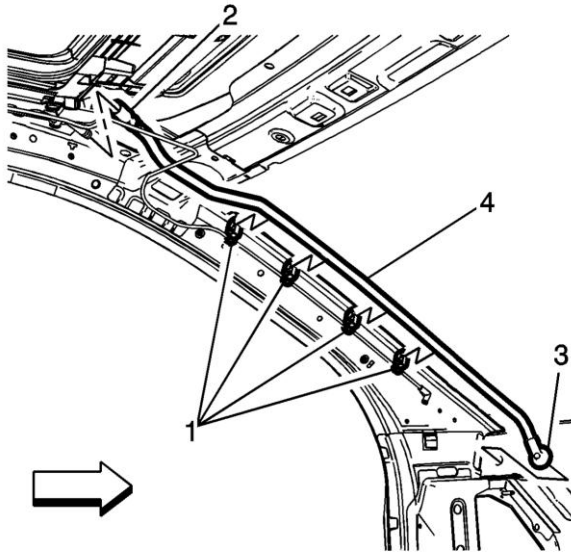
2653136

10. Connect the front sunroof drain hose to the sunroof drain spigot (2).
11. Connect the sunroof drain hose to the attachment points on the windshield pillar (1).
12. Repeat steps 1-11 on the opposite side of the vehicle.
13. Water test the front drain hoses before installing the headliner and trim.
14. Reposition the headliner and reinstall the left and right front assist handles. Refer to *Front Assist Handle Replacement* in SI.
15. Reinstall the left and right sunshades. Refer to *Sunshade Replacement* in SI.
16. Reattach the tether clips and reconnect the speaker wiring harness to the left and right windshield garnish moldings.
17. Ensuring the retaining tabs are fully seated, position the left and right garnish to the A-pillars and push securely in place.
