REFERENCE:	Nova Bus Manuals
SECTION:	16: Electrical System
RS N°:	MQR 7621-813
EFFECTIVE IN PROD.:	L859 (2014DE)

SUBJECT:	Battery cables
JUSTIFICATION:	Terminal lugs of the battery cables may crack due to stress.

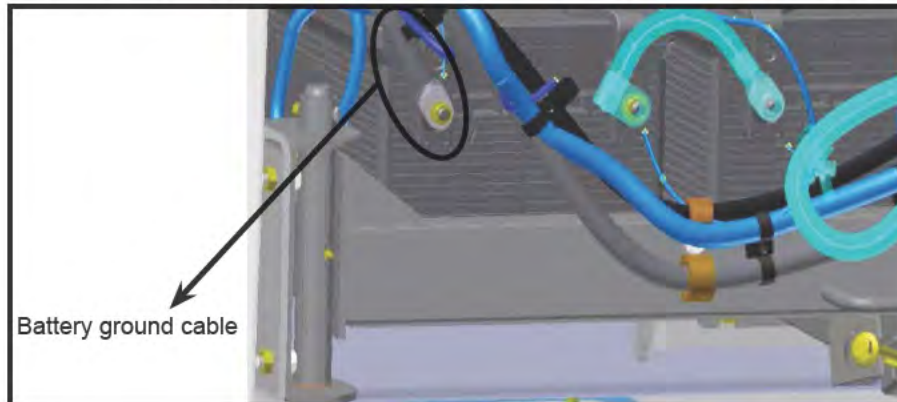
Figure 3 - Location of Battery Ground Cable

- 1.3. Disconnect the battery ground cable (see Figure 3). Insulate the terminals to avoid accidental grounding. Refer section 16: Electrical System of the Nova Bus maintenance manual for precautionary measures.

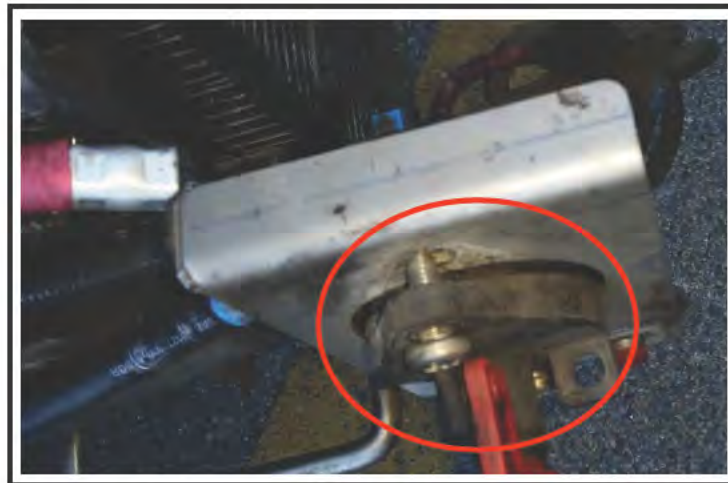
Figure 4 - Loosening of Main Battery Disconnect Switch

- 1.4. Loosen the main battery disconnect switch to gain access for easy removal of existing battery cables (see Figure 4).

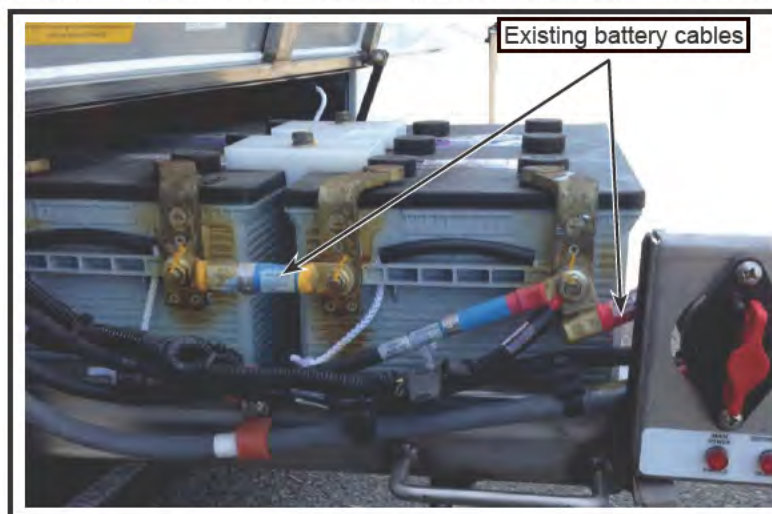
Figure 5 - Removal of Existing Battery Cables

- 1.5. Remove the existing battery cables as shown in Figure 5. Retain the nuts. Discard the cables.

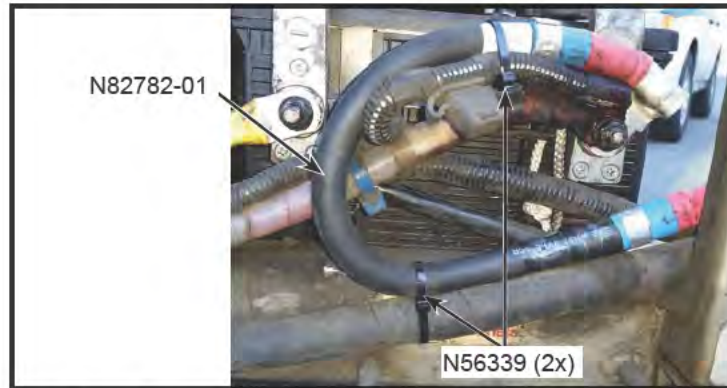
Figure 6 - Installation of New Battery Cable (N82782-01)

- 1.6. Install N82782-01 battery cable between the battery disconnect switch and the battery. Do not tighten the nuts (see Figure 6).
- 1.7. Install 2x N56339 cable tie to support the battery cable (see Figure 6).

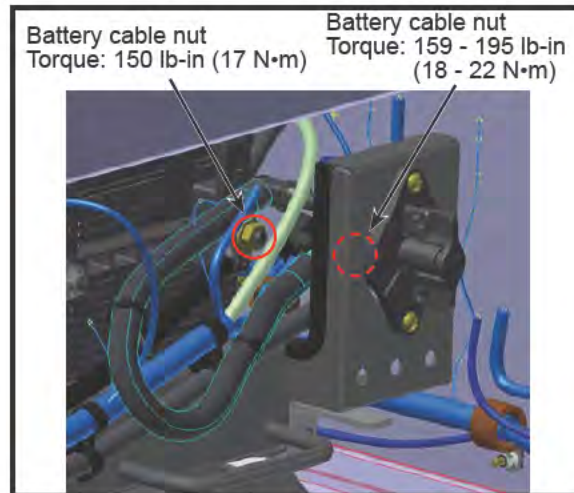
Figure 7 - Torque Values for Battery Connections

- 1.8. Tighten the battery cable nuts. See Figure 7 for torque specifications.

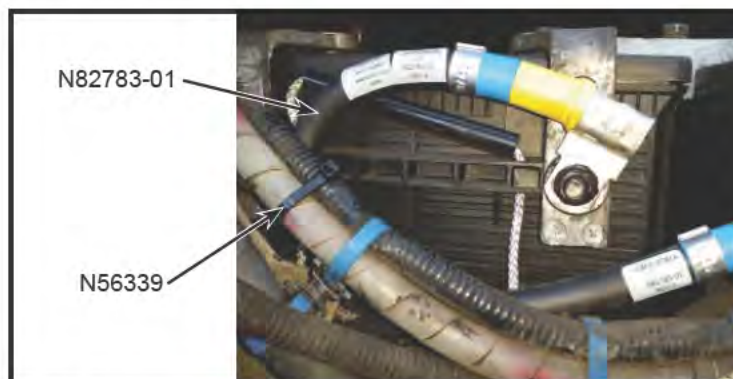
Figure 8 - Installation of New Battery Cable (N82783-01)

- 1.9. Install N82783-01 battery cable between the batteries. Install N56339 cable ties to support the battery cable. Do not tighten the nuts (see Figure 8).

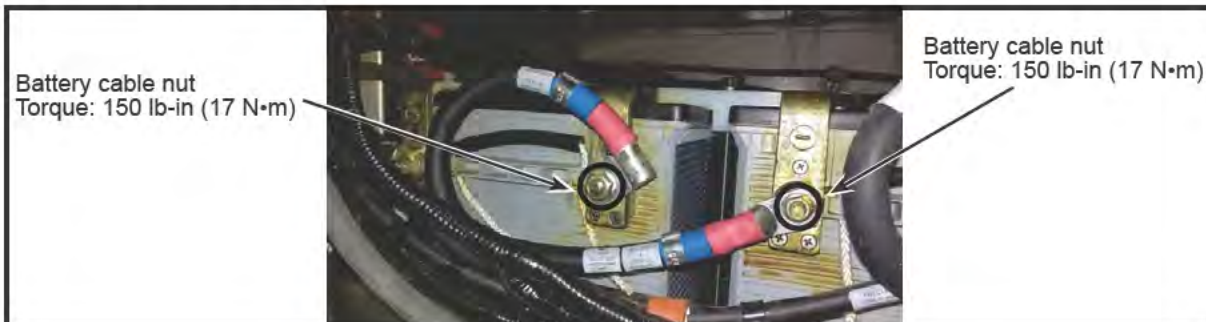
Figure 9 - Torque Values for Battery Connections

- 1.10. Tighten the battery cable nuts. See Figure 9 for torque specifications.
