REFERENCE:	Nova Bus Manuals
SECTION:	16: Electrical System
RS N°:	MQR 7621-838
EFFECTIVE IN PROD.:	2016FEB

SUBJECT:	Replacement of 24-volt and HVAC cables in EGS
JUSTIFICATION:	Cable lugs may break.

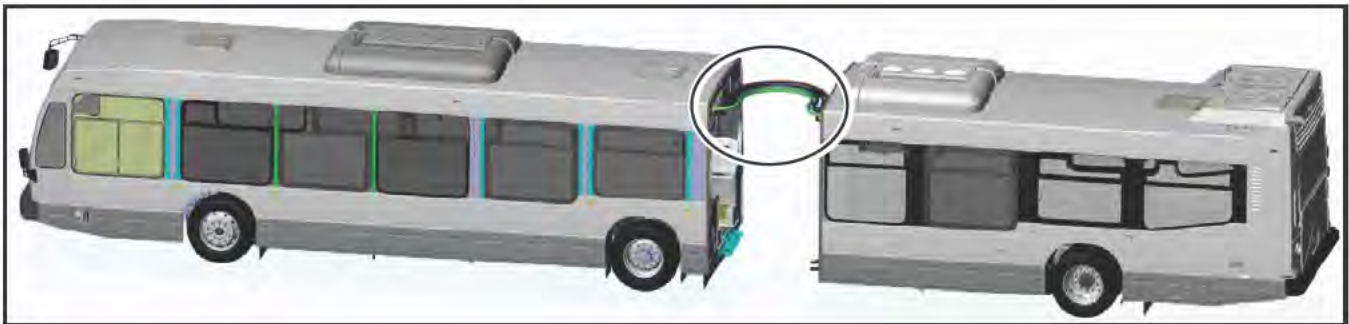
*Figure 1 - EGS Cable Location
(some items removed for clarity)*

- 1.1. Remove the articulation ceiling cover curtains from the inside of the bus in order to access Energy Guidance System (EGS) components. Retain parts for re-installation.
