TSB140019

ISX15 CM2250, QSX15 CM2250 ECF, ISX12 CM2250, and QSX11.9 CM2250 ECF Fuel Pump - Ceramic Plunger and Tappet Roller Inspection and Repair

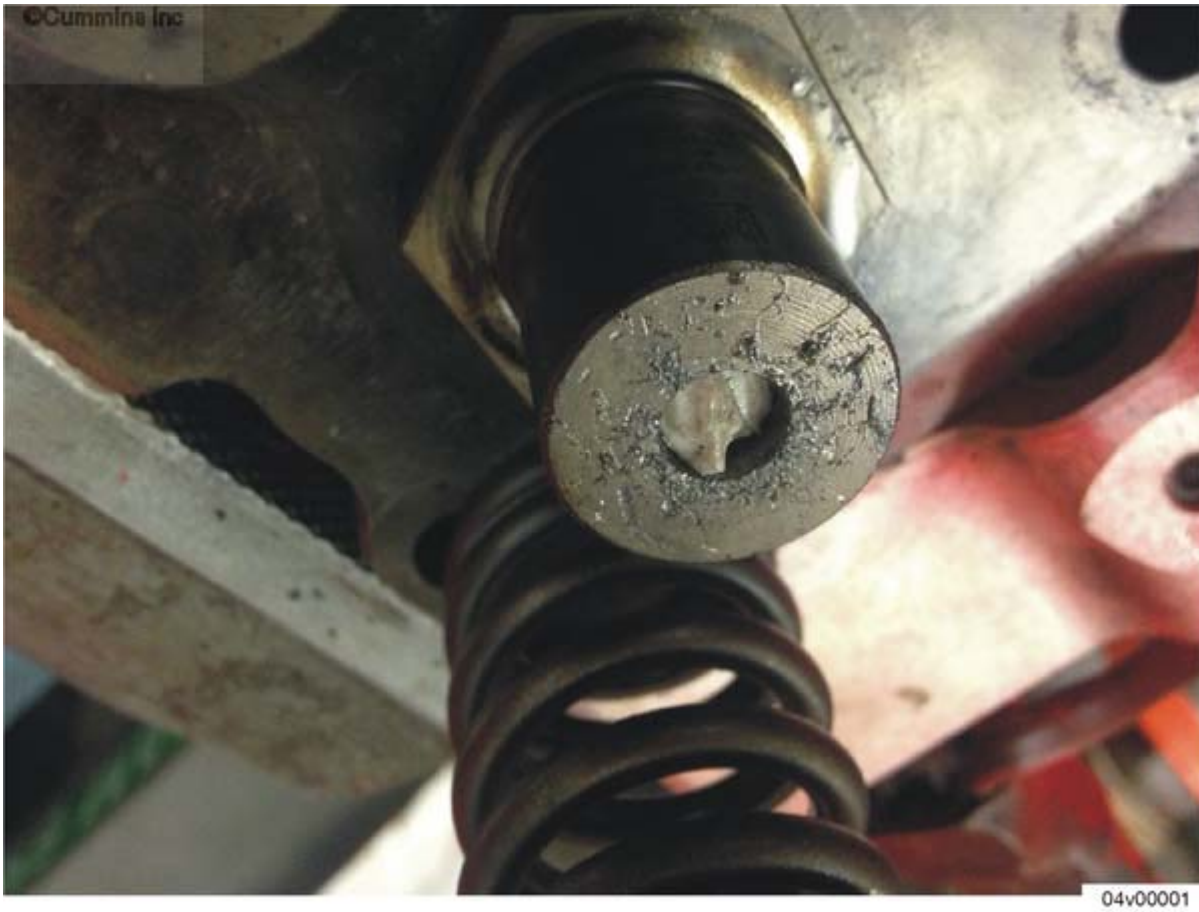
This document, in conjunction with the information provided within the manuals listed in the table above, provides the inspection and repair practice when ceramic plungers are found to be fractured (see Figure 1) and/or tappet roller damage is found on fuel pumps with ceramic plungers (see Figure 2). Ceramic plungers can be identified by their white color. See Procedure 005-227 in the Associated Procedures Table for removal of the fuel pump head.

Figure 1: Fractured Fuel Pump Ceramic Pumping Plunger

If the ceramic plungers are fractured (see Figure 1), but no damage is found on the fuel pump tappet rollers (see Figure 2), no further inspection is needed. Perform the following steps for the appropriate engine (ISX15 CM2250, QSX15 CM2250 ECF, ISX12/ISX11.9 CM2250, or QSX11.9 CM2250 ECF):

1. Replace the fuel pump per one of the options below:
  - a. For ISX15 CM2250 engines with two-cylinder pumps and fuel pump gear pump top mount fuel lines, there is a cost effective option to use a fuel pump short block service kit. See Technical Service Bulletin, New Fuel Pump Short Block Service Kit, TSB150033.
  - b. For ISX15 CM2250 or QSX15 CM2250 ECF: See Technical Service Bulletin, New Two-Cylinder High-Pressure Fuel Pump Assembly, TSB110064 , if replacing a three-cylinder two-piston pump with a two-cylinder pump.
  - c. For ISX15 CM2250 or QSX15 CM2250 ECF: New fuel lines are required if replacing a fuel pump gear pump with bottom mount fuel lines. See Technical Service Bulletin, New Fuel Pump Gear Pump with Revised Fuel Line Locations, TSB130044.
2. Change the engine lubricating oil and lubricating oil filter. See Procedure 007-013 in the Associated Procedures Table.

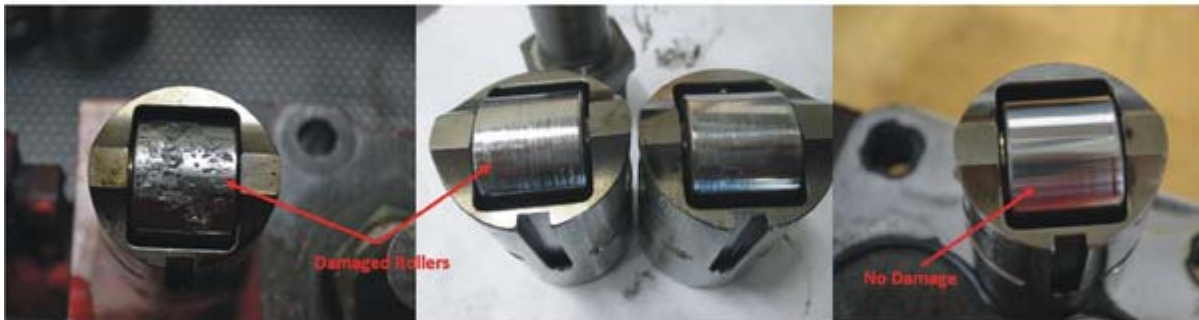
04v00002

Figure 2: Fuel Pump Tappet Roller Assemblies

If the fuel pump tappet rollers are damaged (see Figure 2), perform the following steps for the appropriate engine (ISX15 CM2250, QSX15 CM2250 ECF, ISX12/ISX11.9 CM2250, or QSX11.9 CM2250 ECF):

1. See options below:
  - a. For ISX15 CM2250 engines with two-cylinder pumps and fuel pump gear pump top mount fuel lines, there is a cost effective option to use a fuel pump short block service kit. See Technical Service Bulletin, New Fuel Pump Short Block Service Kit, TSB150033.

- b. For ISX15 CM2250 or QSX15 CM2250 ECF: See Technical Service Bulletin, New Two-Cylinder High-Pressure Fuel Pump Assembly, TSB110064, if replacing a three-cylinder two-piston pump with a two-cylinder pump.

- c. For ISX15 CM2250 or QSX15 CM2250 ECF: New fuel lines are required if replacing a fuel pump gear pump with bottom mount fuel lines. See Technical Service Bulletin, New Fuel Pump Gear Pump with Revised Fuel Line Locations, TSB130044.

2. Drain the engine lubricating oil and remove the lubricating oil filter. See Procedure 007-013 in the Associated Procedures Table.
3. Thoroughly clean the oil cooler housing. See Procedure 007-003 in the Associated Procedures Table.

4. Replace the lubricating oil cooler element. See Procedure 007-007 in the Associated Procedures Table.
5. Replace the oil filter bypass valve. See Procedure 007-014 in the Associated Procedures Table.

6. Replace the lubricating oil thermostat. See Procedure 007-039 in the Associated Procedures Table.
7. Install a new lubricating oil filter. See Procedure 007-013 in the Associated Procedures Table.

8. Fill the engine with new lubricating oil.
9. Perform an aftertreatment diesel particulate filter regeneration. See Procedure 014-013 in the Associated Procedures Table.

10. Perform a second lubricating oil and lubricating oil filter change. See Procedure 007-013 in the Associated Procedures Table.
