# ROADSTER Oil Pressure Switch Connector Protective Boot Cracking (F3) - 123018

The engine oil pressure switch connector protective boot may crack or degrade over time. Follow the steps in this TST to replace the boot with a more resistant part.

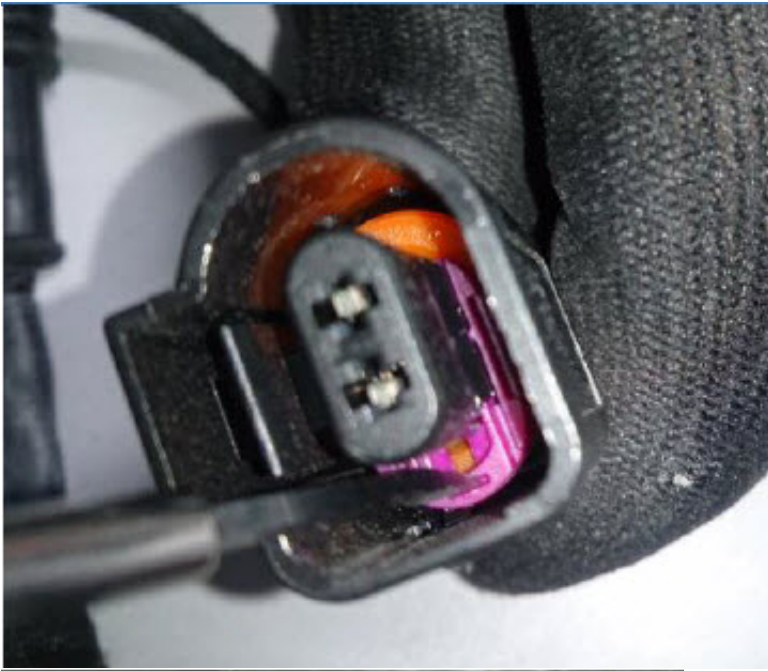
1. Disconnect the oil pressure switch connector.
2. Pull the protective boot from the connector.
3. Unlock the terminals.

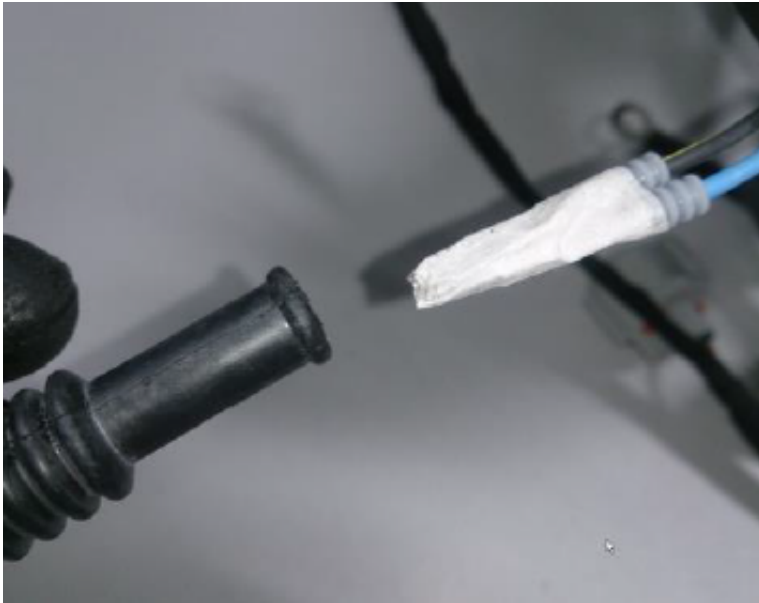
6. Wrap the terminals together with tape. Install the new protective boot.

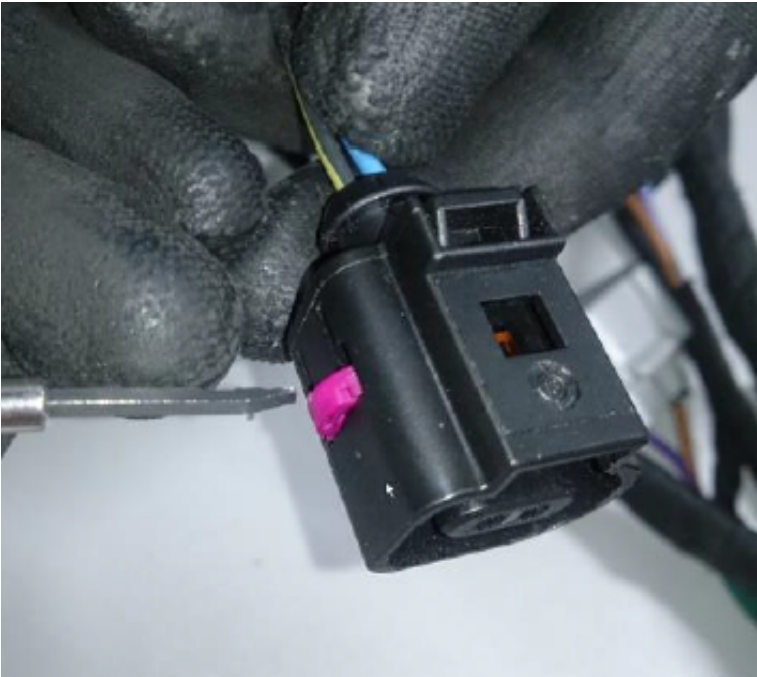
8. Press the secondary lock back into position.

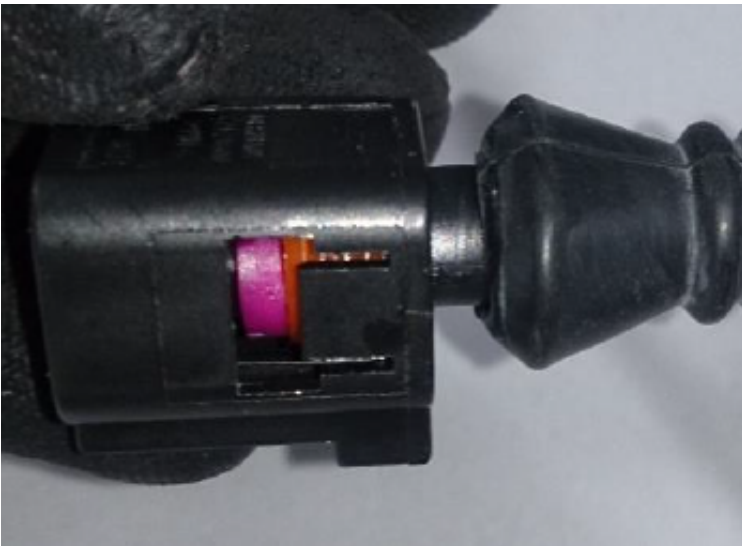
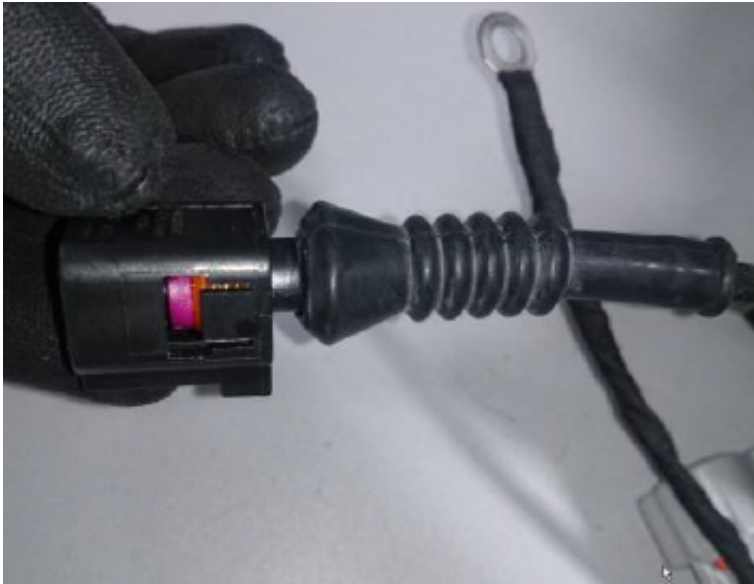
9. Mount the protective boot on the connector.
