GROUP CHA	MODEL 2016MY Sorento (UMa) Optima (JFa)
	NUMBER 061	DATE December 2015
TECHNICAL SERVICE BULLETIN		
SUBJECT: SERVICE ACTION: TPMS REPLACEMENT (SA 213)

This bulletin provides the procedure to check or replace the TPMS sensors for some 2016MY Optima (JFa) and 2016MY Sorento (UMa) vehicles, produced from September 28th, 2015 through December 7th, 2015 which may exhibit a false TPMS malfunction indicator light on the cluster, with DTC C131200, C131300, C131400, and/or C131500, even when the inflation pressure in the tire is correct. To correct and/or prevent this condition, Kia is requesting the completion of this Service Action on all affected vehicles. Before conducting the procedure, verify the vehicle is included in the list of affected VINs on Page 8.

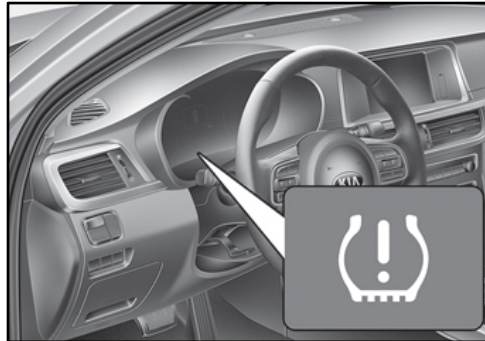
1. Use GDS/KDS to obtain the TPMS sensor IDs. Then, compare the TPMS IDs to the VIN list on Page 8 to identify the affected TPMS sensors (highlighted in red).

Sensor Name(92)	Value	Unit	Link Up
Front Left ID	81E37882	-	
Front Right ID	81E365A3	-	
Rear Right ID	81EE89A3	-	
Rear Left ID	81E37926	-	
Front Left Pressure	78	inHg	
Front Left Temperature	93	'F

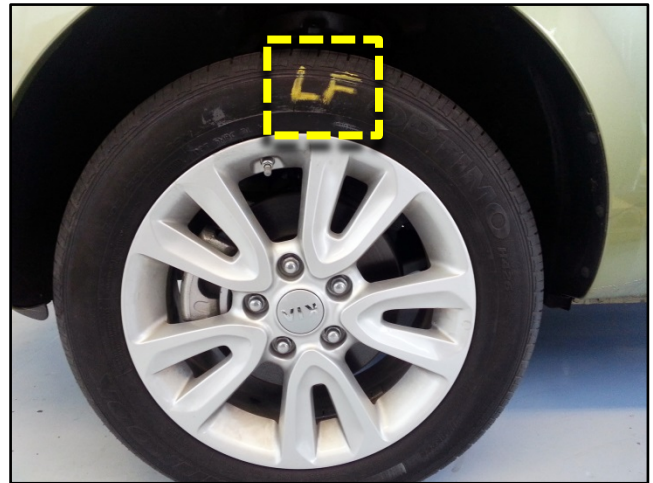
2. Use yellow chalk to create a reference mark for the original mounting location on the affected tire, as shown.

Upon reinstallation, use the tire reference marks to re-install each tire in the same location.

Image shown is for reference only and will vary by model.

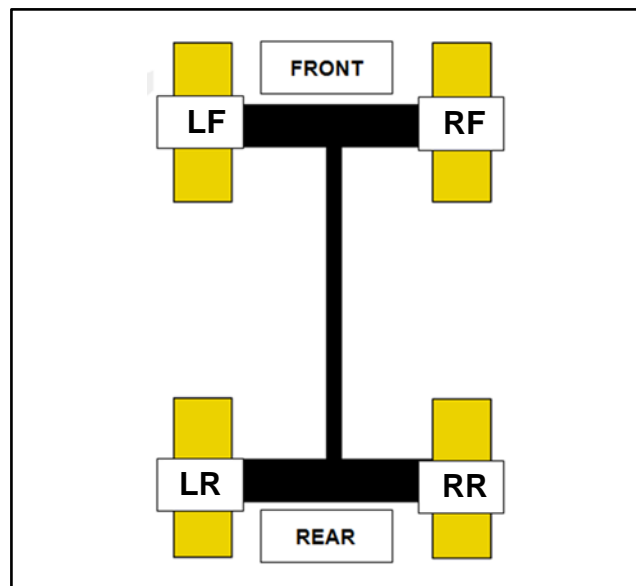
- Place the vehicle on the lift and remove the affected wheel assembly.

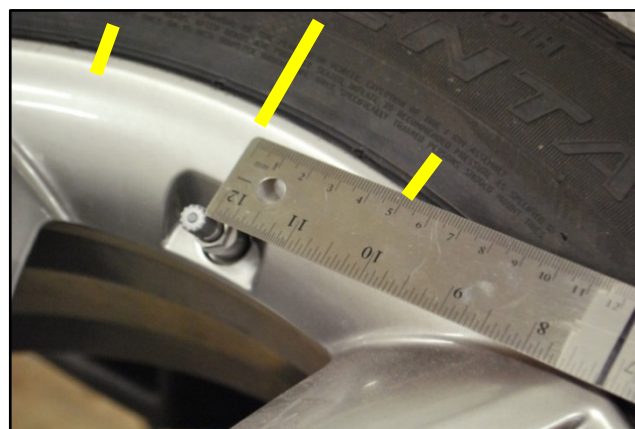
- Use a ruler and yellow chalk to make reference marks 2" to either side of the valve stem, as shown.

To prevent damage to the TPMS sensor, avoid breaking the bead too close to the sensor. Any damage to the TPMS sensor during removal is **NOT** considered a warrantable concern.

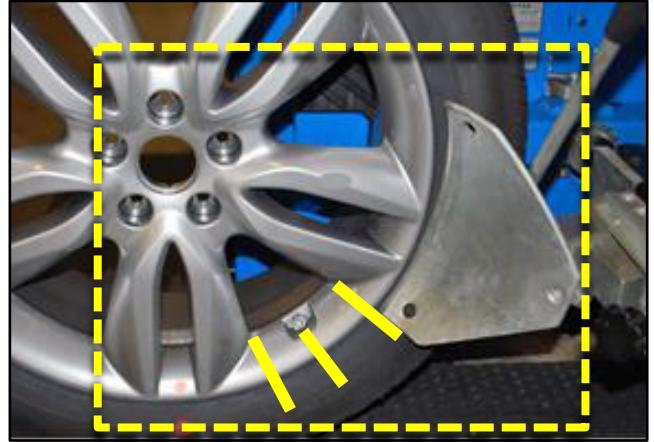
6. Insert the machine's shoe into the bead to either side of the reference marks.

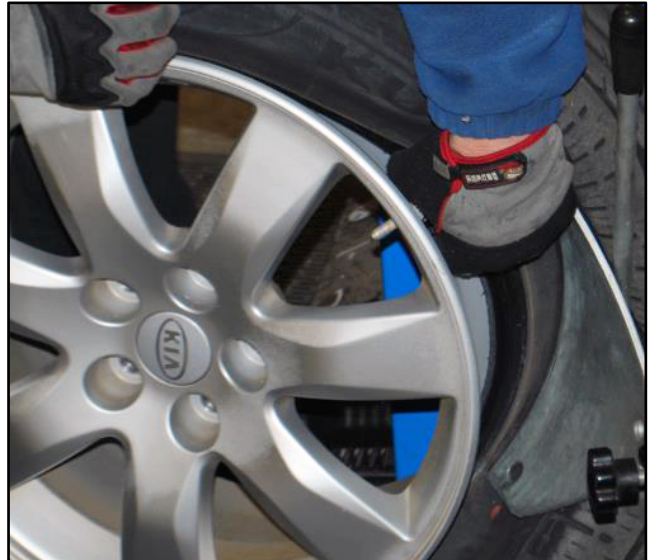
7. Use the machine's shoe to break the bead ONLY enough to expose the TPMS sensor. Then, remove the nut and pull the TPMS sensor from the wheel. **NOTE: Be careful NOT to drop the TPMS sensor inside the wheel/tire assembly.**

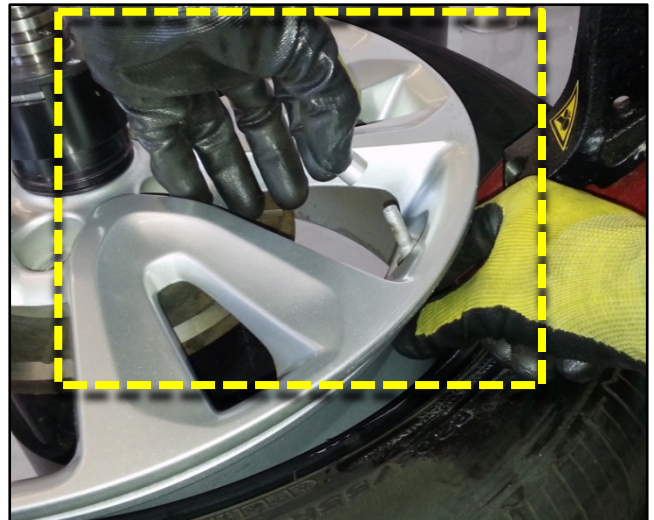
8. Re-install the TPMS assembly onto the wheel and secure in place using the new nut.

**Torque TPMS nut to:
2.6 ~ 3.3 lb-ft (3.5 ~ 4.5 Nm)**

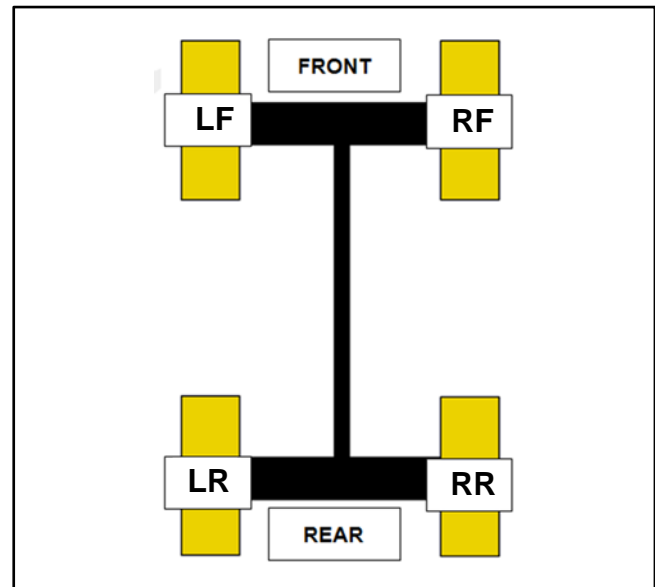
9. Inflate the tires to the proper pressure by referring to the table and install the valve stem caps.

10. Re-install the wheels, in the same mounting location, by using the reference marks created in step 2.

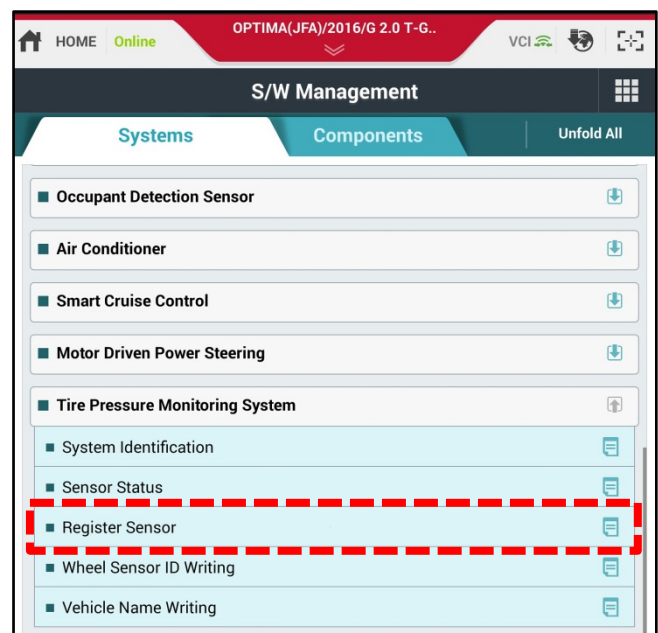
11. Use GDS/KDS to register the new TPMS sensor(s).

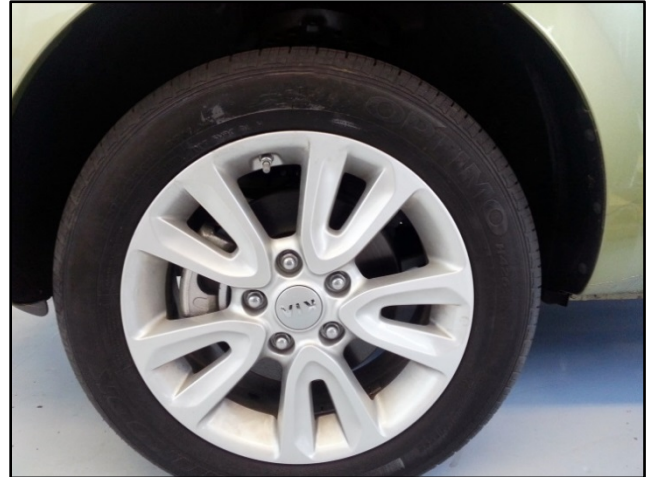
12. Wipe off the reference marks on the sidewall of the tire.
