| | GROUP BOD | MODEL 2011MY Sorento (XMa) |
| | NUMBER 118 | DATE December 2015 |
| TECHNICAL SERVICE BULLETIN | | |
| SUBJECT: SERVICE ACTION: INTERIOR DOOR HANDLE PEELING (SA 203) | | |

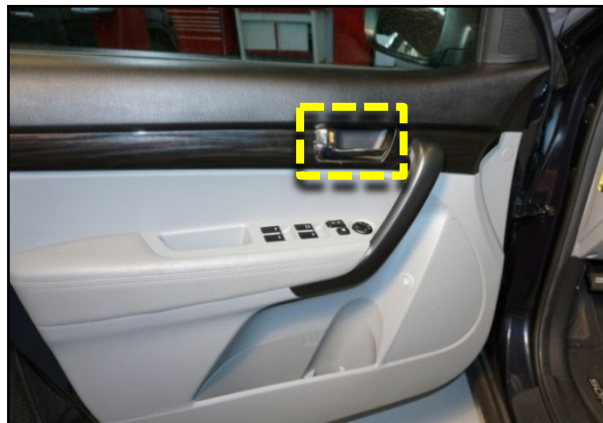
This bulletin provides the procedure to inspect or replace the inside chrome door handle(s) on some 2011MY Sorento (XMa) vehicles, produced from July, 2010 through February, 2011 which may experience chrome trim peeling on the inside door handle(s). Follow the procedure in this bulletin to inspect the appearance of the chrome door handle(s) and, if necessary, to replace any affected door handle(s). To correct this condition, Kia is requesting the completion of this Service Action on all affected vehicles as they come in for normal service/maintenance. Before conducting the procedure, verify the vehicle is included in the list of affected VINs.

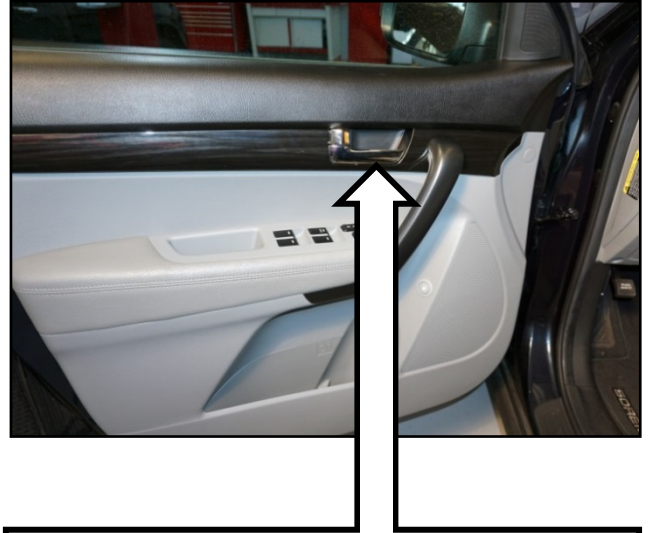
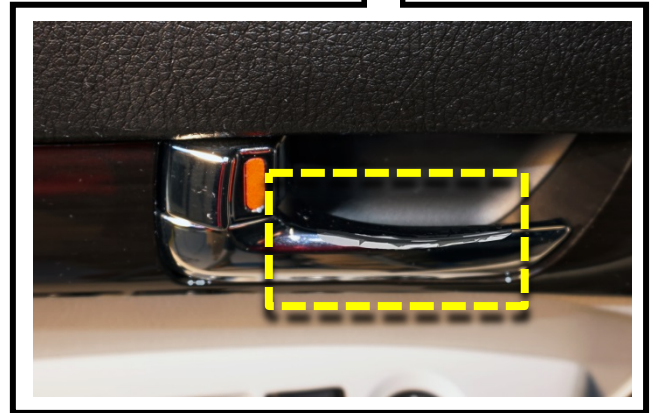
1. Inspect all four (4) door handles for peeling chrome, as shown.
 - If any of the door handle(s) are affected by this condition, proceed to the Service Procedure on Page 3.
 - If none of the door handles are affected by this condition, no further action is required.

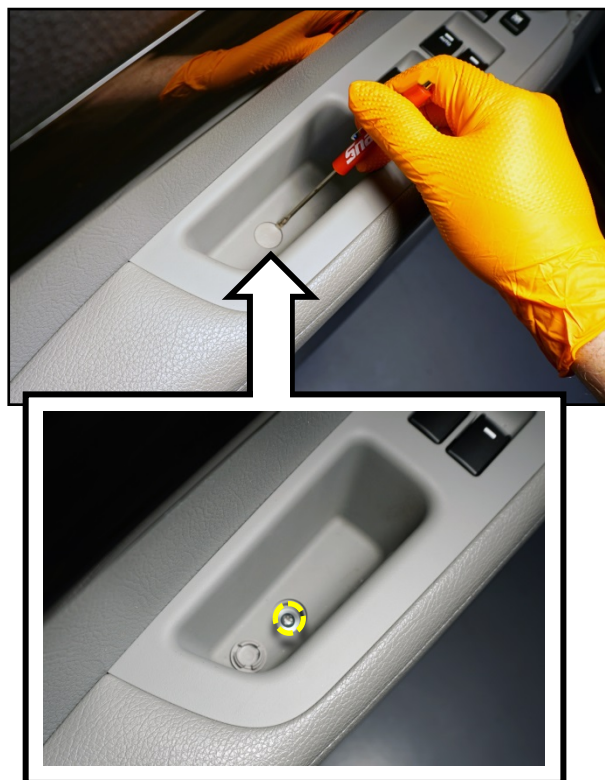
- Carefully remove the blanking cover from inside the door grip area and remove one (1) door panel mounting screw.
