GROUP <b>Body</b>	MODEL <b>2013MY Soul (AM)</b>
	NUMBER <b>123</b>	DATE <b>December 2015</b>
<b>TECHNICAL SERVICE BULLETIN</b>		
<b>SUBJECT: SERVICE ACTION: INTERIOR DOOR HANDLE(S) INSPECTION AND/OR REPLACEMENT (SA205)</b>

**SUBJECT: SERVICE ACTION: INTERIOR DOOR HANDLE INSPECTION AND/OR REPLACEMENT (SA 205)**

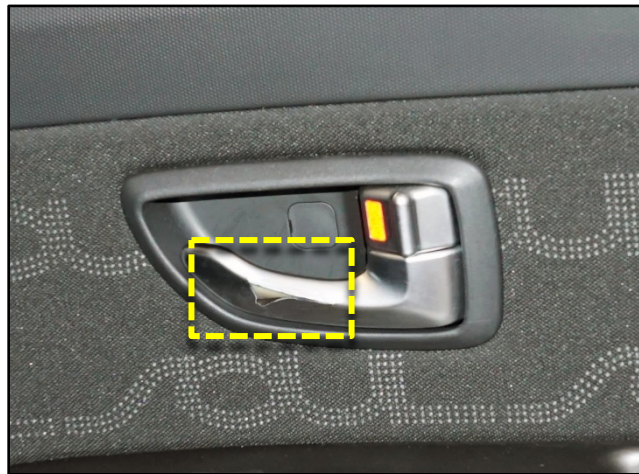
This bulletin provides the procedure to inspect and/or replace the interior door handle(s) of some 2013MY Soul (AM) vehicles, produced from August 1, 2012 through September 30, 2013, which may exhibit peeling of the chrome finish on the door handle (as shown below). To correct this condition, Kia is requesting the completion of this Service Action on all affected vehicles. Before conducting the procedure, verify the vehicle is included in the list of affected VINs.

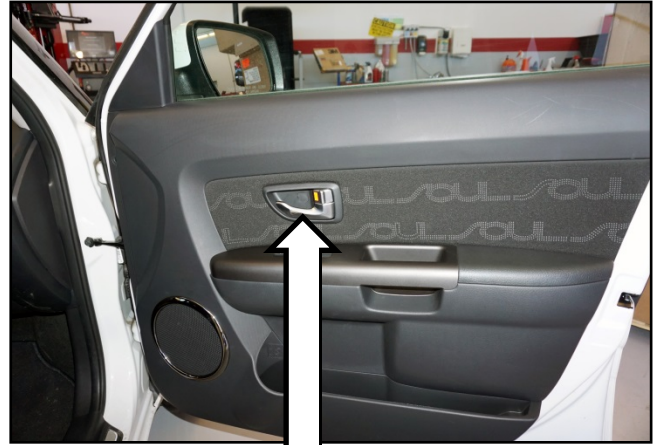
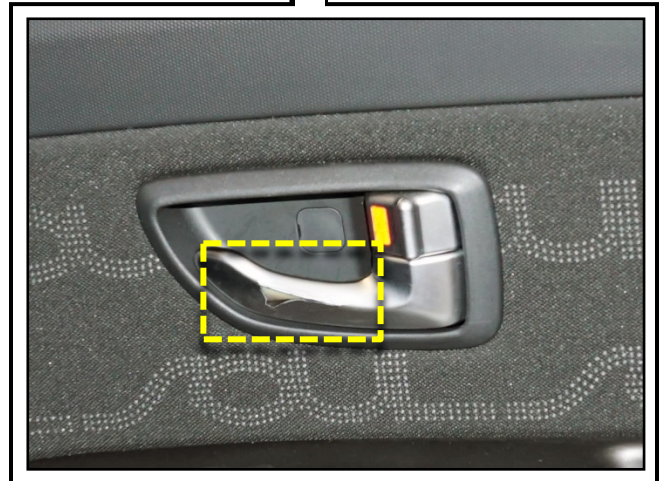
1. Open all four (4) vehicle doors and inspect each interior door handle for signs of peeling chrome, as shown.
  - If any of the interior door handle(s) exhibit peeling chrome, proceed to the Service Procedure on Page 3.
  - If none of the interior door handle(s) exhibit signs of peeling chrome, no further action is required.

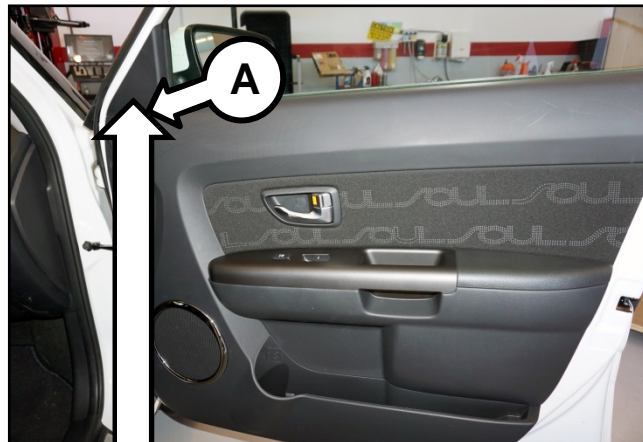
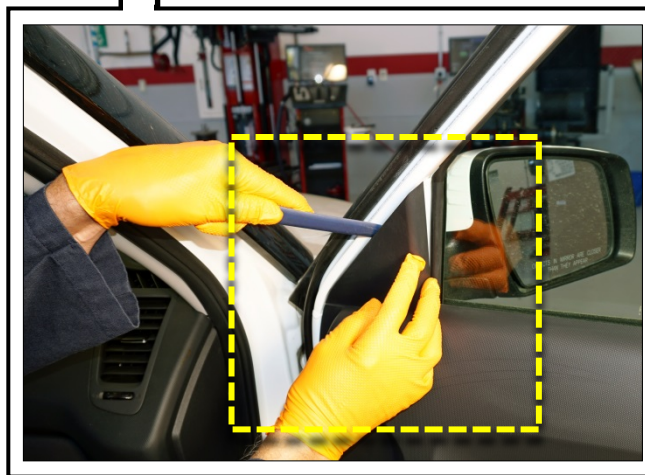
1. Open the affected door and remove the quadrant inner cover using a trim removal tool.

- Use a non-marring trim removal tool (Such as Snap-on® Part Number PBN5 or equivalent) to avoid damaging trim pieces.
- Be sure to wear disposable gloves throughout this procedure to avoid soiling any interior trim components.
- Exercise caution when removing the quadrant inner cover, as it can be easily damaged.

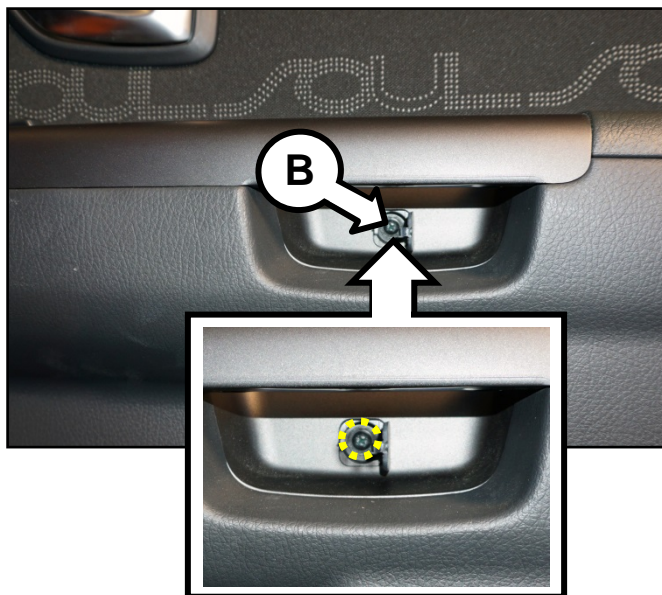
2. Carefully remove the blanking cover from the mounting location under the door grip, and remove one (1) door panel mounting screw (B).

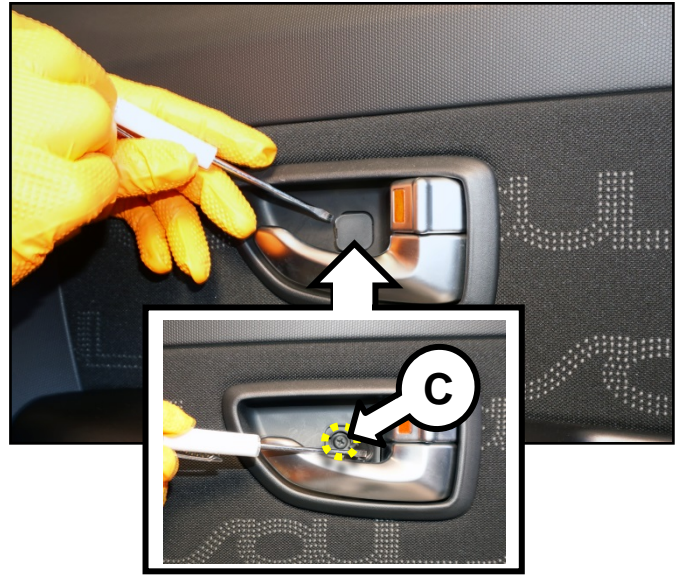
- Carefully remove the blanking cover from the mounting location under the door handle, and remove one (1) door panel mounting screw (C).

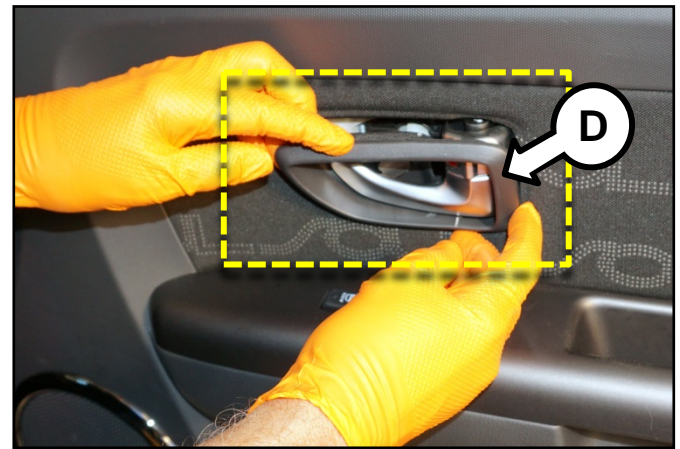
- Carefully remove the door handle trim cover (D), as shown.

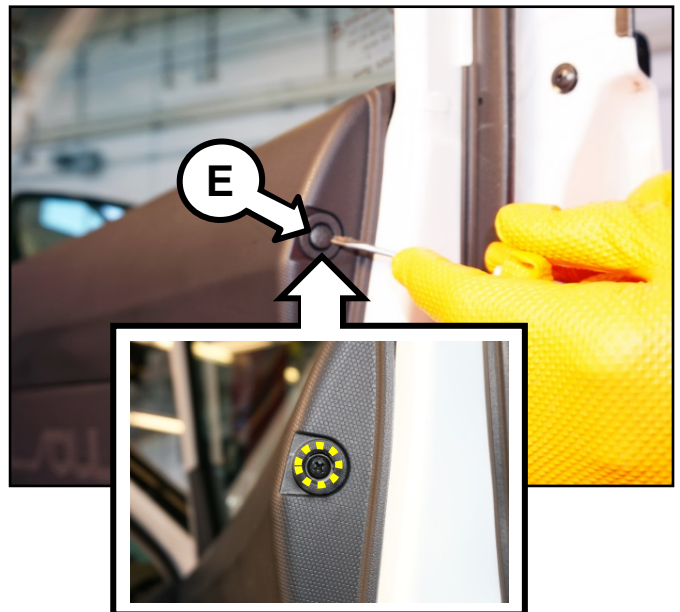
- Carefully remove the blanking cover from the outermost mounting location, and remove one (1) door panel mounting screw (E).

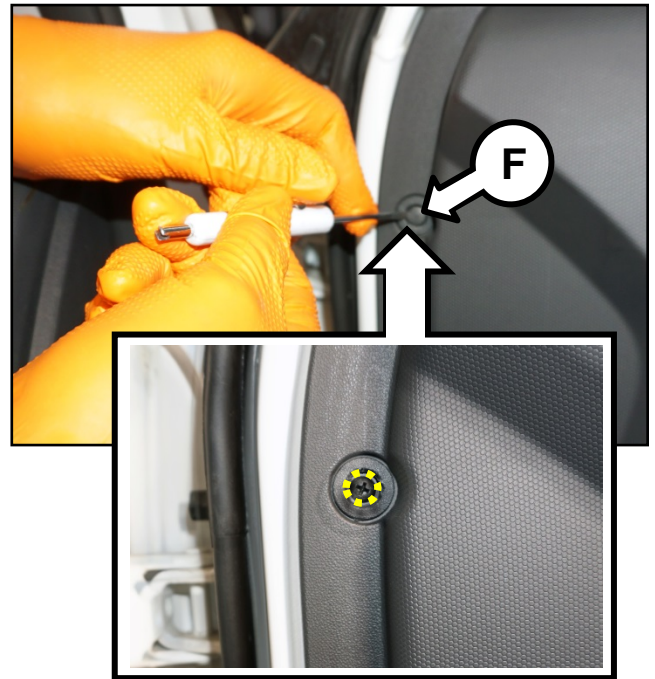
6. Carefully remove the blanking cover from the innermost, upper mounting location (F), and remove one (1) door panel mounting screw.

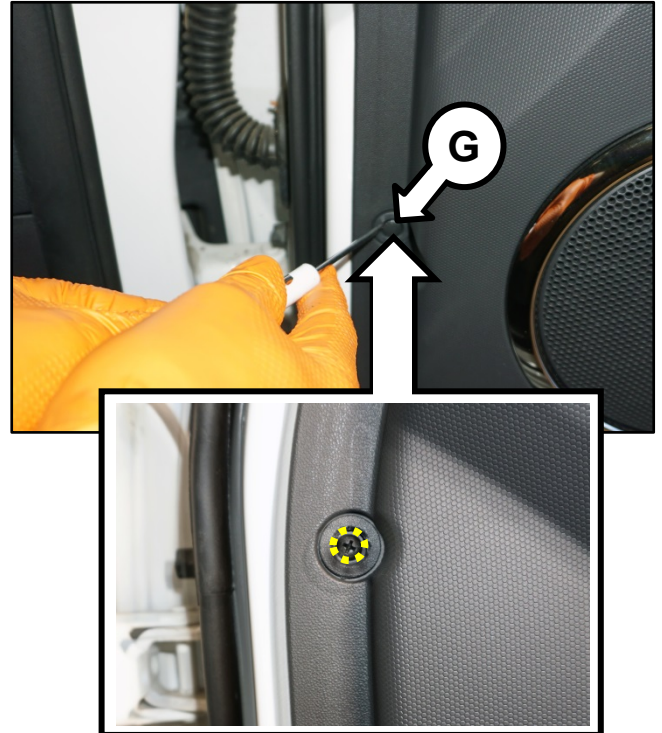
7. Carefully remove the blanking cover from the innermost, lower mounting location (G), and remove one (1) door panel mounting screw.

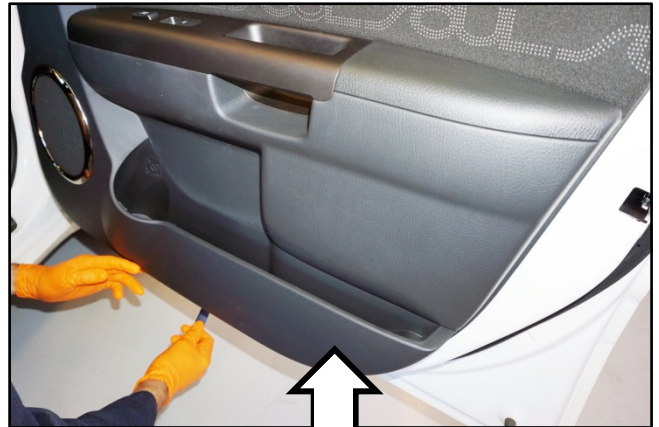
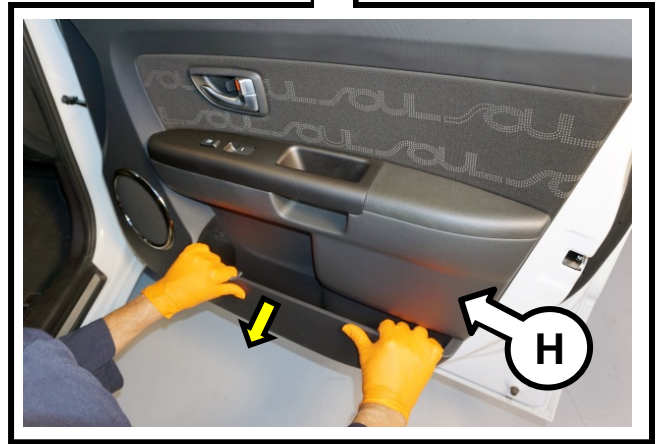
- 8. Use a plastic trim panel remover to dislodge the bottom edge of the door panel (H), and remove the door panel by applying gentle outward pulling force.

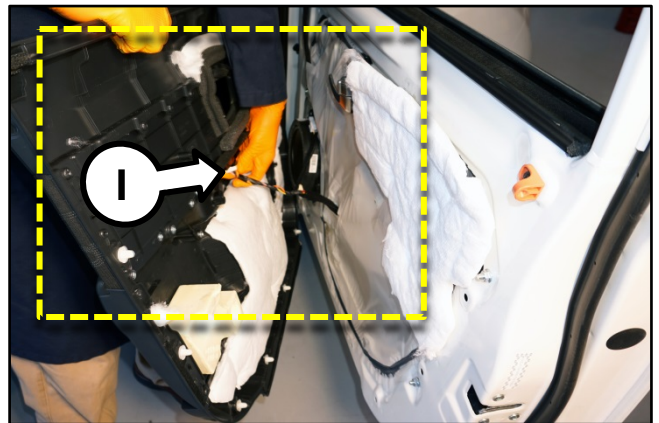
- 9. Carefully disconnect all connectors (I) from the back of the door panel.

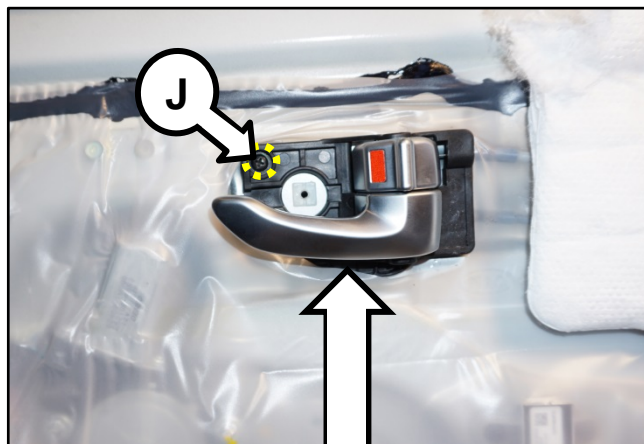
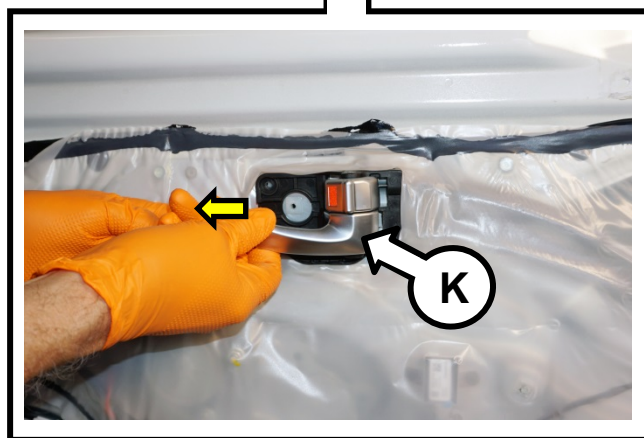
10. Remove one screw (J) from the door handle and pull the door handle (K) forward to separate from the door.

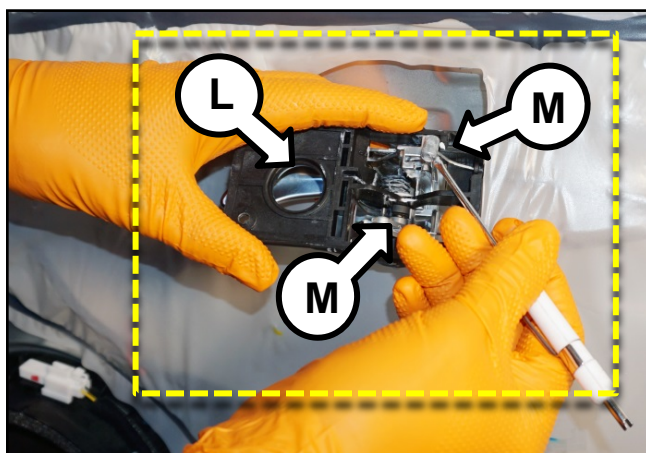
11. Remove the cable end fittings (M) from the door handle mechanism (L), as shown.

12. Install the new interior door handle and reinstall all removed components by reversing the order of removal.
13. Verify proper door handle(s) operation.
