GROUP BOD	MODEL 2016MY Sorento (UMa)
	NUMBER 113 (REV 1 , 09/23/2015)	DATE September 2015
TECHNICAL SERVICE BULLETIN		
SUBJECT: SERVICE ACTION: FRONT SEAT HEADREST REPAIR (SA196)

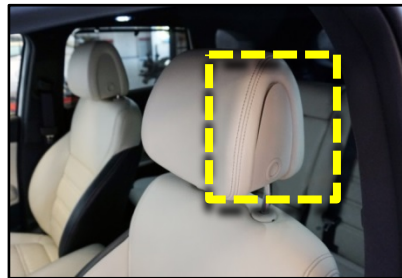
This bulletin provides the procedure to repair or, if necessary, replace the front seat headrests of some 2016MY Sorento (UMa) vehicles, produced from Job #1 through June 15, 2015, which may exhibit detachment of the plastic trim piece on either side of the headrest, as shown below. To correct and/or prevent this condition, Kia is requesting the completion of this Service Action on all affected vehicles, including dealer stock, prior to delivery. Before conducting the procedure, verify the vehicle is included in the list of affected VINs.

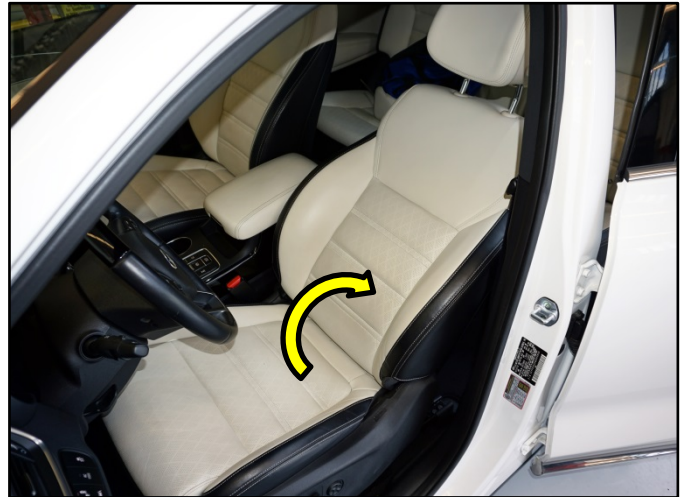
1. Recline the seat to allow for removal of the headrest.

Be sure to wear disposable gloves throughout this procedure to avoid soiling the seat cover or the headrest.

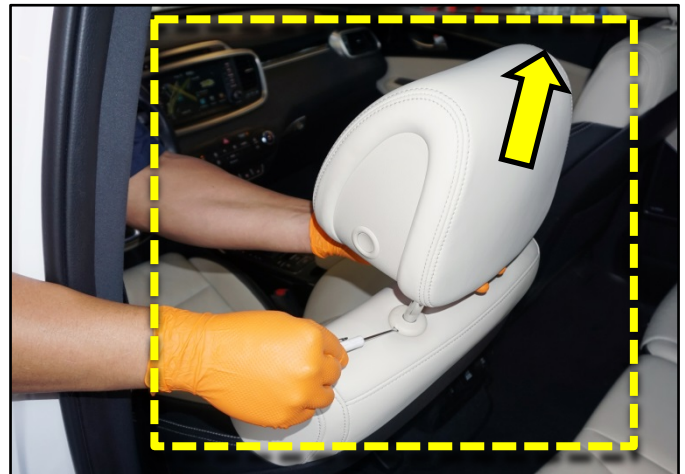
2. Use a small, flat screwdriver to release the headrest detent and remove the headrest from the seat.

Use great care to avoid perforating the leather cover with the screwdriver. Additionally, be sure to clean the screwdriver shaft and tip to avoid soiling the seat cover.

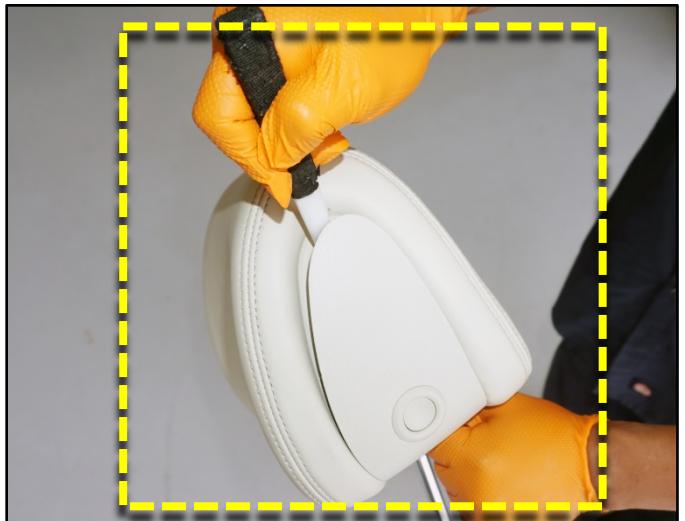
3. Use a clean, non-marring trim removal tool to detach the headrest trim piece from either side of the headrest, as shown.

Use a non-marring trim removal tool (Such as Snap-on® Part Number PBN5 or equivalent) to avoid damaging trim pieces.

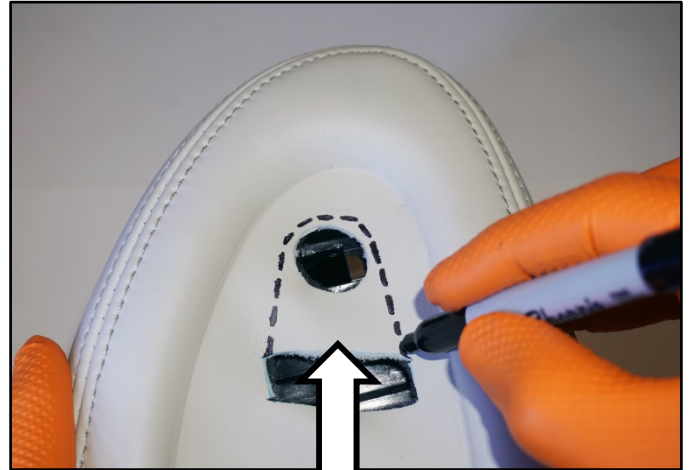
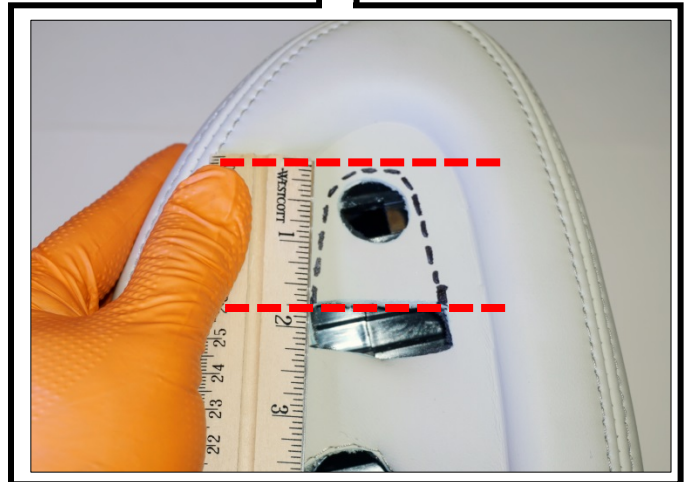
4. Carefully move the headrest trim piece out of the way and mark a set of "cut-lines" on either side of the headrest, as shown.

Headrest plastic trim piece removed for illustration purposes.

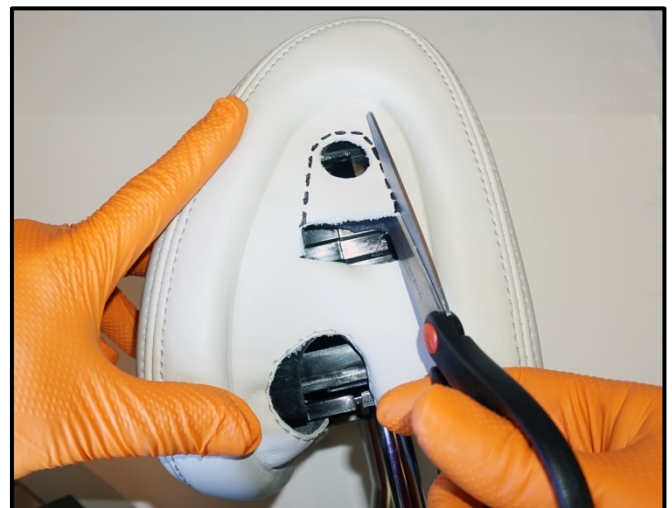
5. Use a pair of sharp scissors to carefully remove the material along the "cut-lines", as shown.

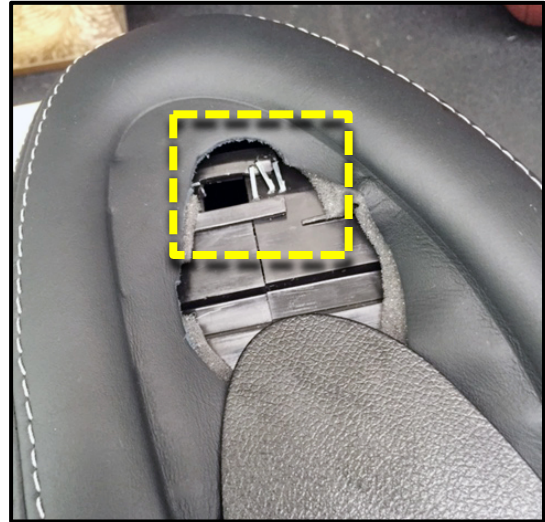
If there are staples in place on the headrest body, replace the affected headrest with a new part.

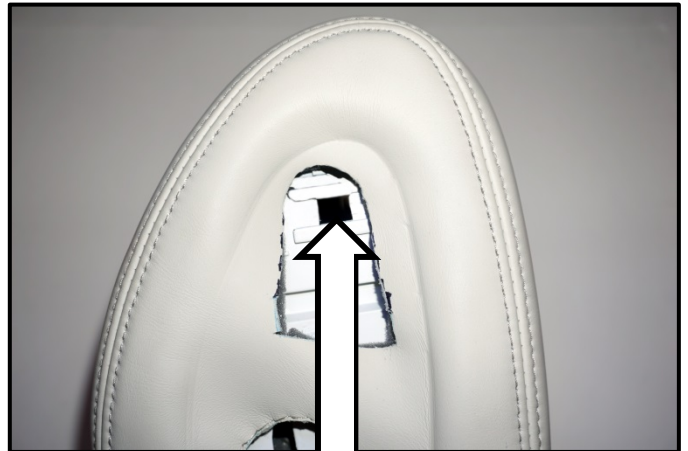
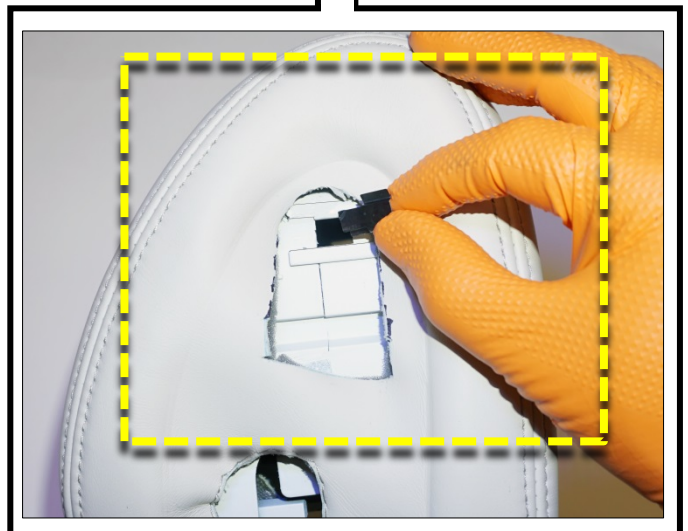
- 6. Insert the clip into the headrest, as shown.

Headrest plastic trim piece removed, and white paint applied to headrest body for illustration purposes.

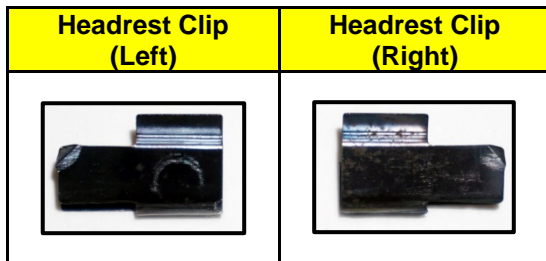
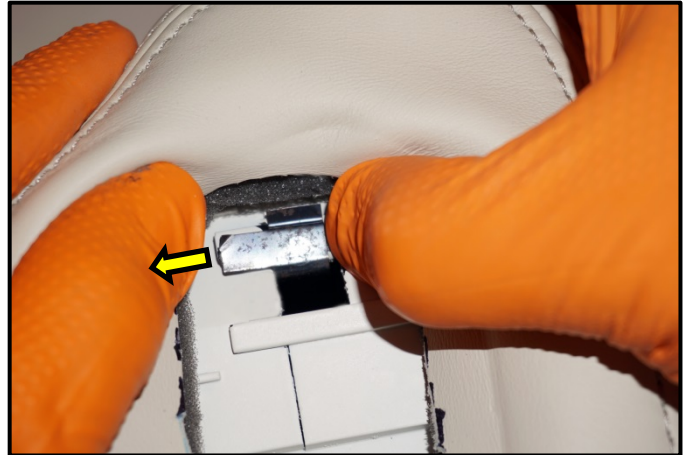
7. Push the clip forward until fully seated against the headrest body.

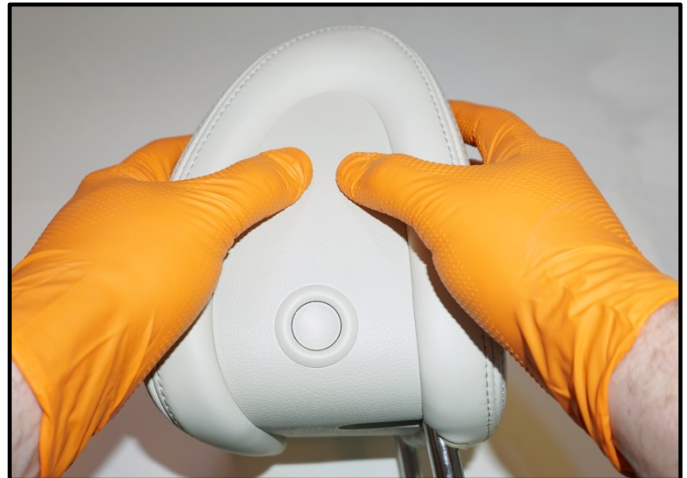
8. Push the sides of the headrest trim piece into the holes on the headrest, until firmly clipped in place.

9. Verify the headrest trim piece is held securely in place. If the trim piece disengages, check and adjust the position of the clip (steps 6~7). Once the clip is properly adjusted, push the trim piece into position on the headrest. If the trim piece stays in place, proceed to step 10. If the trim piece disengages, replace the affected headrest with a new one.
