# Program Bulletin

## CUSTOMER SATISFACTION PROGRAM

**SUBJECT:** Sunroof Glass Breaking

**MODELS:** 2015 Buick Regal  
2014-2015 Chevrolet Cruze  
Equipped with Sunroof (RPO CF5 or C3U)

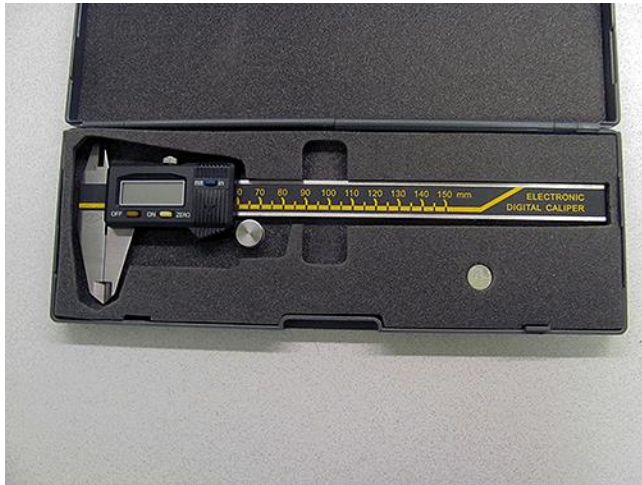
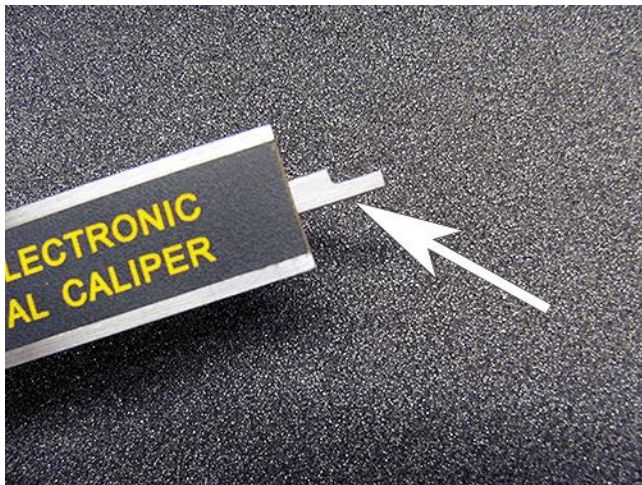
This inspection procedure requires the use of an electronic digital caliper with a depth measuring feature. Ensure the depth probe will fit into the gauge hole.
