Program Bulletin

CUSTOMER SATISFACTION PROGRAM

SUBJECT: Water Leak onto the Left Cabin Floor

MODELS: 2016 Chevrolet Colorado
2016 GMC Canyon

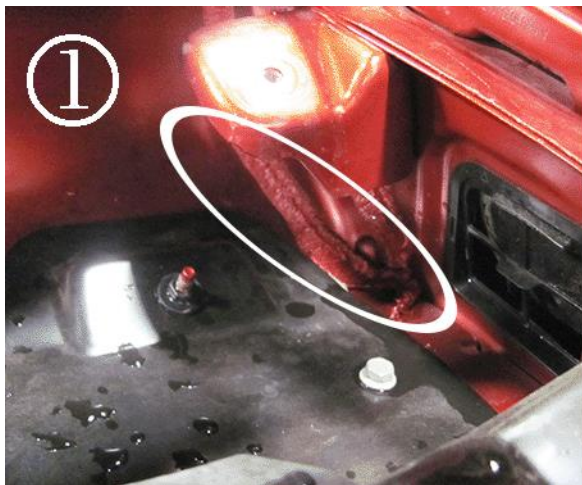
4310932

5. Apply seam sealer to the above (1) and the below (2) seams as shown above.

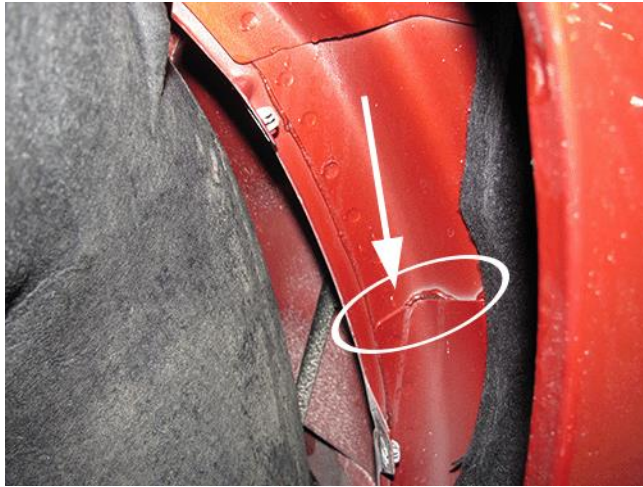
4310933

7. If required, clean any dirt or loose debris from the seam to be sealed.
8. Using a general purpose adhesive cleaner, clean the area to be sealed.
9. Apply seam sealer to the seam as shown above.
10. Allow the sealer to cure per the manufacturer’s instructions.
11. Install the front wheelhouse liner. Refer to *Front Wheelhouse Liner Replacement* in SI.
12. Install the windshield wiper motor. Refer to *Windshield Wiper Motor Replacement* in SI.
13. Remove fender covers and close hood.
14. Perform a water test to verify repair.
