2016MY  
Sorento (UMa)

## TECHNICAL SERVICE BULLETIN

**SUBJECT:** SERVICE ACTION: A/C SUCTION HOSE/PIPE INSPECTION  
AND/OR MODIFICATION (SA 183)

This bulletin provides the procedure to inspect and, if necessary, correct the routing for the A/C suction hose/pipe on some 2016MY Sorento (UMa) vehicles, produced from October 27, 2014 through February 9, 2015, to prevent possible contact between the A/C suction hose/pipe and the compressor pulley. To correct and/or prevent this condition, follow the procedure outlined in this bulletin. Kia is requesting the completion of this Service Action on all affected vehicles, including dealer stock, prior to delivery. Before conducting the procedure, verify the vehicle is included in the list of affected VINs.

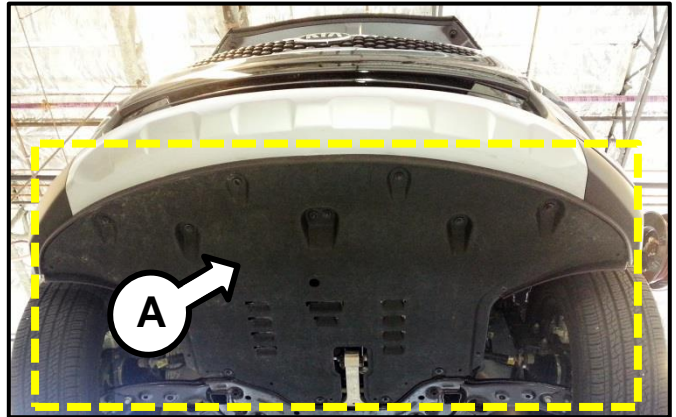
1. Place the vehicle on the lift and remove the underbody splash shield (A).

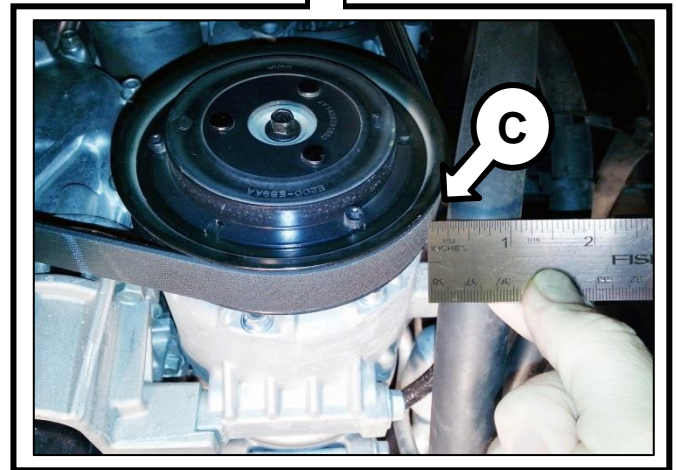
3. Measure the gap (C) between the A/C suction hose/pipe and the compressor pulley.

- If the gap (C) between the A/C suction hose/pipe and the pulley is less than 3/4" (19mm), proceed to the Service Procedure on Page 3.
- If the gap (C) between the A/C suction hose/pipe and the pulley is 3/4" (19mm) or more, no further action is required.
