MODEL
2015MY
Sedona (YP)

NUMBER
053

TECHNICAL SERVICE BULLETIN

SUBJECT: SERVICE ACTION: SEDONA (YP) HYDRAULIC STEERING RACK INSPECTION AND/OR REPLACEMENT (SA182)

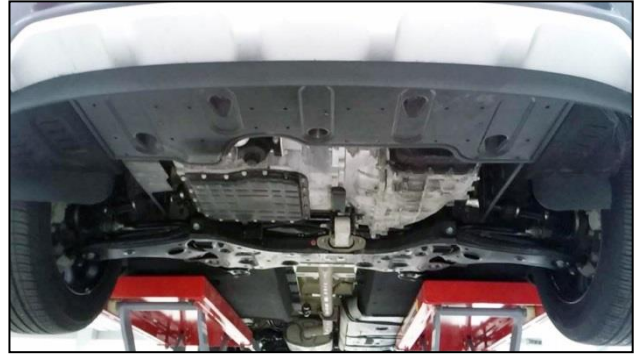
1. Place the vehicle on the lift.

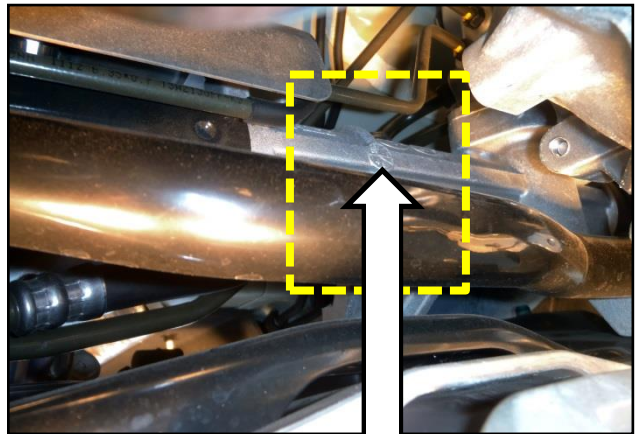
Reading the Date Code on the Steering Rack
4 J 1 7 (dots)

2. Locate the date code on the hydraulic steering rack. **NOTE: Refer to the table shown below to accurately read the date code information.**

A diagram showing a circular date code stamp on a steering rack. The stamp is divided into seven segments, numbered 1 through 7. Segment 1 contains the letter 'A', segment 2 contains '4', segment 3 contains 'J', segment 4 contains '1', segment 5 contains '7', segment 6 contains '1', and segment 7 contains '7'. Below the stamp is a circular legend with the same seven segments, each containing a number from 1 to 7. The legend is used to identify the date code from the stamp. The legend shows '4' in segment 1, 'J' in segment 2, '1' in segment 3, '7' in segment 4, '1' in segment 5, '7' in segment 6, and '7' in segment 7.

A close-up photograph of a steering rack date code stamp. The stamp is circular and divided into seven segments. The segments contain the following characters: 1 (A), 2 (4), 3 (J), 4 (1), 5 (7), 6 (1), 7 (7). A red dashed circle highlights the stamp, and a white arrow points from the stamp down to a text box.

3. If the rack date code matches 4 J 1 7 (dots), replace the rack with an improved part. Proceed to the Service Procedure on Page 3.
4. If the date code is different than 4 J 1 7 (dots), do NOT replace the rack. No further action is required.
