SERVICE INFORMATION

APPLICABILITY: 2015MY Legacy and Outback Models **NUMBER:** 07-89-15R
SUBJECT: Interior Fuse Box (F/B) "IG" and "ACC" Relay **DATE:** 02-10-15
 Under-Hood Fuse Box (M/B) Main Relay **REVISED:** 12-08-15
 Replacement for Engine Will Not Crank / Start Condition

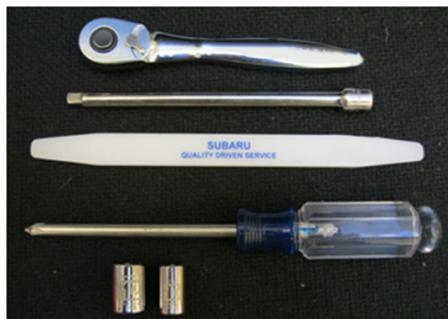
TOOLS REQUIRED

- 1/4" Drive Ratchet
- 6" 1/4" Drive Extension
- Plastic Trim Tool
- #2 Phillips Screw Driver
- 10mm and 12mm sockets
