SERVICE BULLETIN

APPLICABILITY: 2015-16MY Legacy and Outback Models
SUBJECT: Design Change to the Fuel Filler Door Assembly

NUMBER: 09-61-15R
DATE: 11/24/15
REVISED: 12/17/15

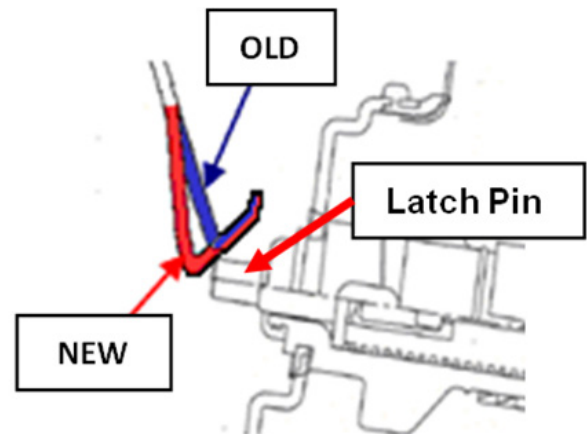
This bulletin announces a design change to the fuel filler door (saucer) assembly to address customer concerns of it being difficult to open and / or close. The striker portion's shape has been changed as shown in the cross-section illustration below along with the type of plastic material used in the construction of the saucer assembly.

If a complaint of the fuel filler door being hard to open or close is confirmed, replace the saucer and lock ring (seal) assembly along with a new "Unleaded Fuel Only" label using the applicable parts listed above. Follow the repair procedure outlined in the applicable Service Manual's Security and Locks section.

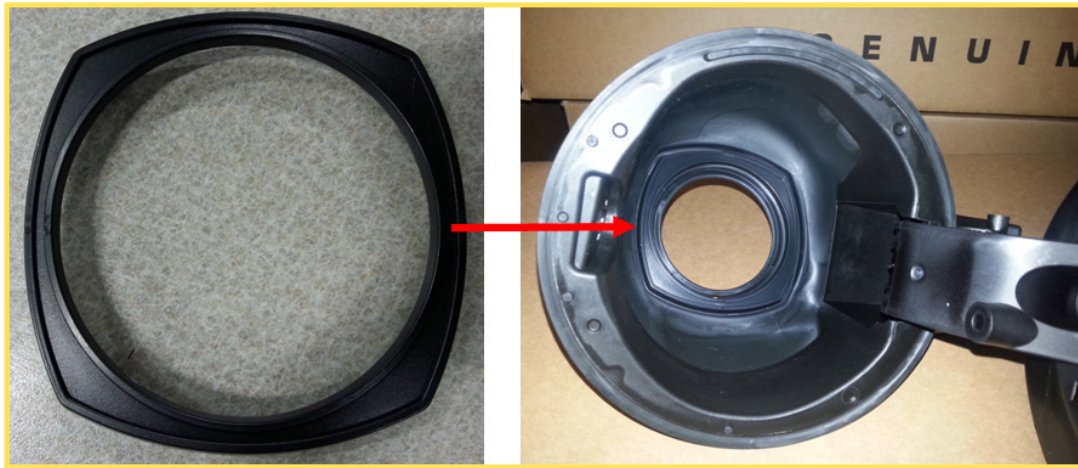
NOTE: The plastic lock ring shown below which is **INCLUDED** with the new saucer assembly is a one-time use part. **If needed, the lock ring is available separately by ordering p.n. 51467AL07A.**

- **NEVER** attempt to re-use a previously installed **lock ring**.
- **ALWAYS** take precautions to protect the vehicle finish when **removing and installing the saucer assembly**.

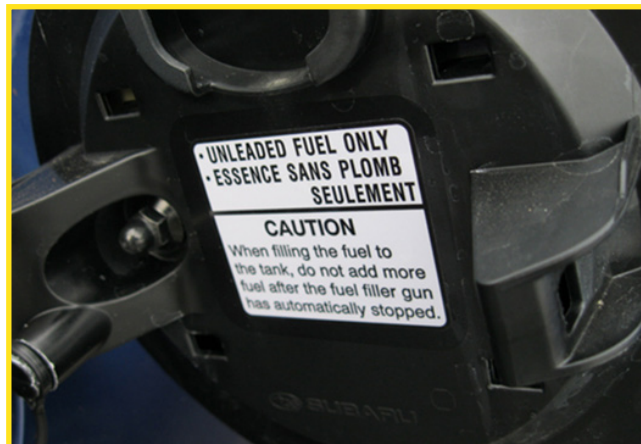
- **Affix a new “UNLEADED FUEL ONLY” label to the inside of the fuel door as shown. Always clean the area with a mild solvent on a clean shop cloth and allow to dry before application.**
