TECHNICAL BULLETIN
JTB00396NAS1
05 JAN 2015

SECTION: 501-10

'Creak' Noise From Front Seat Frame

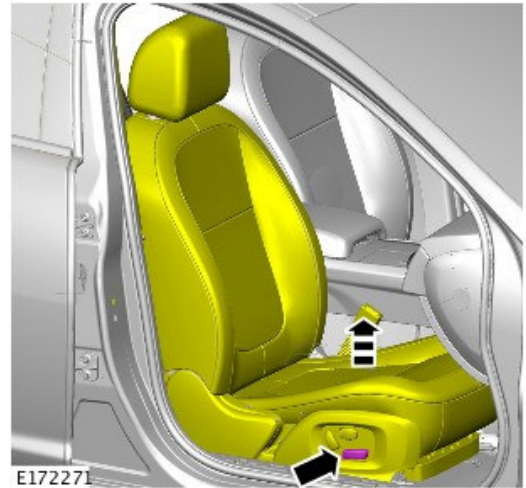
1. Adjust the affected front seat to the highest and most forward position.

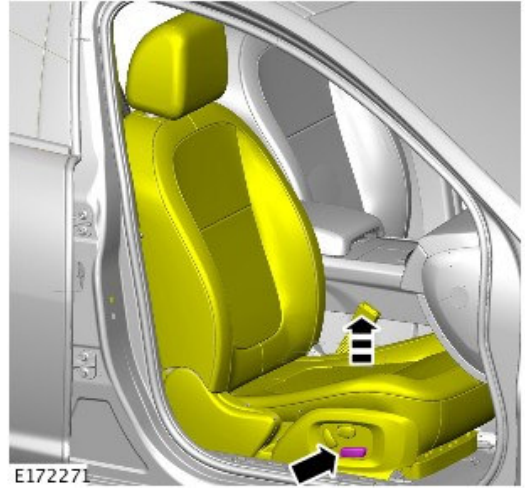
E172271

5. Sit on the seat and operate the height of seat from highest to lowest position, then return to the highest position.
- Repeat this step ten times.
