TECHNICAL BULLETIN JTB00343NAS2 08 APR 2015

SECTION: 501-14

Compact Key Handset - Lower-Level Service Repair

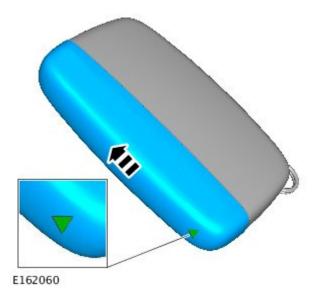
2. Remove the chrome cap; place to one side.

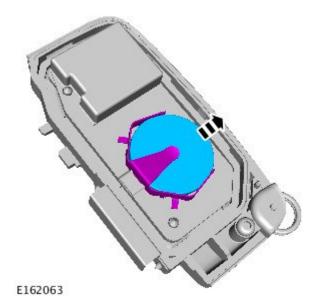
5. Remove the battery from the upper case.

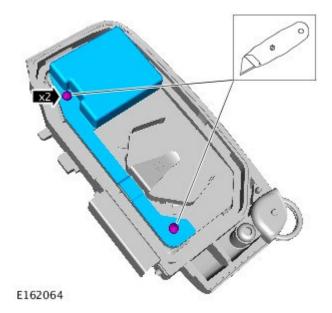
6. CAUTION: make sure the Printed Circuit Board [PCB] is not damaged when removing the black anti-tamper cover. If the copper coil antenna is damaged, the unit will be unserviceable.

Using a suitable tool, cut the fixings of the black anti-tamper cover and lift away from the Printed Circuit Board [PCB].

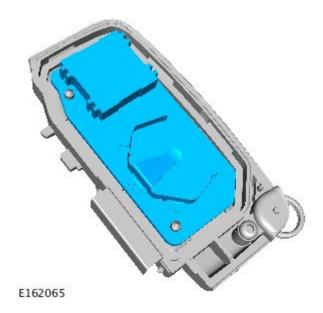
7. CAUTION: when removing the PCB, only handle the outer edges of the board.

Remove the PCB; place to one side.

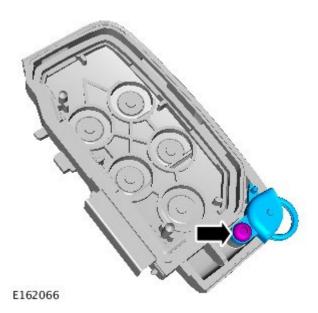
8. Remove the key ring retainer; place to one side.

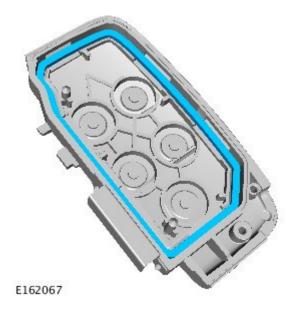
- **9.** Remove the silicone seal from the lower case; place to one side.
 - Discard the upper case.
 - .

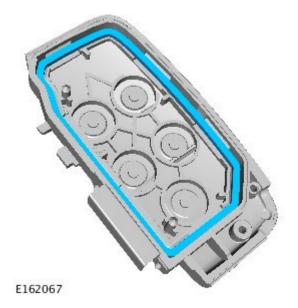
11. Install the silicone seal to the upper case.

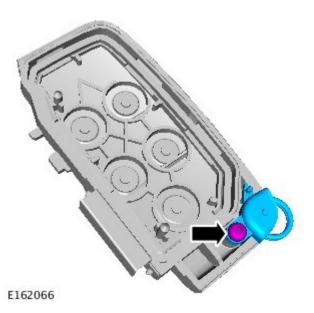
- **12.** Install the key ring retainer to the upper case:
 - Tighten to 1Nm.

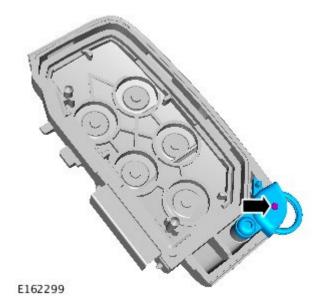
13. Make sure the key ring retaining pin is present in the upper case.

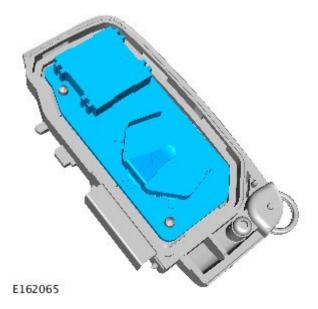
14. CAUTION: when installing the PCB, only handle the outer edges of the board.

NOTE: the PCB and cover are held in position with the foam pads on the new upper case.

Install the PCB to the upper case.

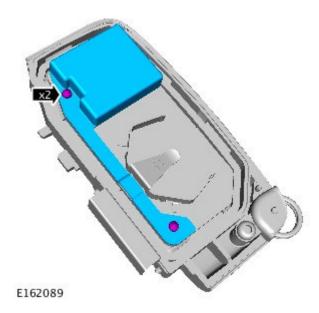
15. Install the PCB anti-tamper cover.

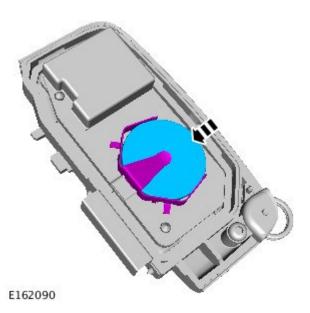
16. NOTE: make sure the battery is installed positive [+] side up.

Install the battery to the upper case.

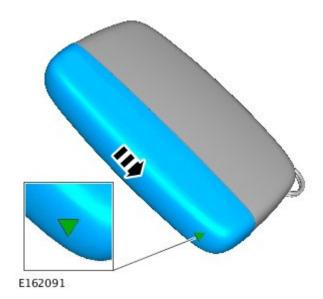
19. Install the chrome cap.
