TECHNICAL BULLETIN
JTB00343NAS3
15 SEP 2015

SECTION: 501-14

Compact Key Handset - Lower-Level Service Repair

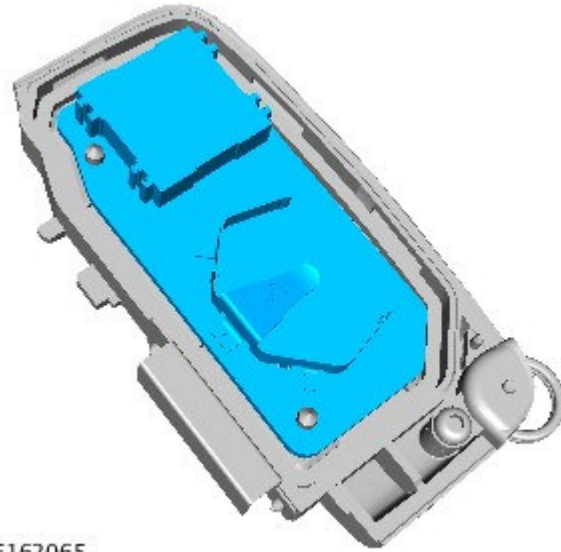
E162065

**CAUTION: when removing the PCB, only handle the outer edges of the board.**

Remove the PCB; place to one side.

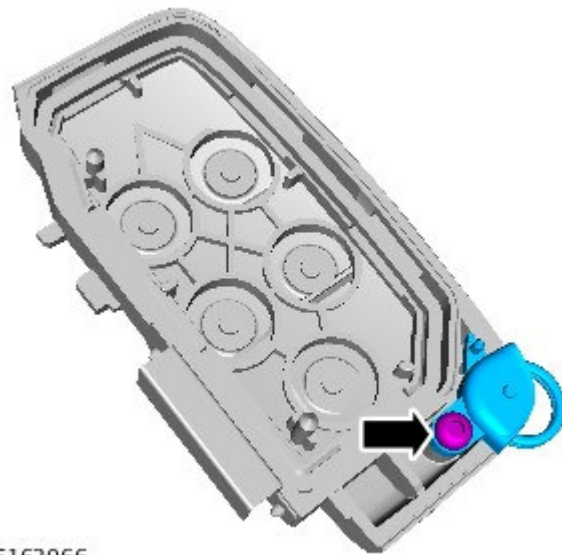
E162066

8 Remove the key ring retainer; place to one side.

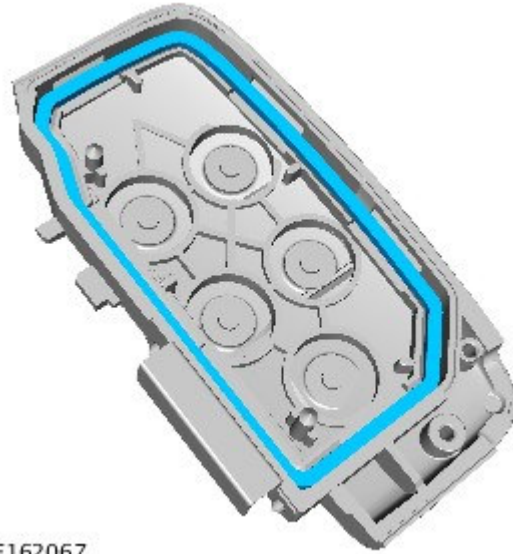
E162067

9 Remove the silicone seal from the lower case; place to one side.

- Discard the upper case.
-

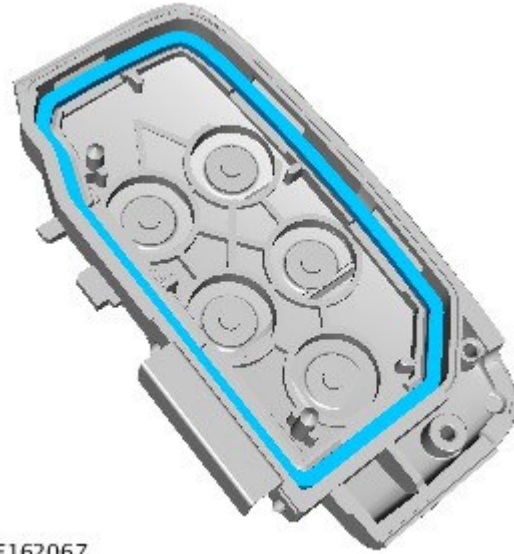
E162067

11 Install the silicone seal to the upper case.

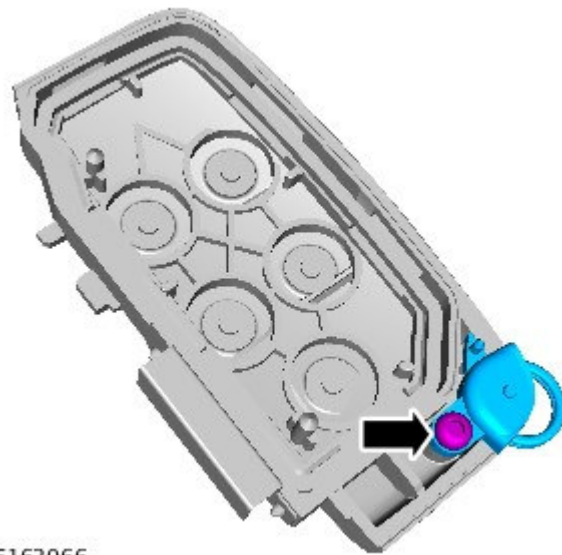
E162066

12 Install the key ring retainer to the upper case:

- Tighten to 1Nm.

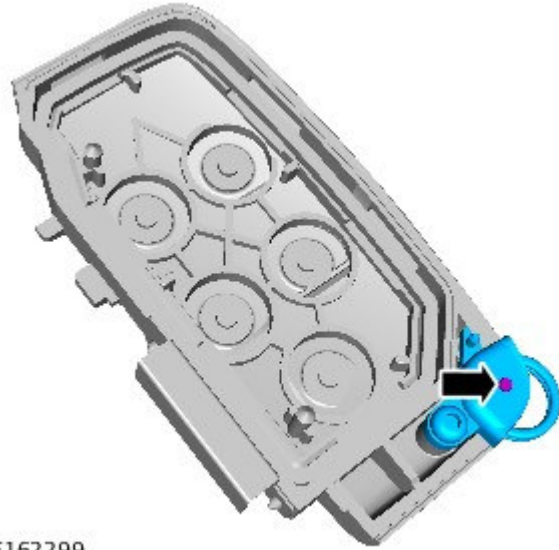
E162299

13 Make sure the key ring retaining pin is present in the upper case.

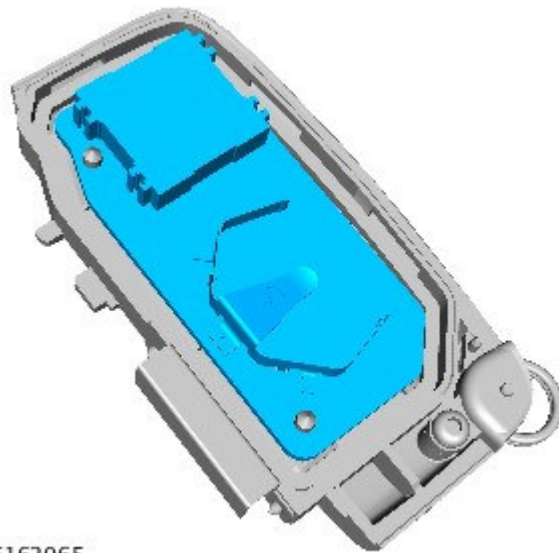
E162065

**CAUTION:** when installing the PCB, only handle the outer edges of the board.

**NOTE:** the PCB and cover are held in position with the foam pads on the new upper case.

Install the PCB to the upper case.

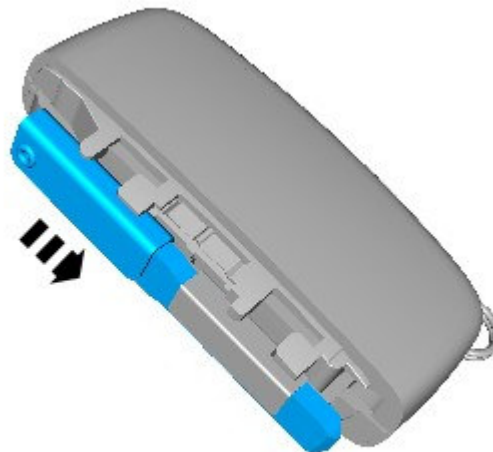
E162092

18 Install the key blade.
