# TECHNICAL BULLETIN

## JTB00434NAS1

## Rear Door Exterior Finisher Delamination

#### **XF (X250)**

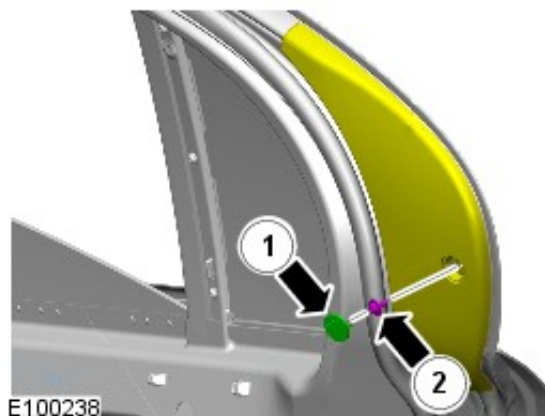
3 Remove the rear door cap fixing cover and rear door cap fixing.

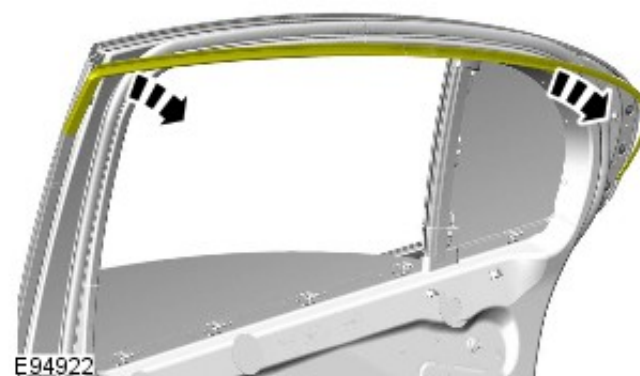
5 Position to one side the rear door seal.

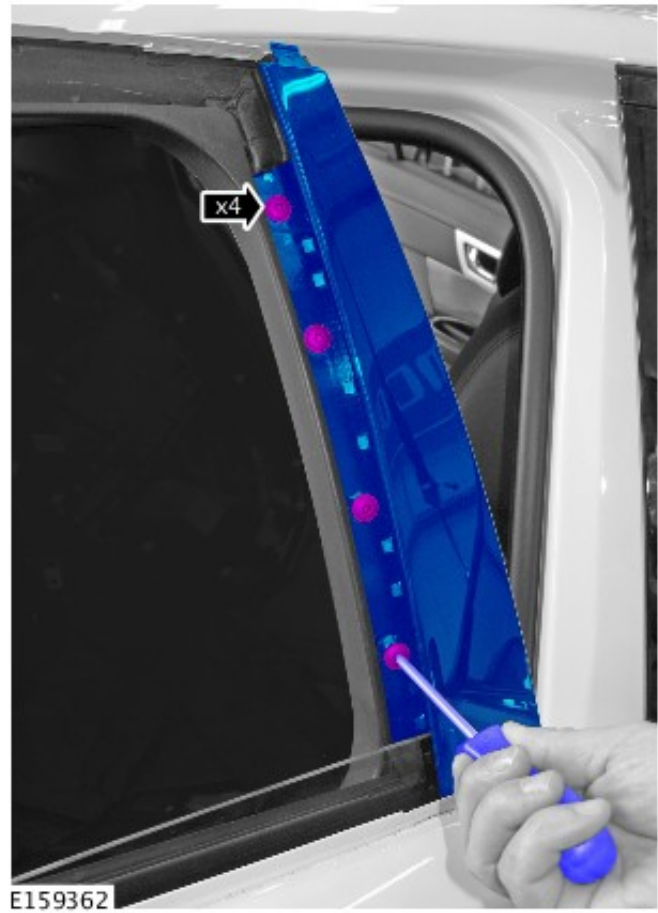
**9** Position to one side the rear door glass to gain access to the rear door B-Pillar fixings (see TOPIx Workshop Manual, Section 501-11).

**10** Release the four fixings.

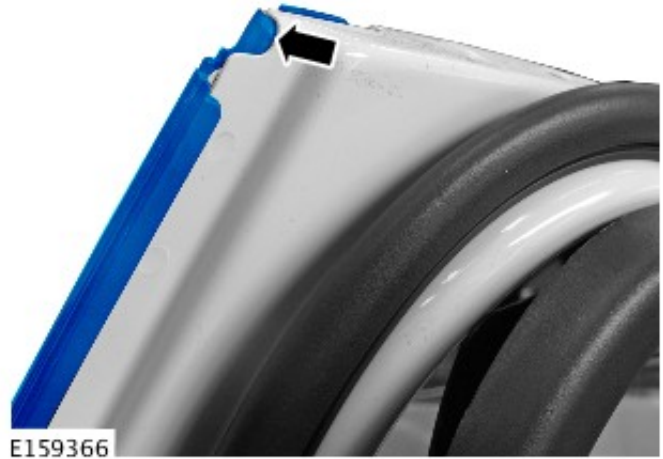
**11** Make sure the B-Pillar rear door exterior finisher is correctly located.

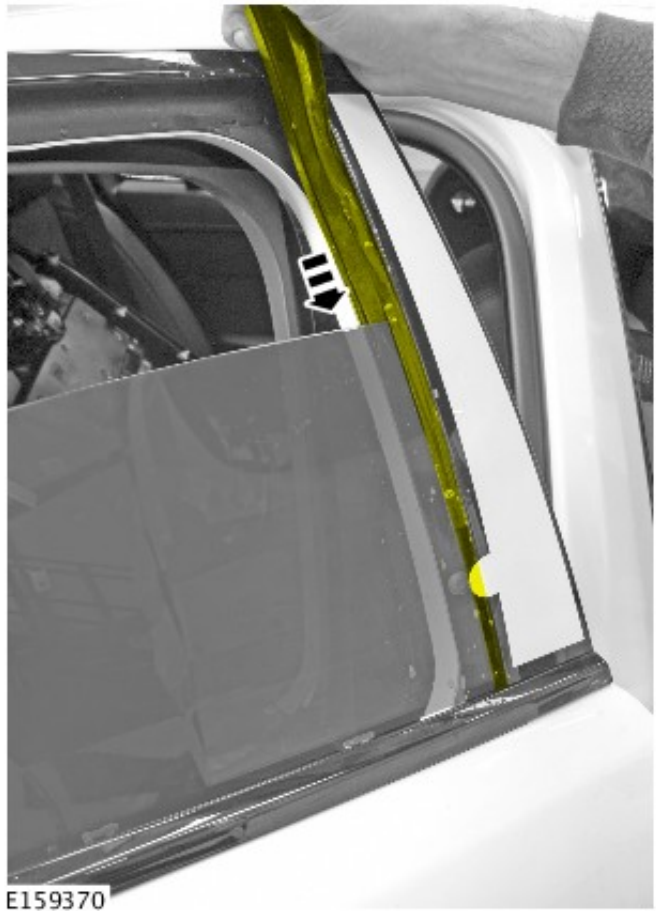
**15** Install the rear door glass seal.

- Apply a suitable lubricant to allow easier installation of the rear door glass seal.

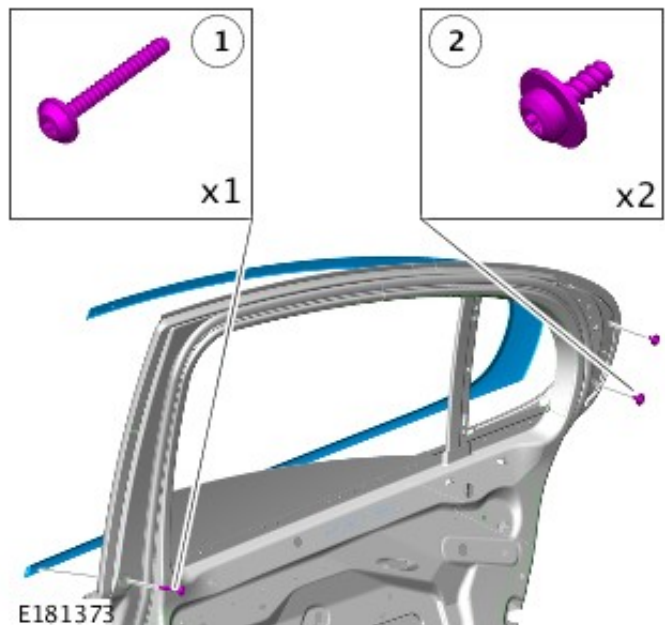
**17**

**NOTE: only install a new component if there are visible signs of damage.**

**NOTE: make sure the component is installed in the correct position.**

Install the rear door exterior finisher.

- Install the new rear door finisher short fixing (1).
- Install the rear door fixings (2).
- Torque: 2.1 Nm

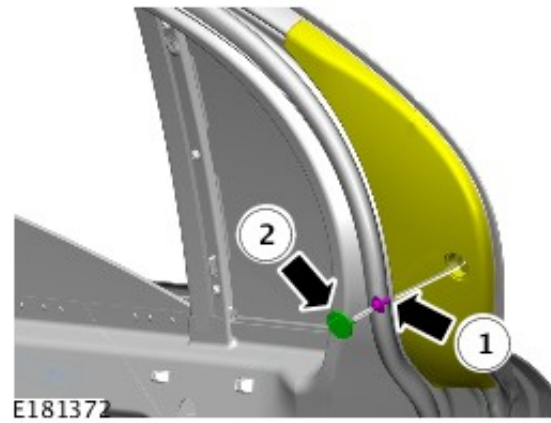
**19** Install the rear door cap, fixing and fixing cover.

- 1. Torque: 1.1 Nm
