## **\*\* 2015 OUTLANDER SPORT 2.4L \*\***

### **EXHAUST MANIFOLD BRACKET INSPECTION AND INSTALLATION INSTRUCTIONS**

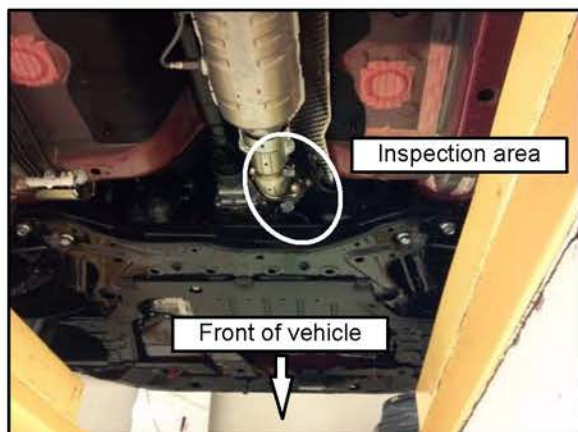
- Qty. 1: Exhaust Manifold Bracket – P/N 1555A495
- Qty. 2: Bolt – P/N MF247891

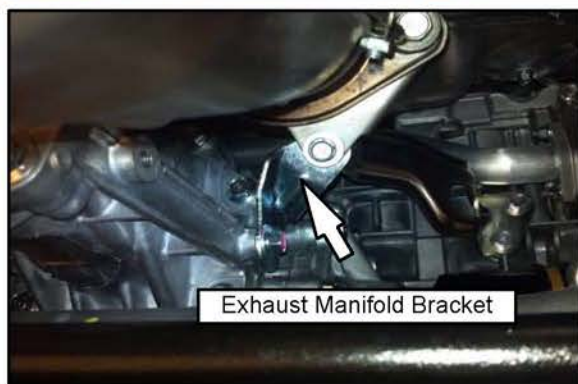
Visually inspect from under the vehicle (see attached photos).

From underneath the vehicle, the inspection area is on the passenger's side of the vehicle centerline, above the front cross member, where the manifold bolts to the exhaust pipe (see photo in step 2).

If the bracket is installed, submit a warranty claim for inspection only. See the Warranty Information section of these instructions.

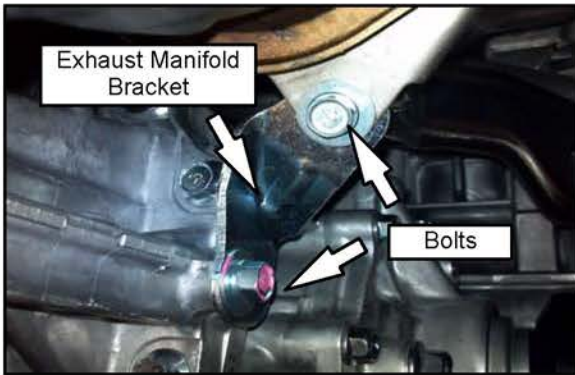
1. If no bracket is installed, install a bracket using two bolts.

2. Contact Techline to obtain parts.
3. Install the bracket using 2 bolts (provided).

Torque to 15–25 Nm (12–18 ft lbs).
