02365 Version 1

Security System Sounds or May Not Set

AFFECTED VEHICLES

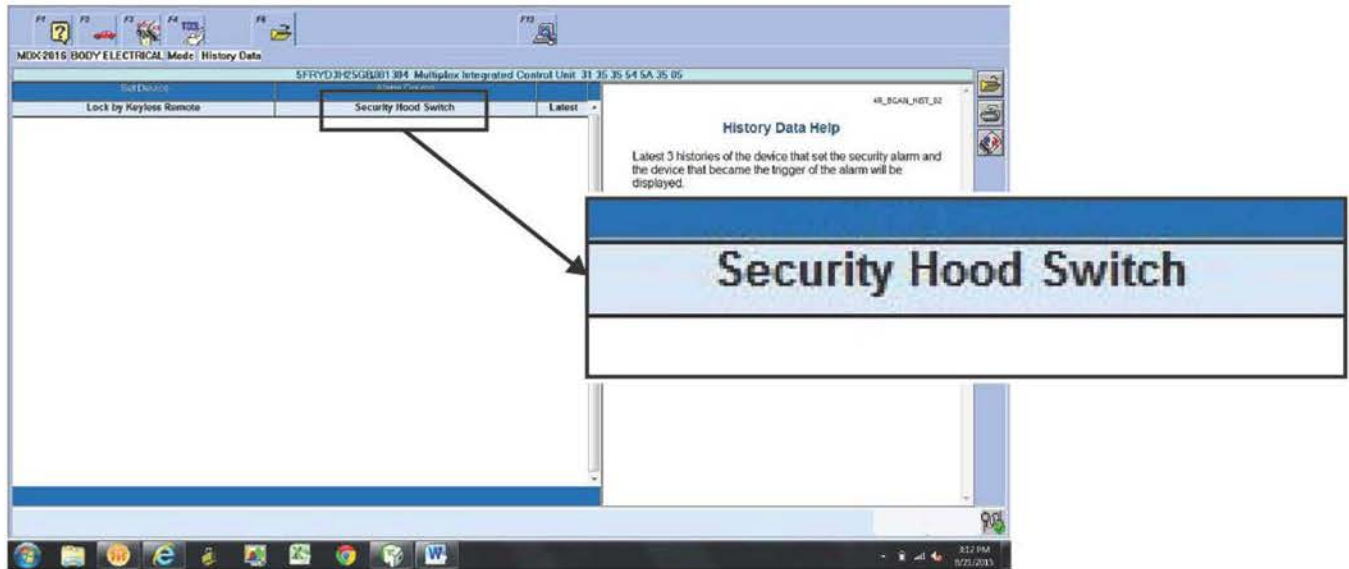
1. If the client complaint is alarm goes off by itself, check the security system history data using the HDS. If the **Alarm Device** shows **Security Hood Switch**, go to REPAIR PROCEDURE. If the history data does not show **Security Hood Switch**, this bulletin does not apply.

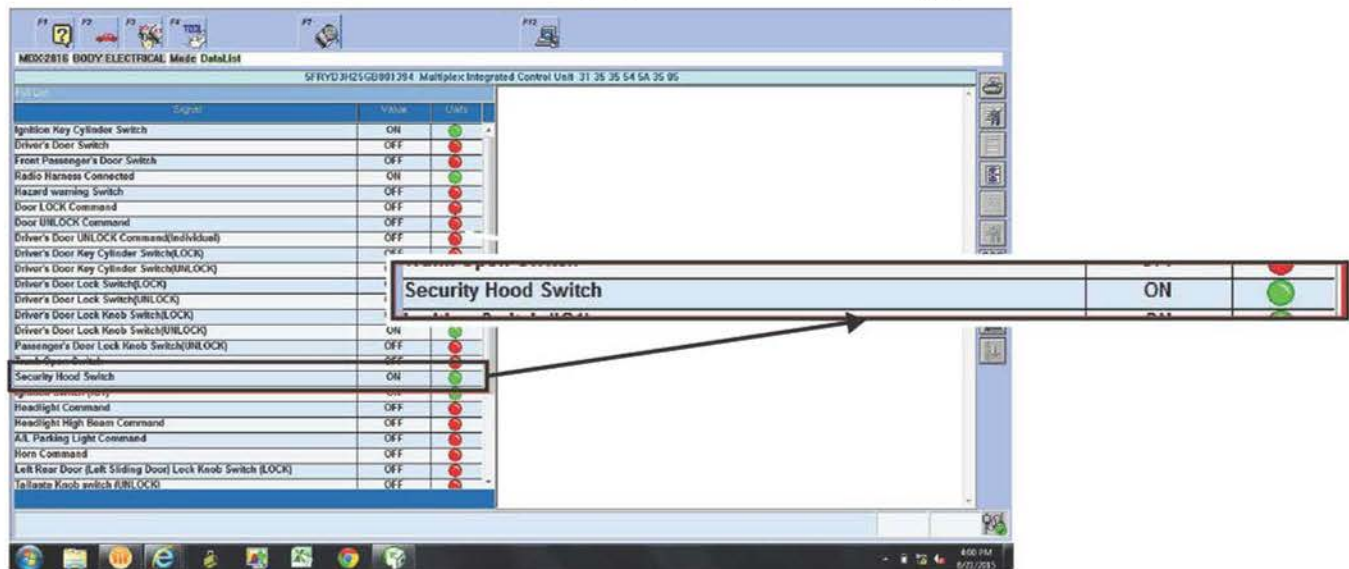
2. If the client complaint is "Security system will not arm", "Parking lights do not flash when setting security system", or "No feedback beep when pressing the lock button twice". Duplicate the complaint, then check the **Body Electrical Data List** using the HDS with the hood closed. If the Security Hood Switch signal reads **ON** (green) go to REPAIR PROCEDURE. If the Security Hood Switch **OFF** (red), this bulletin does not apply

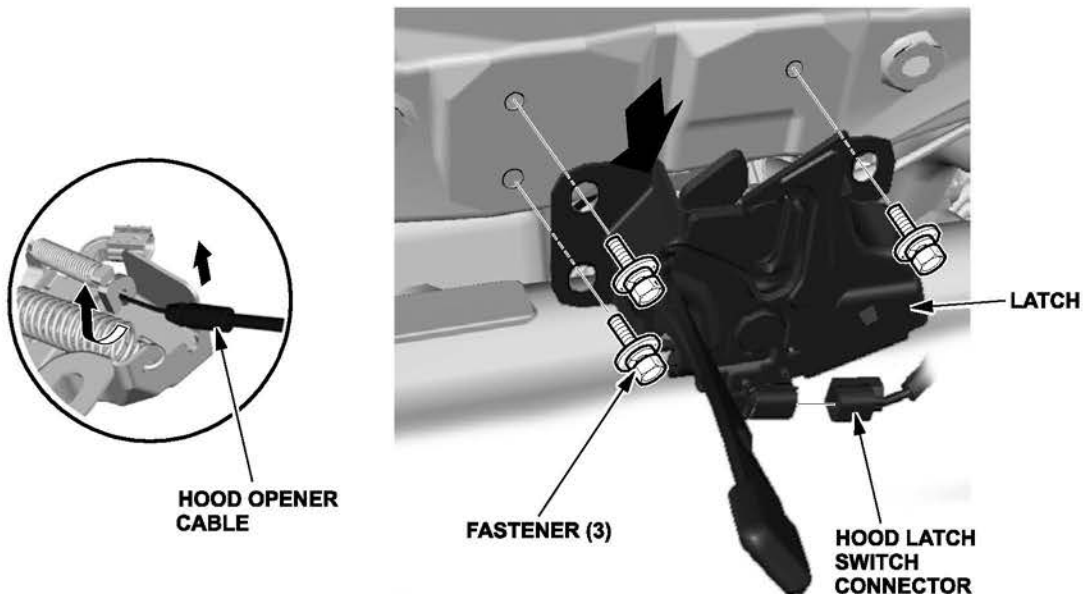
Excessive clearance in the hood latch causes the hood latch switch to indicate the hood is open when it is not.

3. Remove the hood latch:
 - Disconnect the hood opener cable from the latch.
 - Disconnect the hood latch switch connector.
