September 16, 2015

49387-01883 Version 11

Safety Recall: Front Passenger's Airbag Inflator Can Be Over-Pressurized

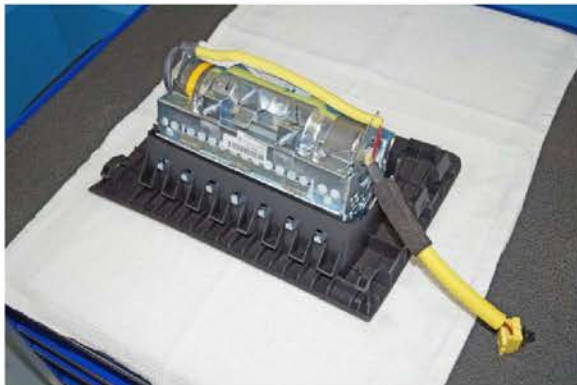
3. Remove the front passenger's airbag by referring to the applicable electronic service manual.
 4. Place the airbag, face-down, on a clean shop towel.

- The orientation of the airbag is critical because if the inflator is installed incorrectly, the harness will be too short when you reinstall the airbag.
- The brackets between the various models are similar but may differ from the example shown.

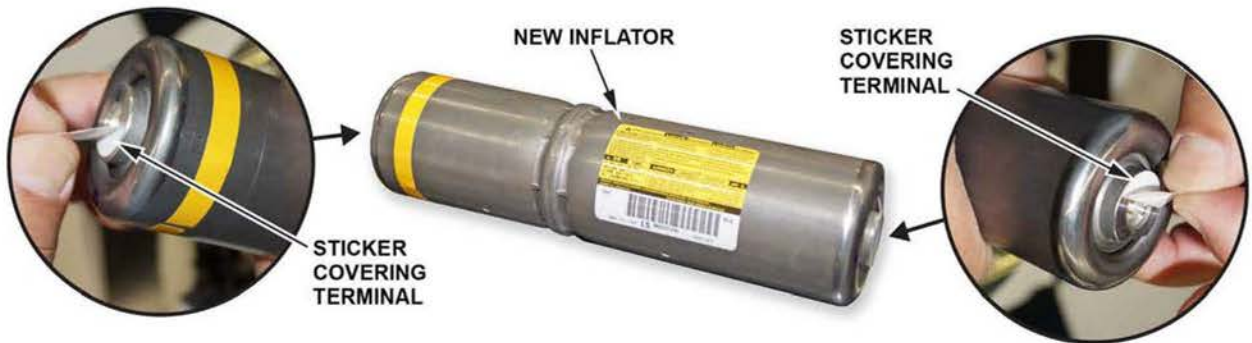
15. Remove the stickers covering the terminals on both sides of the new inflator.
