Subject: DRIVER SEAT GRADUALLY MOVES DOWN BY ITSELF	Bulletin No: 09-006/15
	Last Issued: 6/2/2015

DESCRIPTION

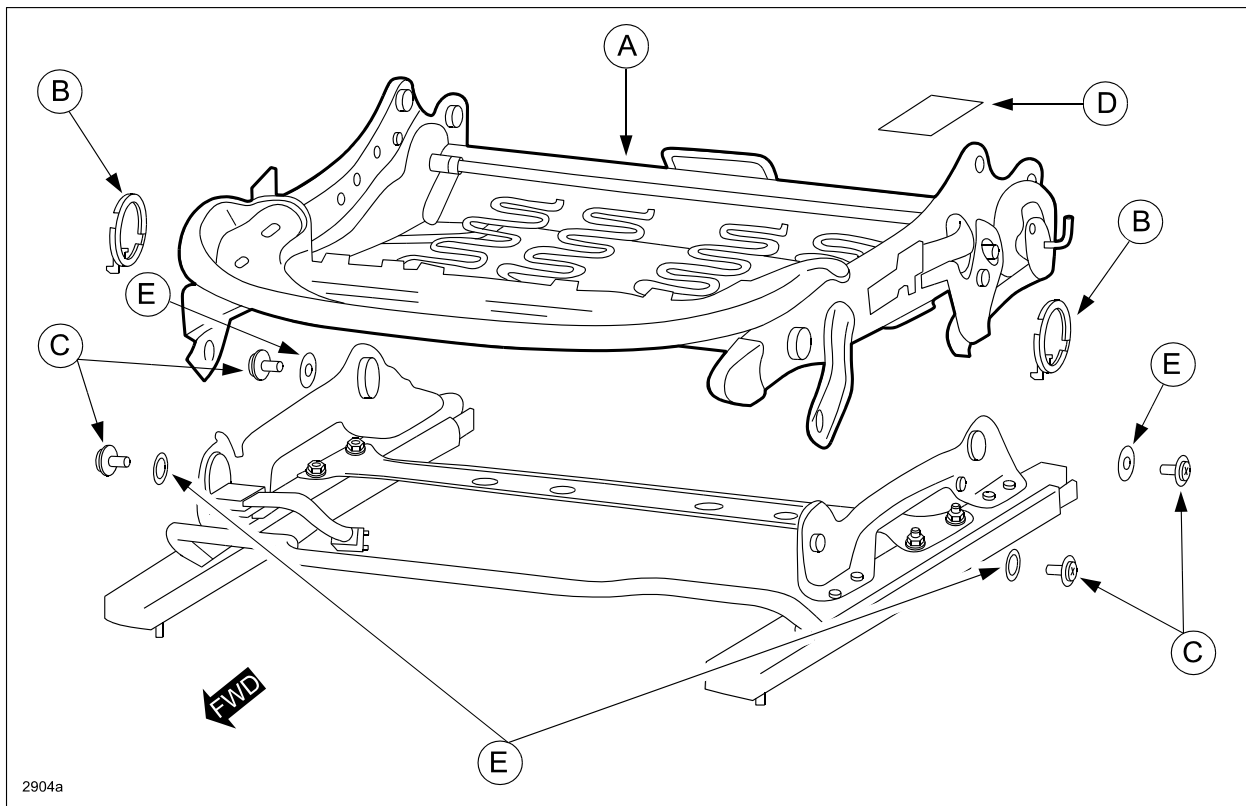
Service Parts kit includes:

- (A) Seat Lift Unit
- (B) Balance Spring, Rear (2)
- (C) Torx T30 Bolt (4)
- (D) Black Tape

NOTE: Be sure to save and re-use all washers (E). New washers are NOT included in the Service Parts kit.

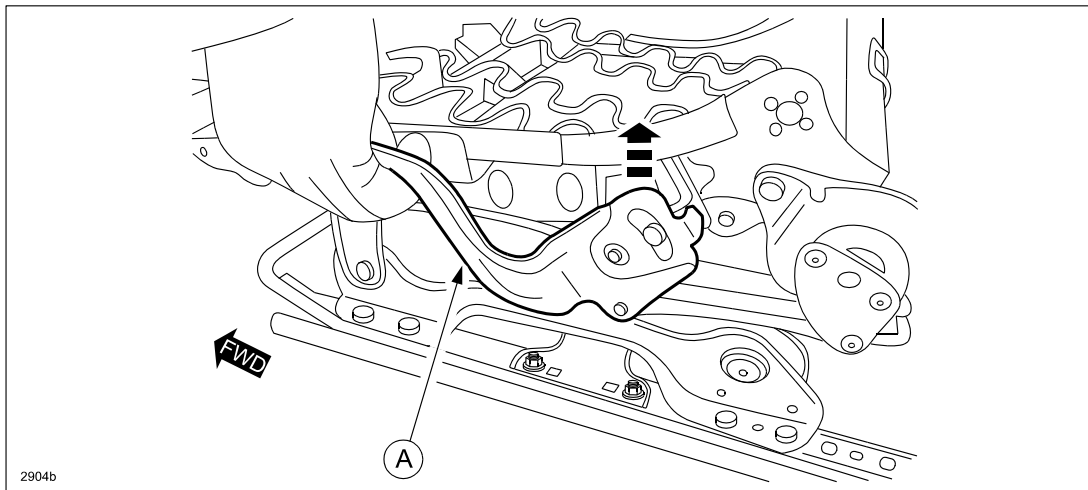
1. Lift the seat lift unit to the highest position using the lift lever (A).

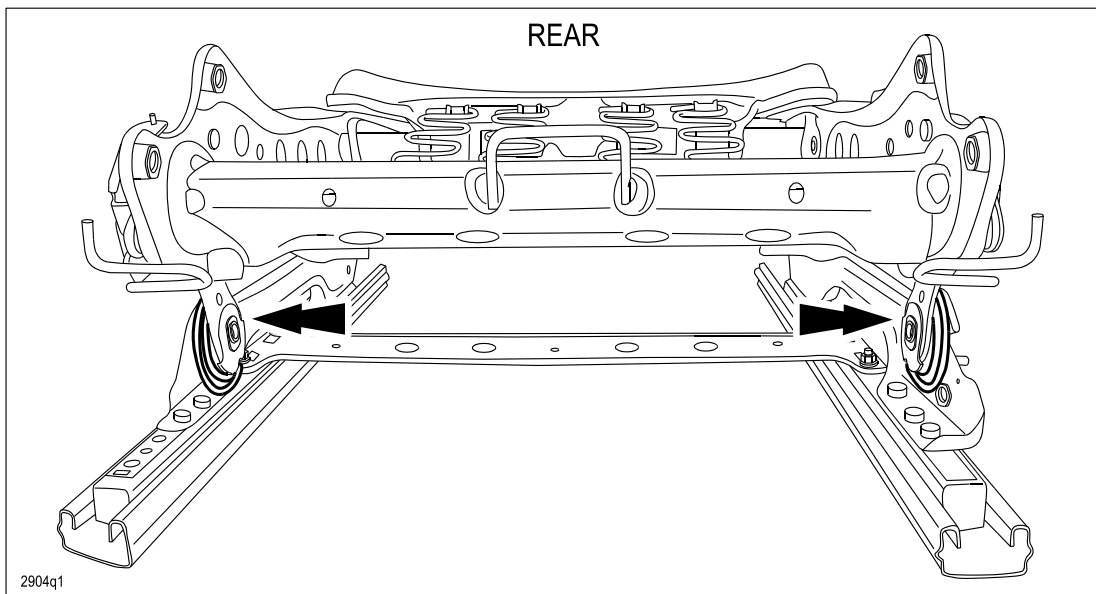
2. Starting with the **REAR** of the seat adjuster unit (as shown below), attach a piece of masking tape onto the inner sides of the left and right sliders to avoid scratch damage during the repair.

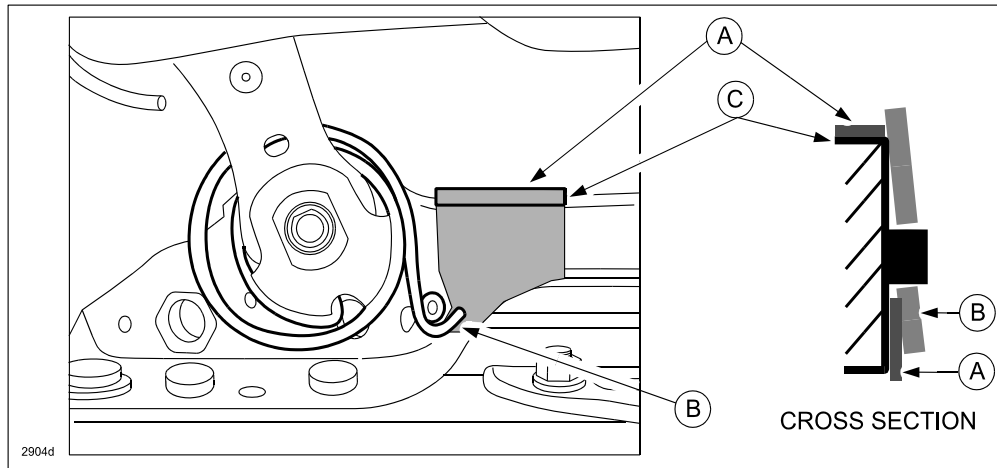
NOTE: Attach the masking tape (A) under the balance spring hook (B) and over the top of the slider (C).

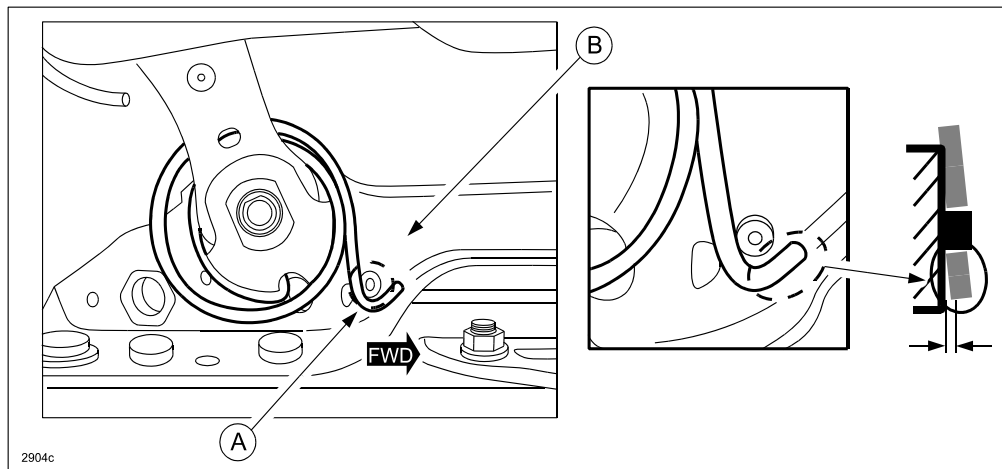
- Using a flat-blade screwdriver with masking tape on the tip, gently pry the balance spring hook (A) away from the slider surface (B).

WARNING: Be careful not to pinch your fingers.

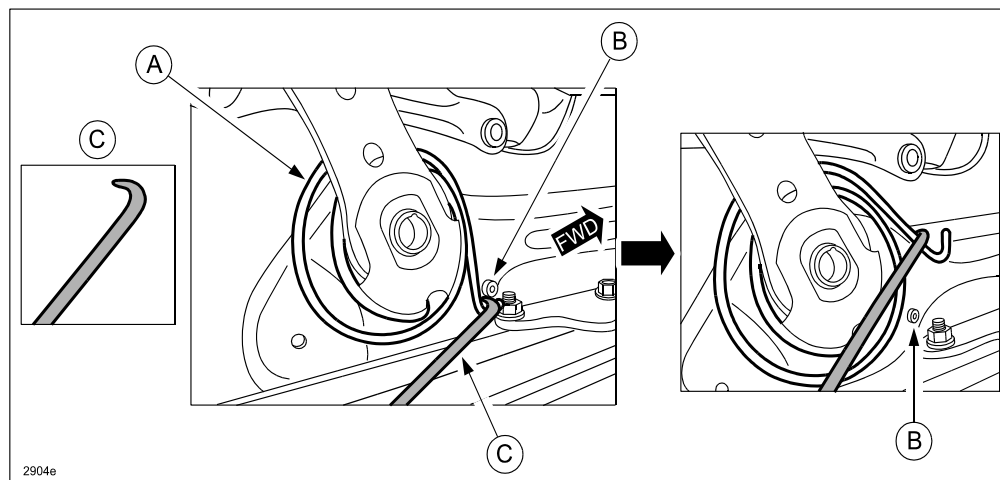
- Release the rear balance spring (A) hook from the pin (B) using a tool with a hooked end (C) (as shown below) or with needle-nose pliers.

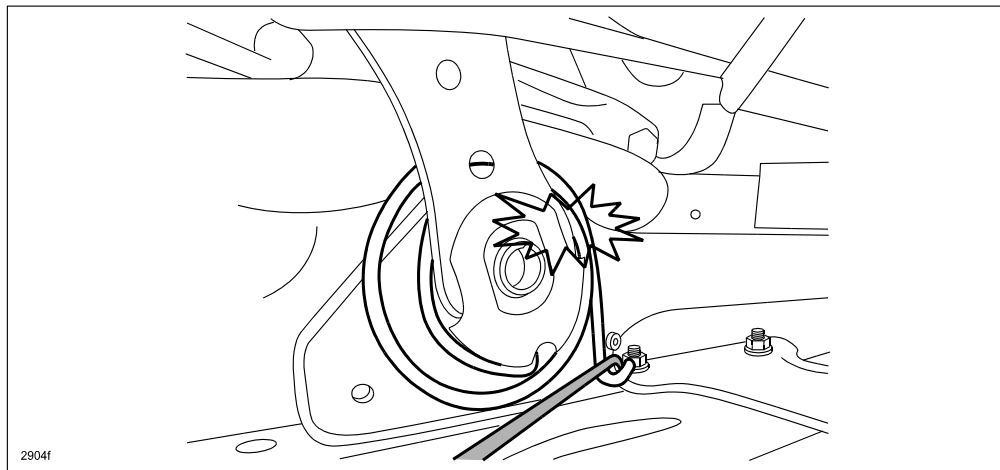
WARNING: The balance spring may jump out suddenly during removal, so keep your hands and face away from the balance spring to avoid injury.

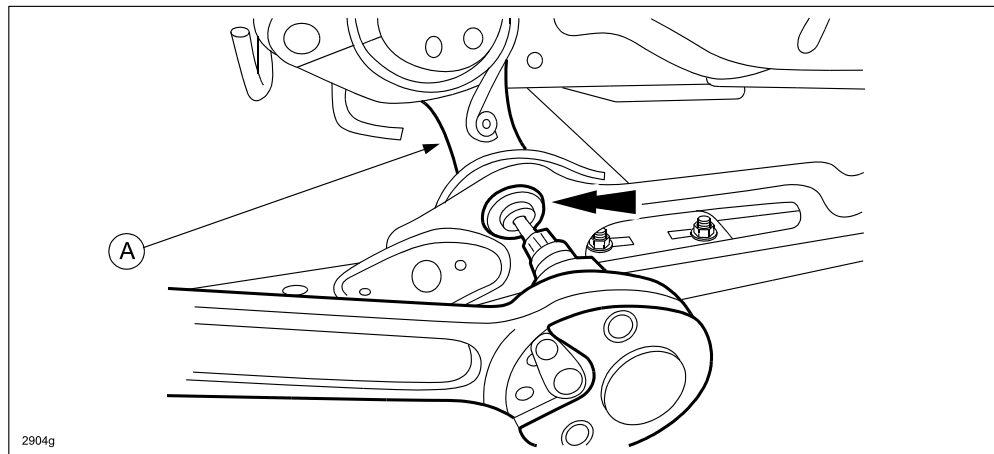
5. Repeat Steps 3 - 4 on the opposite side rear balance spring.
6. Remove four (4) Torx T30 bolts that secure each link (A).

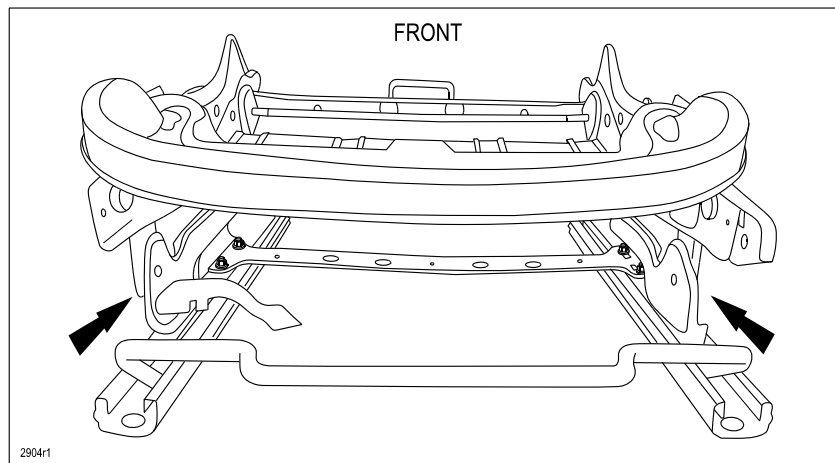
7. Move to the **FRONT** of the seat adjuster unit.

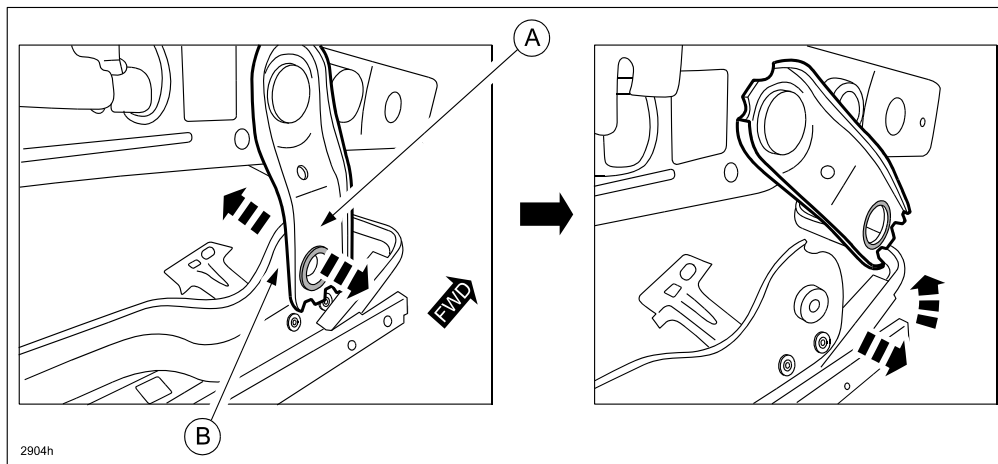
8. Detach the inner link (A) from the slider (B) by gently bending the slider outward and the link inward.

CAUTION: DO NOT bend the slider too much as it may become deformed and cause improper operation.

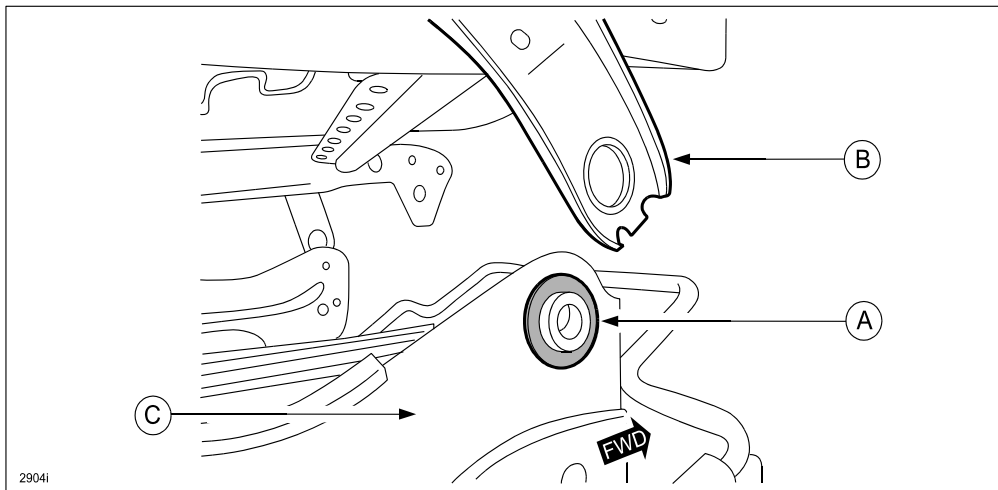
NOTE: Depending on specific production date of the vehicle, some CX-5 models may have plastic washers (A) installed between the front link (B) and the slider (C). **ALWAYS BE SURE TO RE-USE THE PLASTIC WASHERS** when installing the new seat adjuster lift unit.

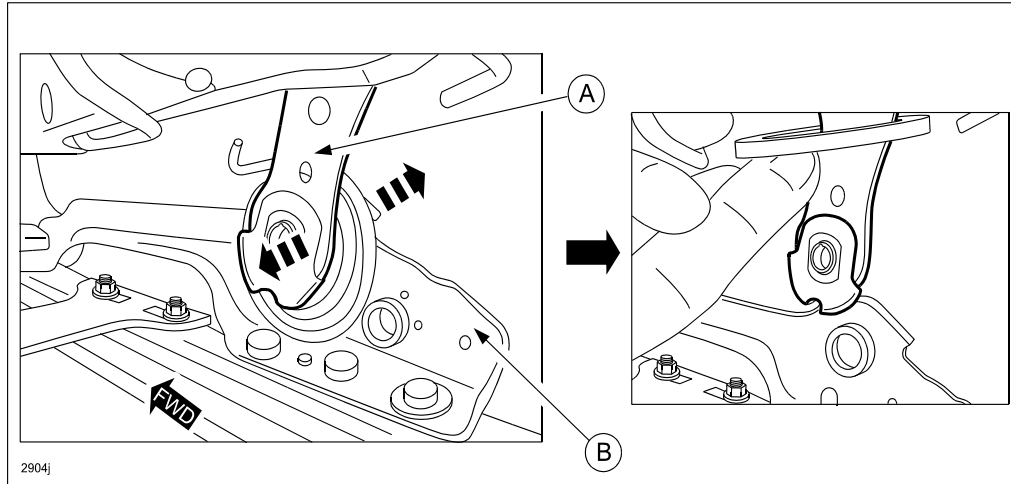
10. Move back to the **REAR** of the seat adjuster unit.
11. Detach the inner link (A) from the slider (B) by gently bending the slider outward and the link inward.

CAUTION: DO NOT bend the slider too much as it may become deformed and cause improper operation.

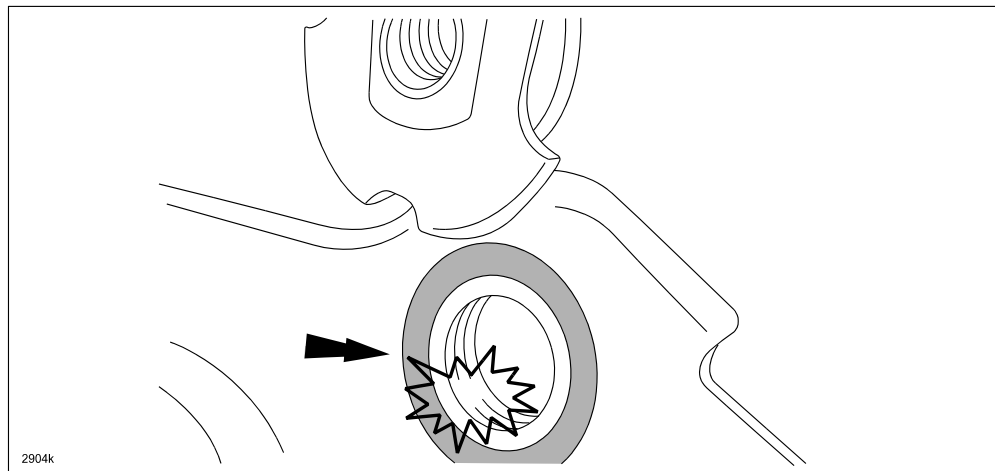
CAUTION: DO NOT damage the bushing during link removal.

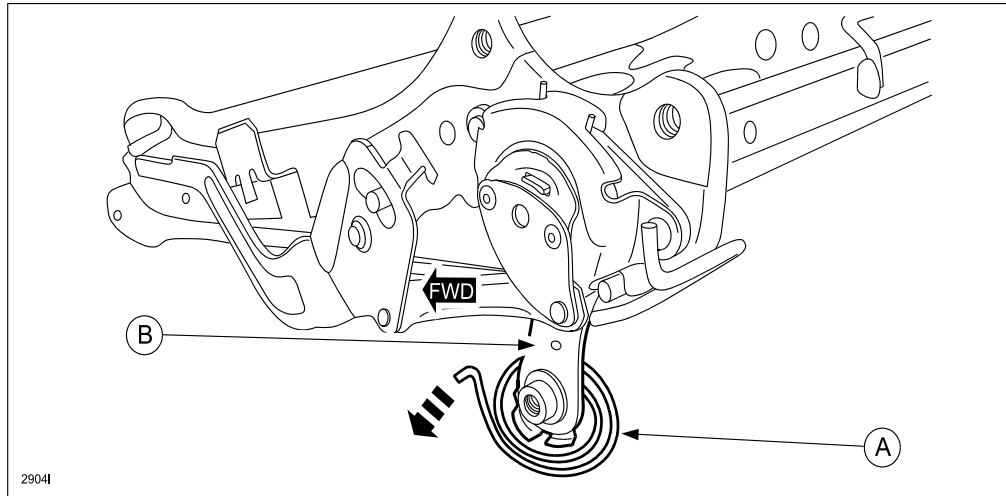
LEFT REAR:

1. Working from the **REAR** of the seat adjuster unit, place the new rear balance springs (A) around the left and right seat adjuster unit links (B).

NOTE: IT IS VERY IMPORTANT TO CORRECTLY POSITION THE NEW REAR BALANCE SPRINGS around the rear seat adjuster unit links before assembly.

NOTE: The end of each balance spring must be facing outward (as shown below).

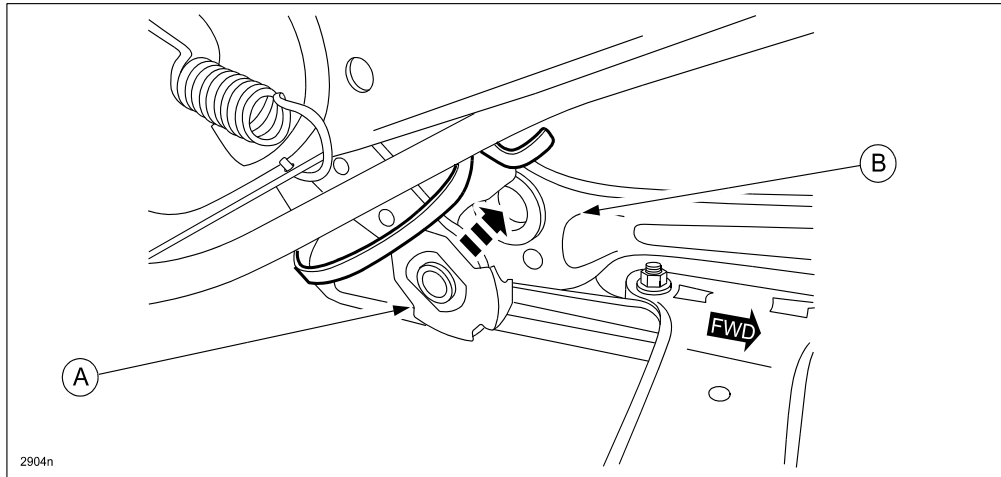
2. **Rear-Outer:** Install the link (A) onto the slider (B).

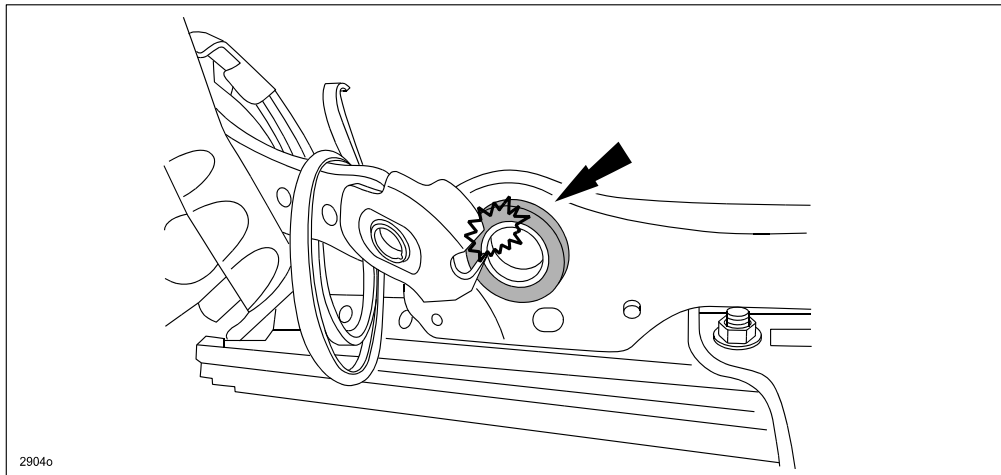
CAUTION: DO NOT damage the bushing during link installation.

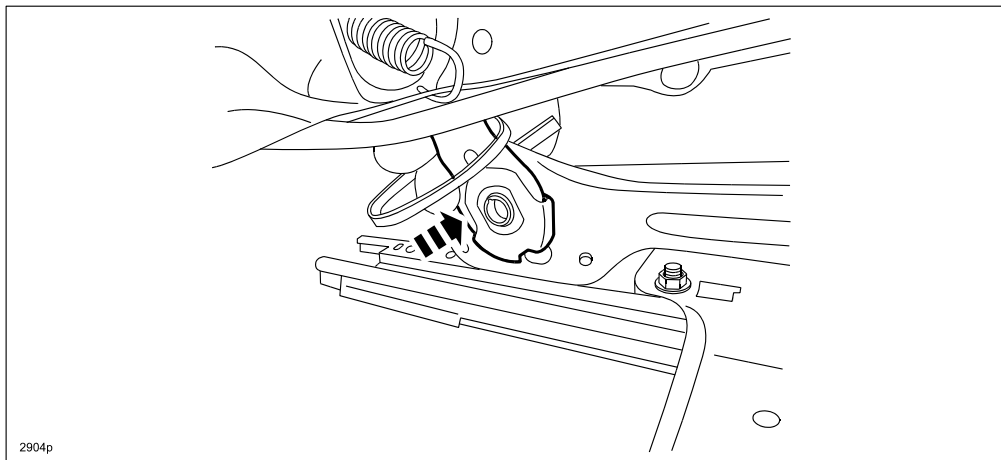
3. Push the link into proper position.

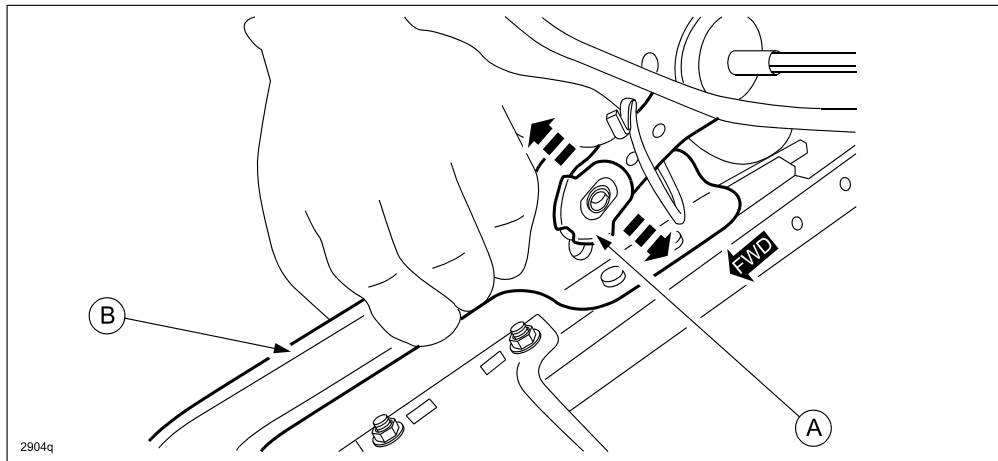
4. **Rear-Inner:** Install the link (A) onto the slider (B) while bending the slider outward and the link inward.

CAUTION: DO NOT bend the slider too much as it may become deformed and cause improper operation.

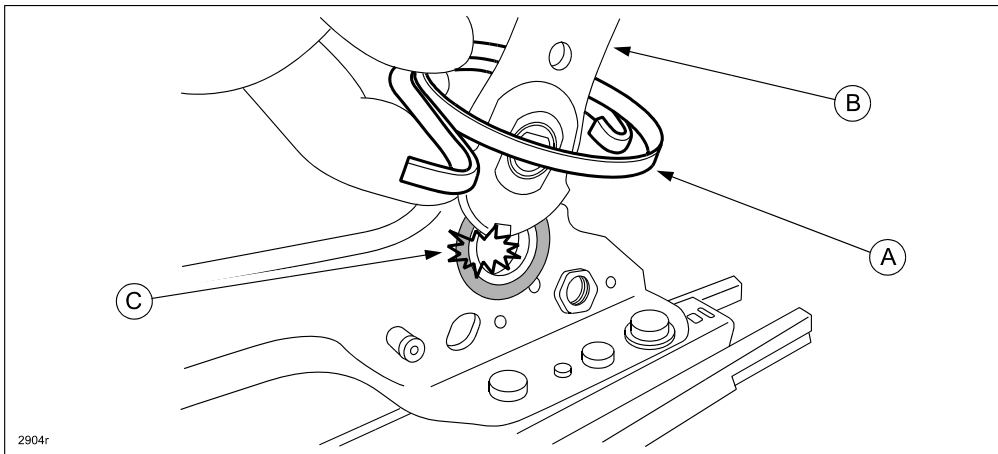
NOTE: Verify that the rear balance spring (A) has been properly positioned around the link (B).

CAUTION: DO NOT damage the bushing during link installation.

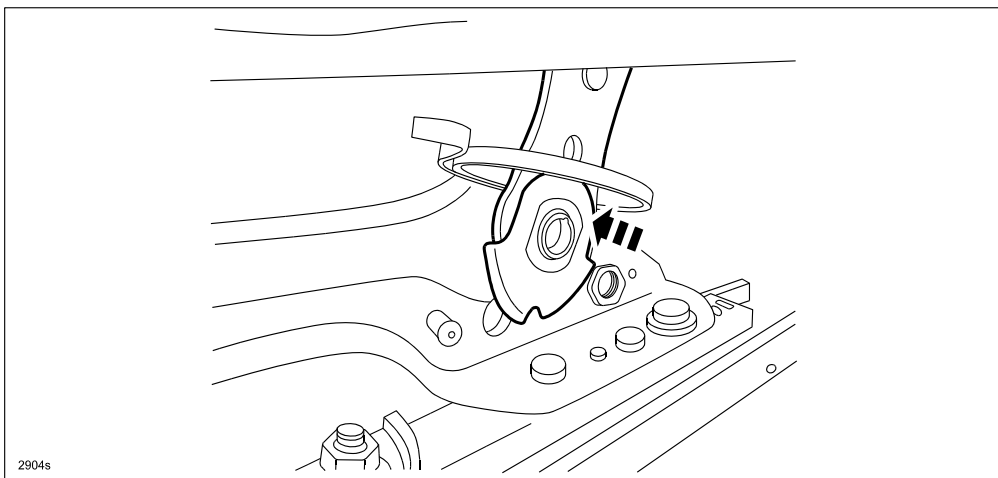
5. Push the link into proper position.

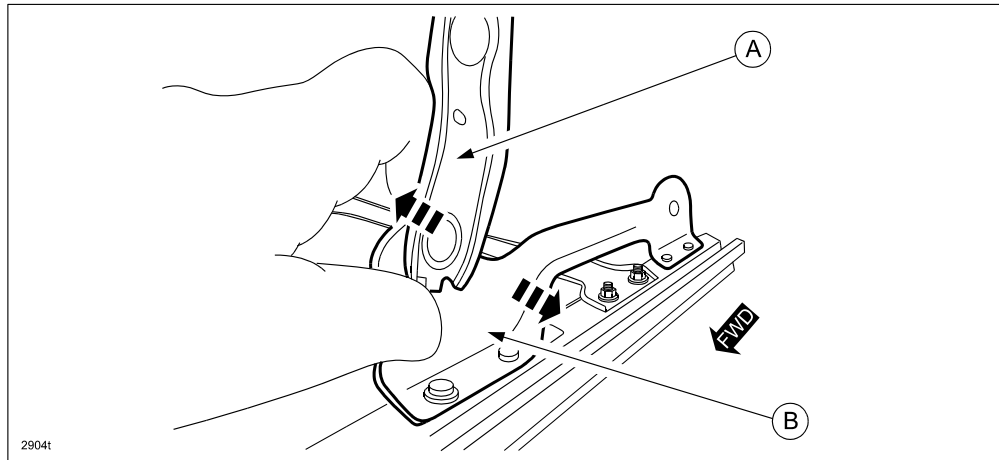
6. **Front-Outer:** Install the link (A) to the slider (B) while bending the slider inward and the link outward.

CAUTION: DO NOT bend the slider too much as it may become deformed and cause improper operation.

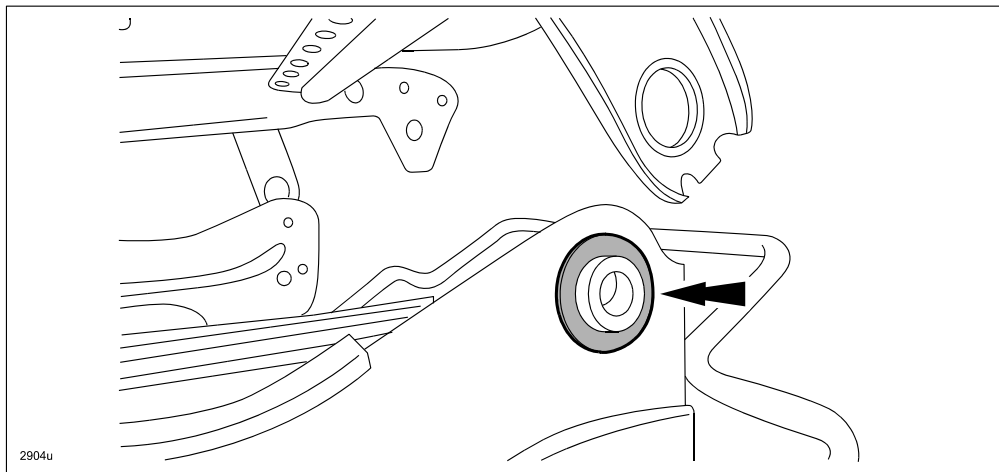
NOTE: Be sure to re-install the plastic washer if originally installed.

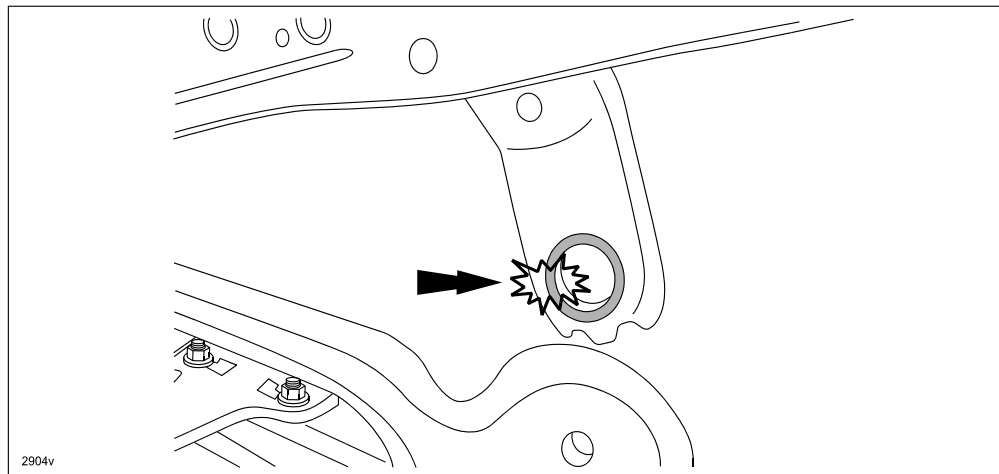
CAUTION: DO NOT damage the bushing during link installation.

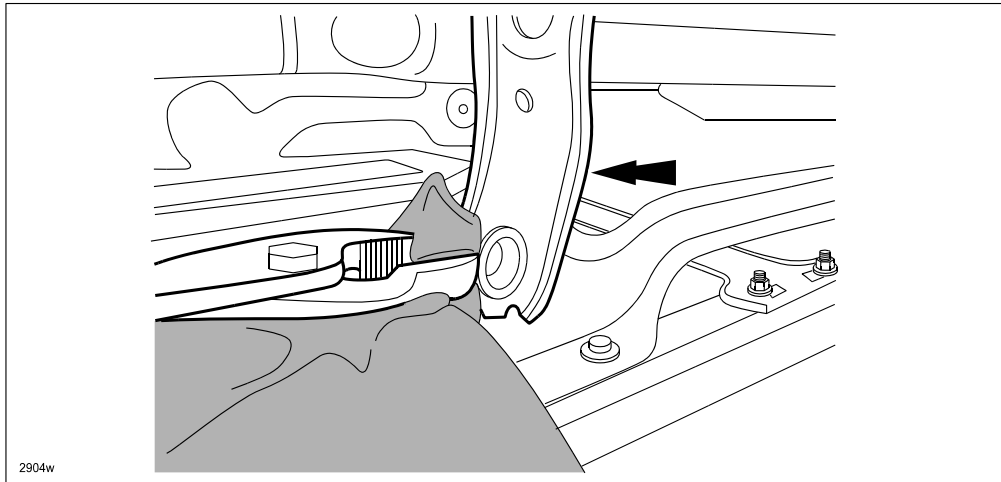
7. Install the link to the proper position using pliers and a shop rag.

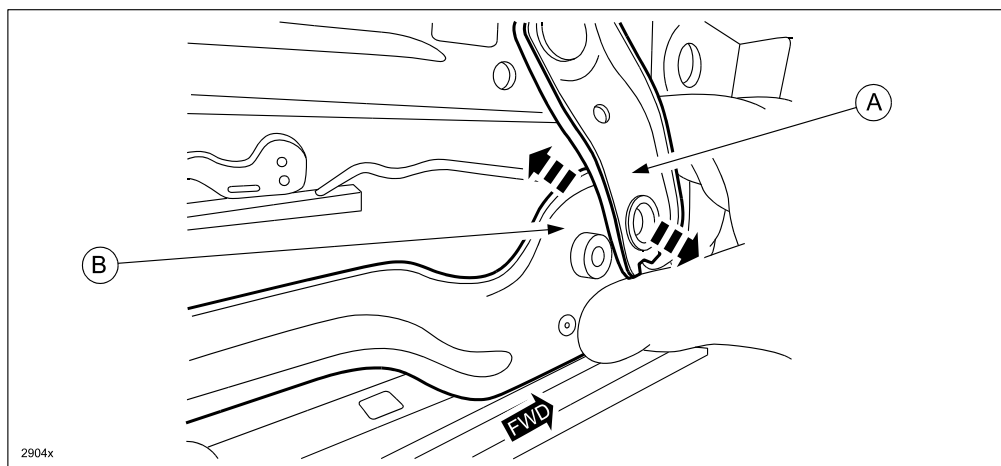
8. **Front-Inner:** Install the link (A) to the slider (B) while bending the slider inward and the link outward.

CAUTION: DO NOT bend the slider too much as it may become deformed and cause improper operation.

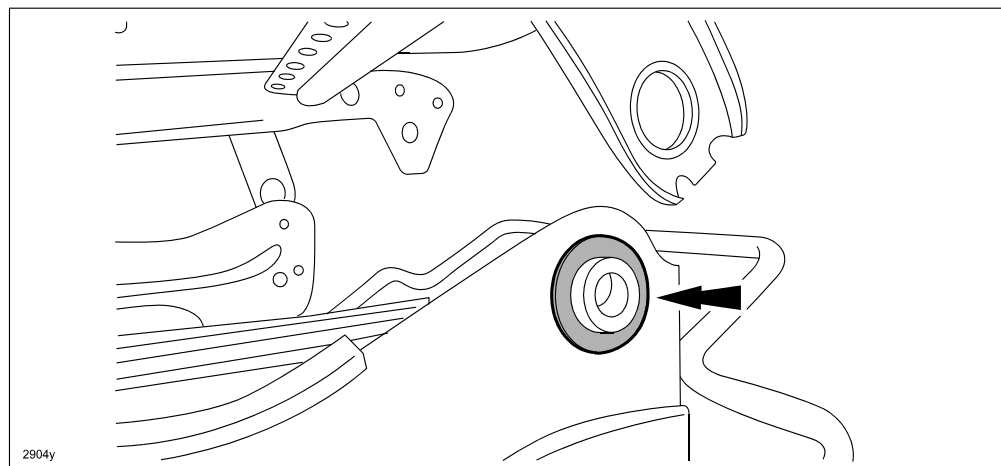
NOTE: Be sure to re-install the plastic washer if originally installed.

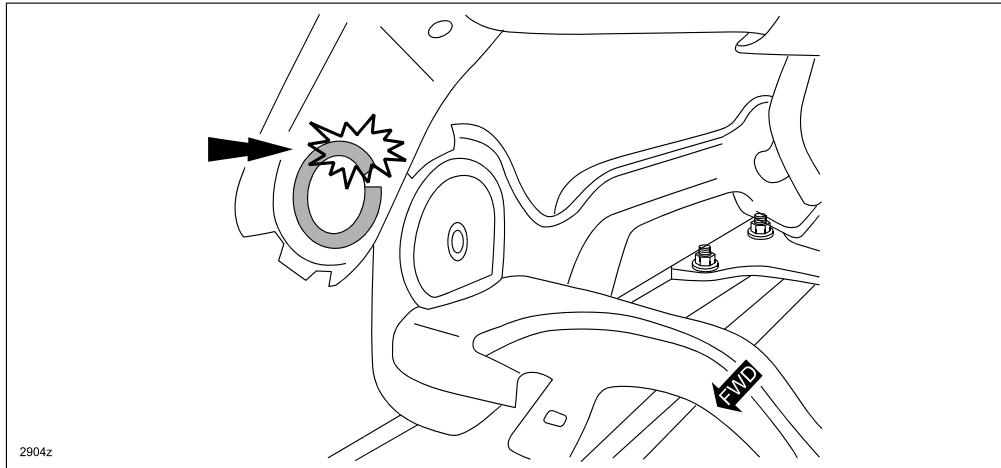
CAUTION: DO NOT damage the bushing during link installation.

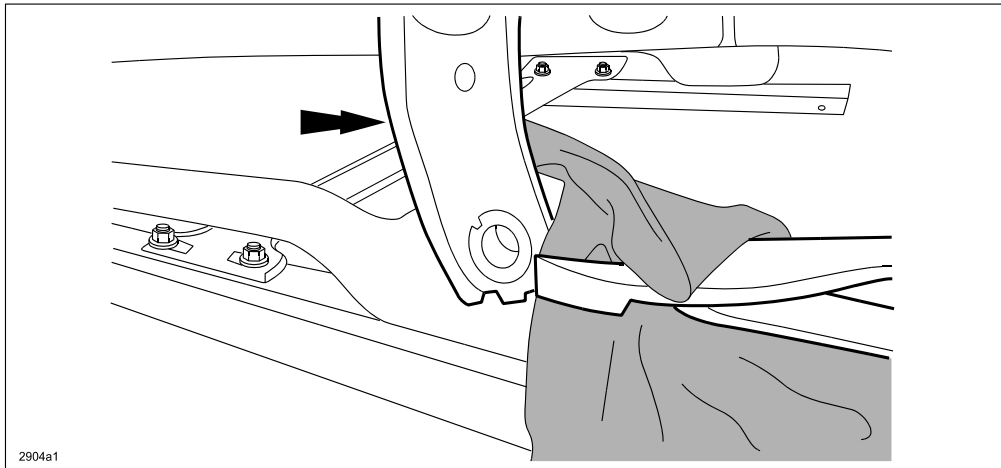
9. Install the link to the proper position using pliers and a shop rag.

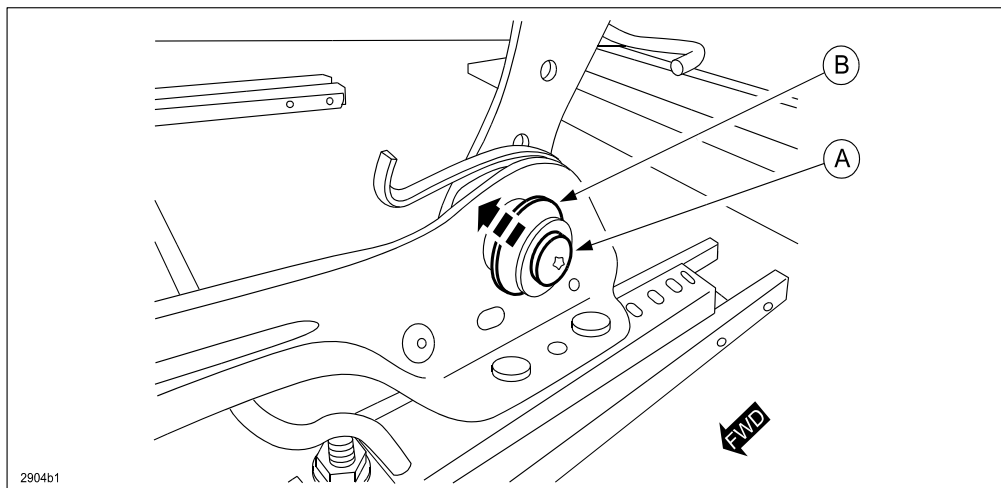
10. Tighten four (4) Torx T30 bolts to the specified torque.

Tightening Torque: (15.7 - 22.6 Nm)

REAR: Tighten bolt (A) with washer (B).

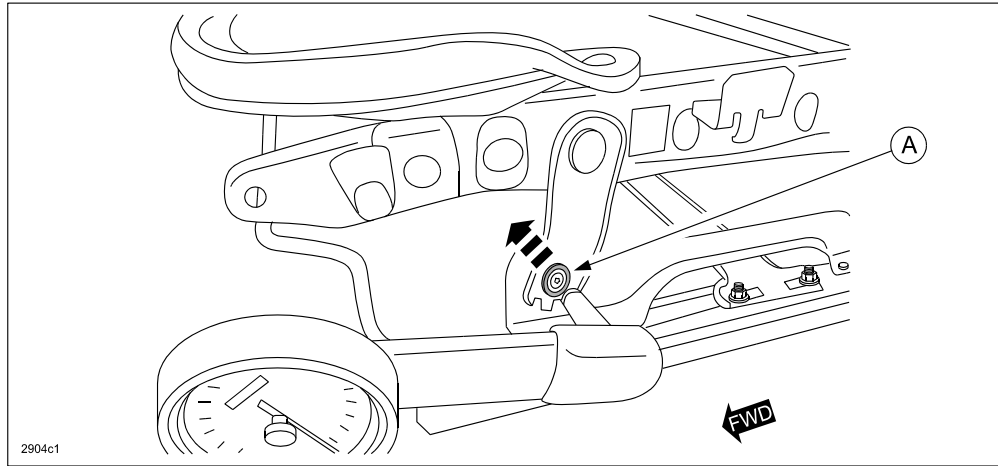
FRONT: Tighten bolt (A) without washer.

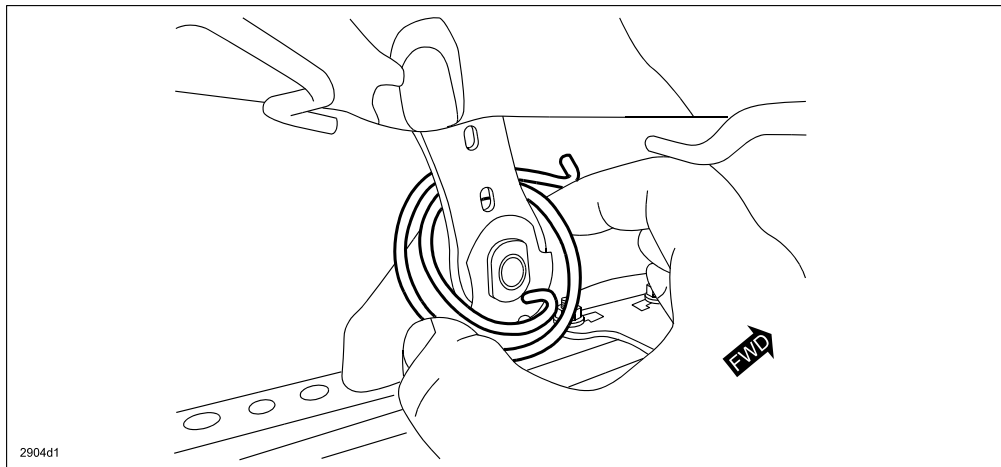
- DO NOT pinch the spring between the link and slider while tightening the bolts.
- Verify that the spring moves freely after all the bolts have been tightened.

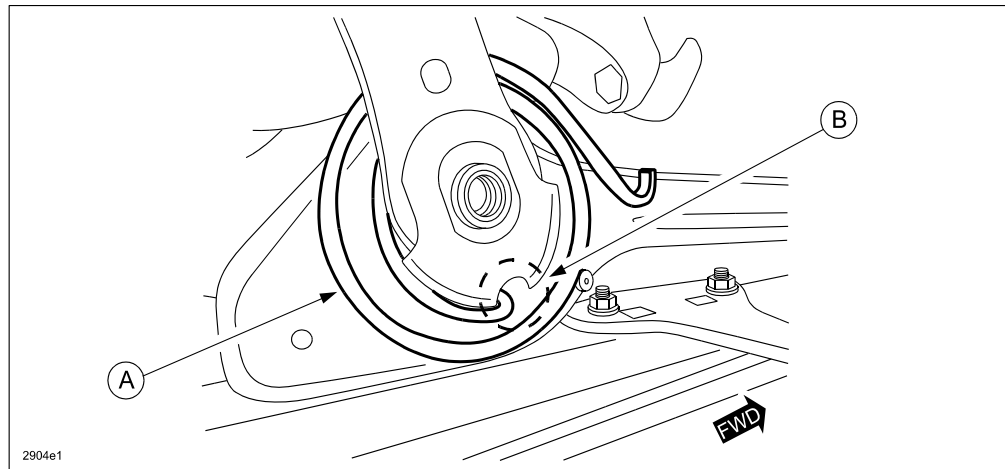
11. **OUTER-SIDE:** Install the balance spring (A) by hooking the end of the spring into the opening (B).

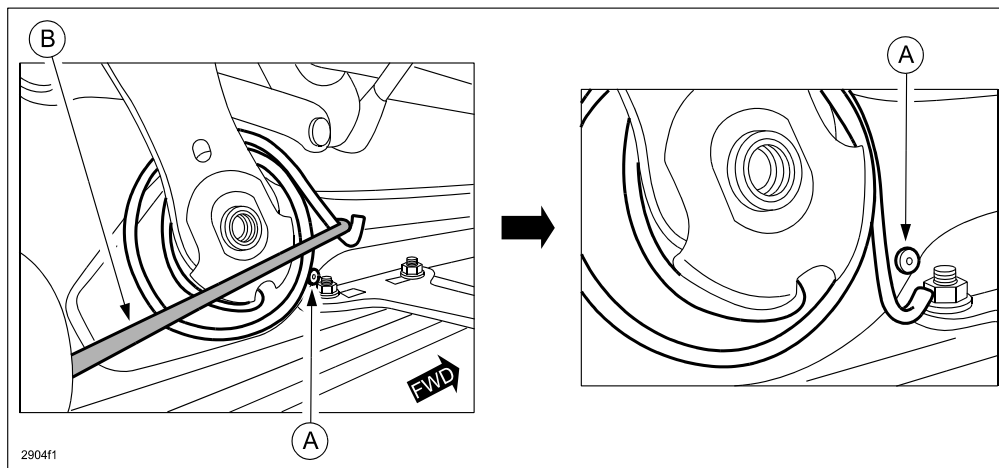
12. Hook the other end of the balance spring around the pin (A) using the hook tool (B) or with needle-nose pliers.

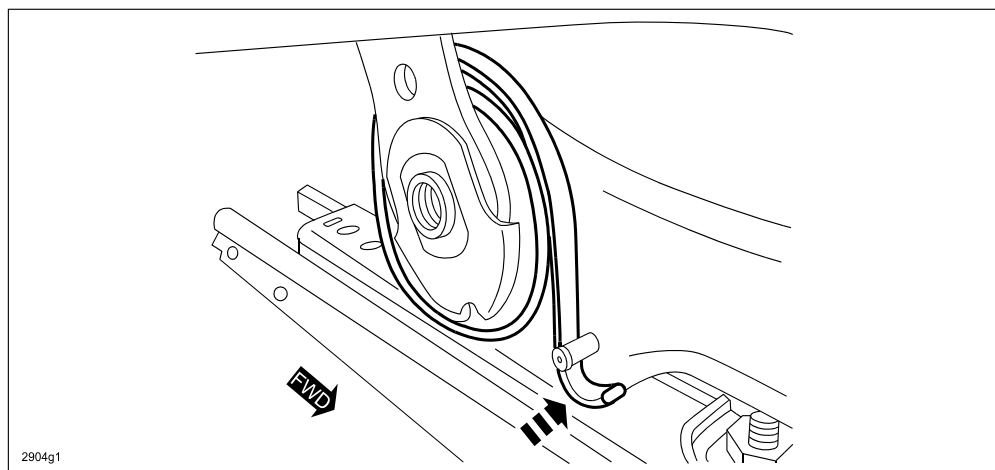
13. Remove the masking tape from the slider.
14. Push the end of the balance spring inward until it contacts the slider.

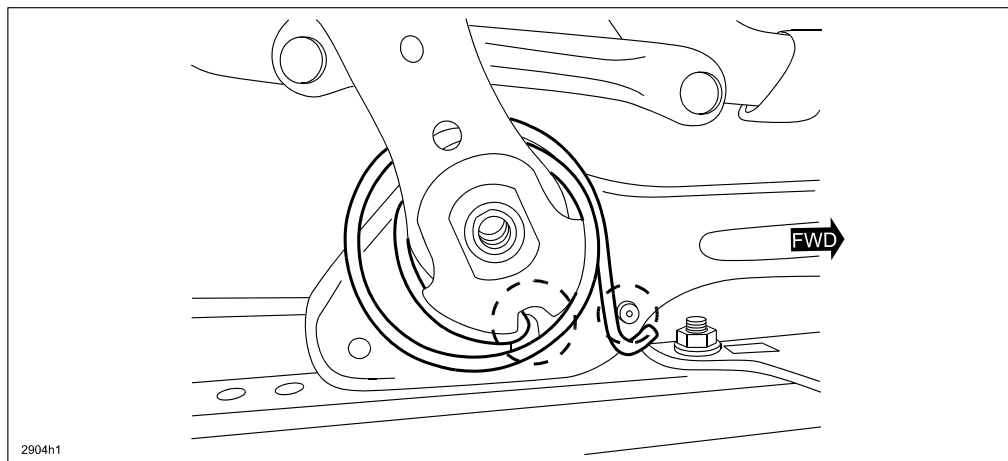
15. Verify that both ends of the balance spring are securely hooked into position.

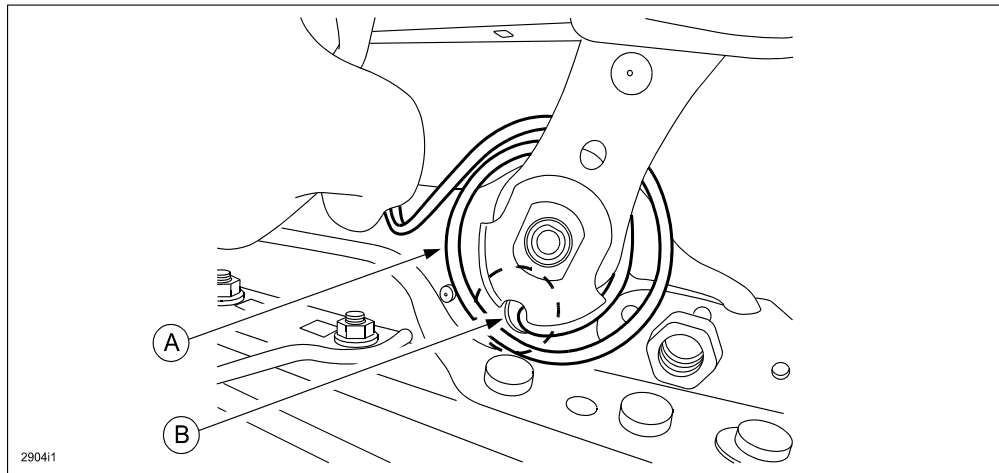
16. **INNER-SIDE:** Install the balance spring (A) by hooking the end of the spring into the opening (B).

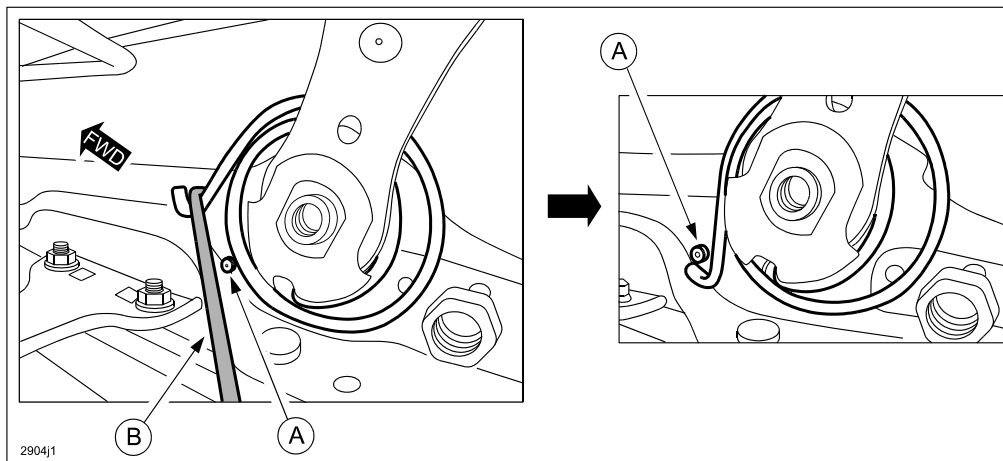
17. Hook the other end of the balance spring around the pin (A) using the hook tool (B) or with needle-nose pliers.

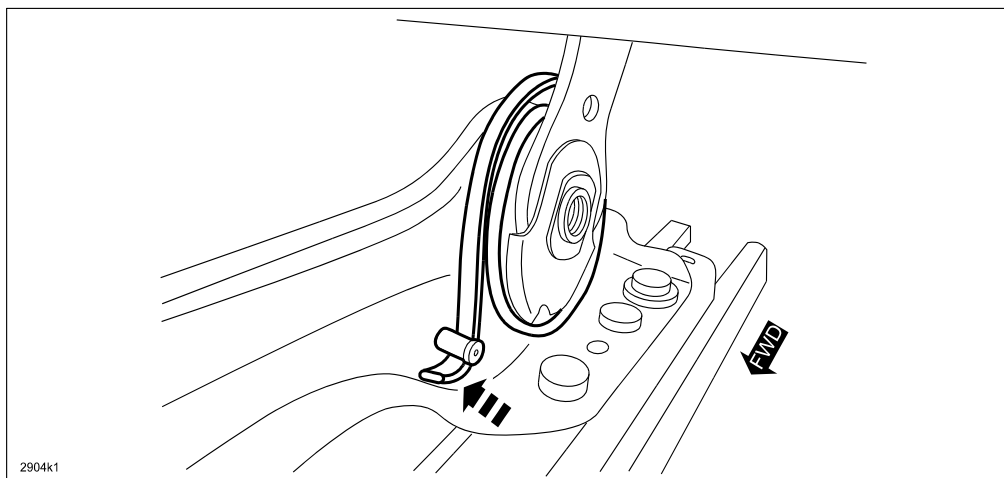
19. Push the end of the balance spring inward until it contacts the slider.

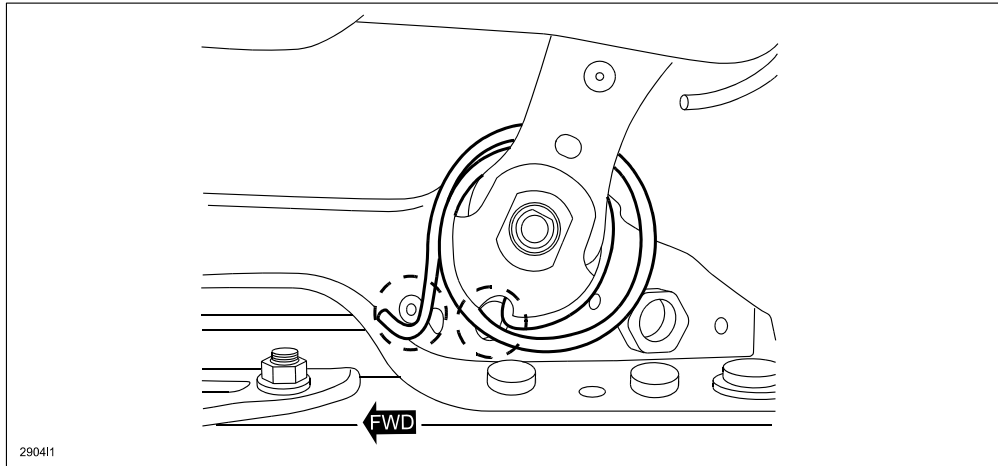
20. Verify that both ends of the balance spring are securely hooked into position.

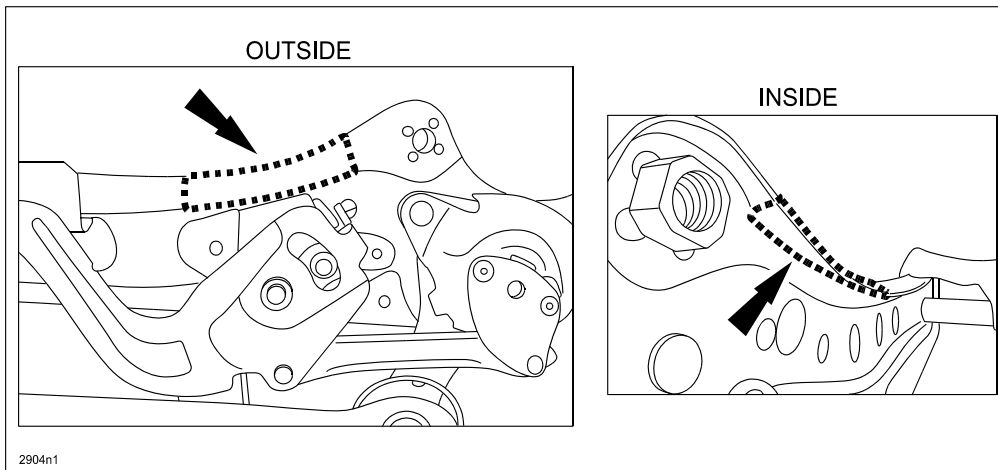
21. Degrease the upper seat frame area with a clean shop rag.

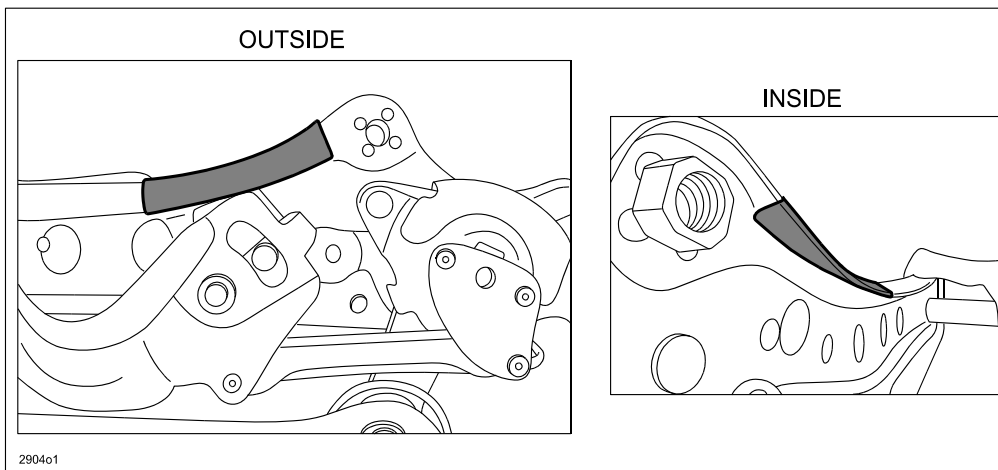
22. After degreasing the upper seat frame area, attach the piece of black tape (from kit) as shown below.

NOTE: When looking from the space between the seat cushion and the cover, the silver color of the seat lift frame is visible. By attaching the black tape to the upper frame, the silver color is covered up.
