December 19, 2015

51968-01885 Version 11

## Recall: Front Passenger's Airbag Inflator May Produce Excessive Pressure After Long-Term Exposure To High Absolute Humidity

Supersedes 14-046, dated September 16, 2015 to revise the information highlighted in yellow

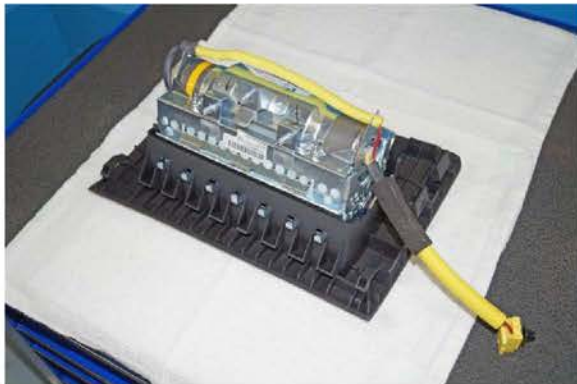
4. Place the airbag, face-down, on a clean shop towel.

- The orientation of the airbag is critical because if the inflator is installed incorrectly, the harness will be too short when you reinstall the airbag.
- The brackets between the various models are similar but may differ from the example shown.

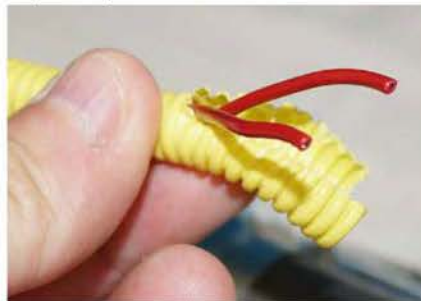
- Cut about 2 inches of the corrugated tube, then pull out the two red wires.

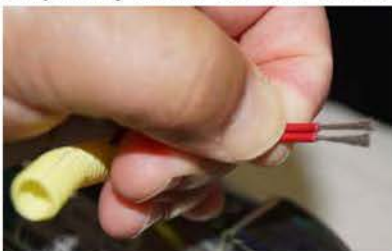
- Strip away about 1 inch of the wire insulation, then twist the wires together.

- Tape the twisted ends with electrical tape.

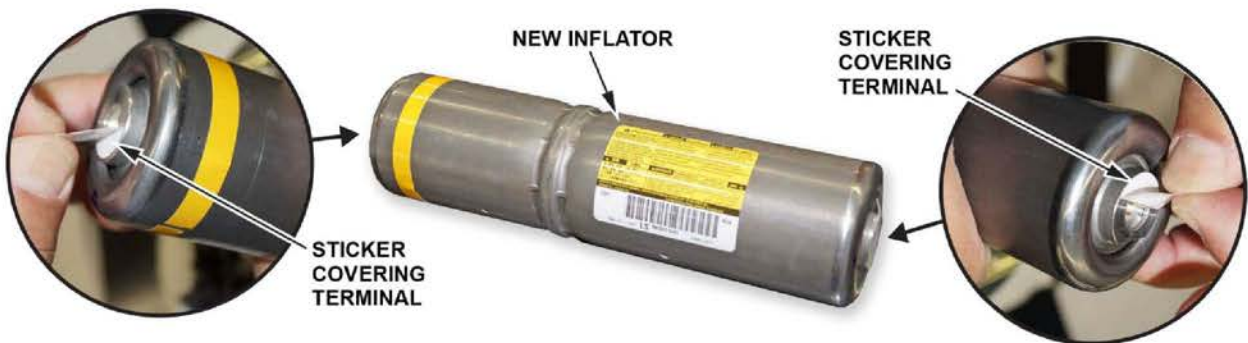
15. Remove the stickers covering the terminals on both sides of the new inflator.

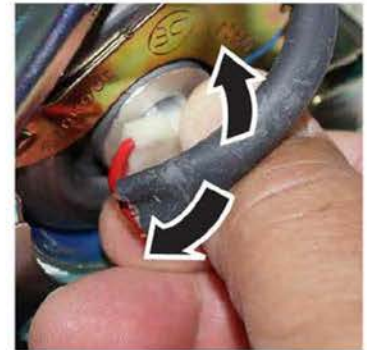
③ Wiggle the connector to make sure it's secure.

- After you hear each connector click, wiggle it to make sure it is secure.

NOTE: If the connector is not properly aligned, it will come out.
