**December 19, 2015**

00407-01886 Version 8

## **Safety Recall: Front Passenger's Airbag Inflator May Produce Excessive Pressure After Long-Term Exposure To High Absolute Humidity**

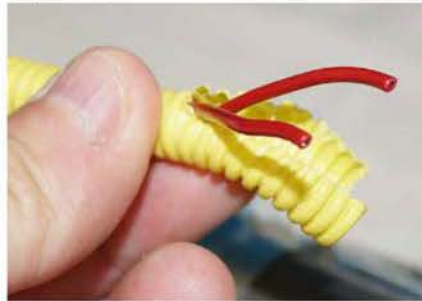
- Cut about 2 inches of the corrugated tube, then pull out the two red wires.

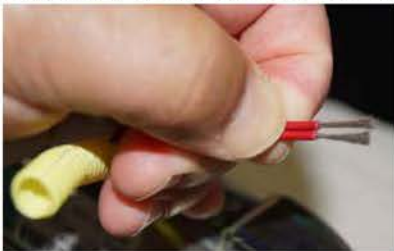
- Strip away about 1 inch of the wire insulation, then twist the wires together.

- Tape the twisted ends with electrical tape.

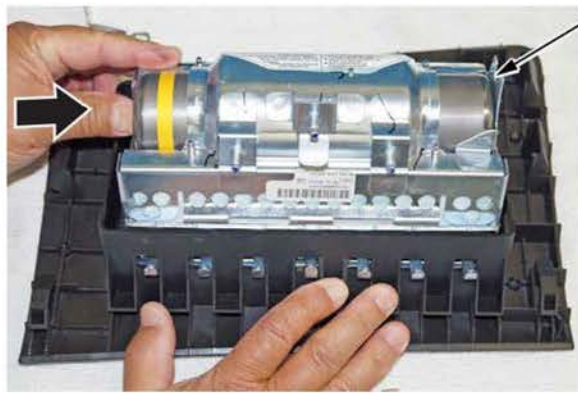
- Slide the inflator in until the "D" aligns with the tab on the inflator bracket. There should be no space or gap between the inflator and bracket.

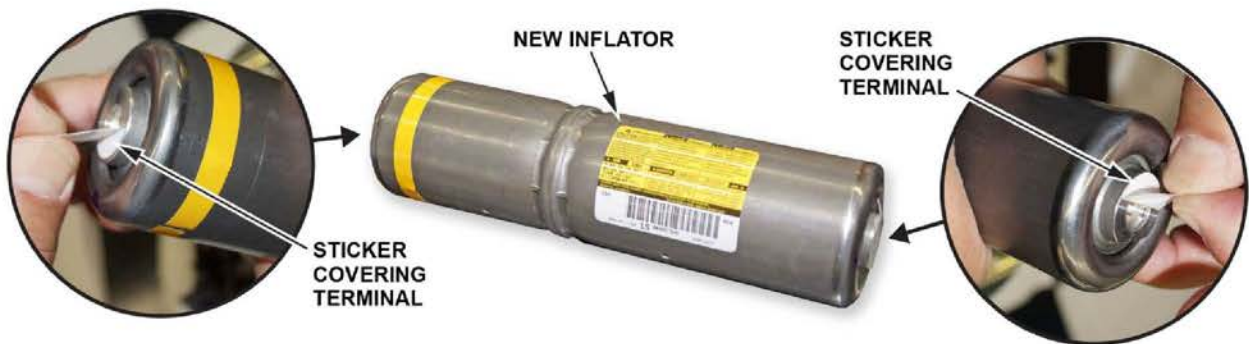
15. Remove the stickers covering the terminals on both sides of the new inflator.

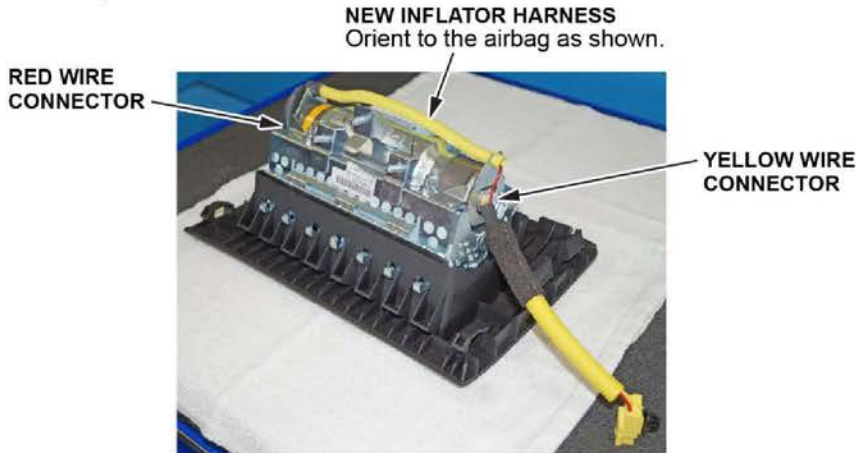
- Make sure the airbag and harness are aligned as shown.

- **Make sure you have the orientation correct as shown below.** If you connect the harness incorrectly, the harness cannot be removed, and you will not be able to reinstall the airbag because the harness will be too short.
- On the replacement inflators with plastic collars, connect the red wire connector to the connector with the red dot.
- On the replacement inflators without plastic collars, connect the red wire connector to the connector nearest the yellow band.

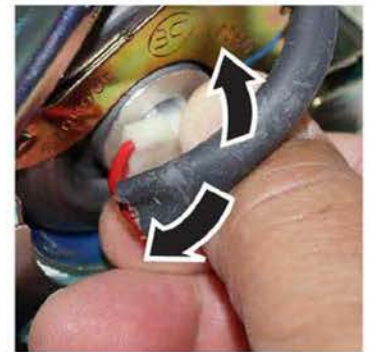
③ Wiggle the connector to make sure it's secure.

- After you hear each connector click, wiggle it to make sure it is secure.

NOTE: If the connector is not properly aligned, it will come out.
