December 22, 2015

00406-01910 Version 5

Safety Recall: Front Passenger's Airbag Inflator May Produce Excessive Pressure After Long-Term Exposure To High Absolute Humidity

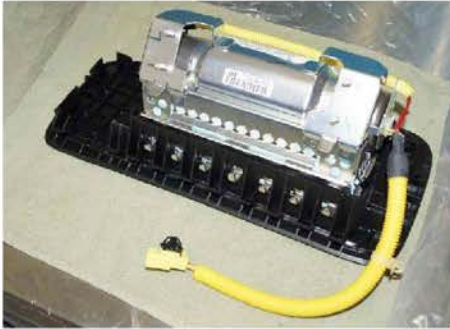
3. Remove the front passenger's airbag by referring to the applicable electronic service manual.
 4. Place the airbag face-down on a clean shop towel as shown.

- The orientation of the airbag is critical because if the inflator is installed incorrectly, the harness will be too short when you reinstall the airbag.
- The brackets between the various models are similar but may differ from the example shown.

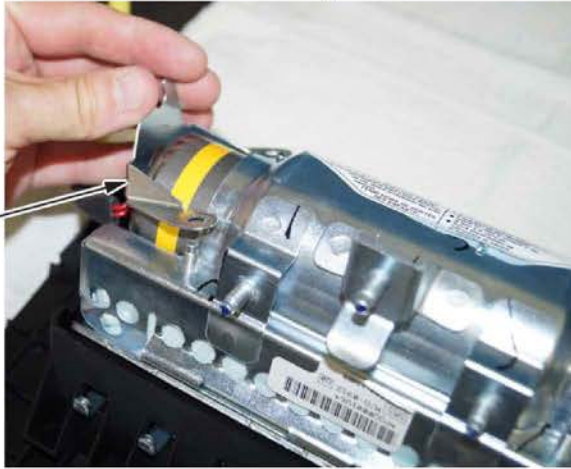
INFLATOR BRACKET

11. Remove the inflator bracket.

NOTE: You can only remove one of the brackets, as the other is welded to the airbag housing.

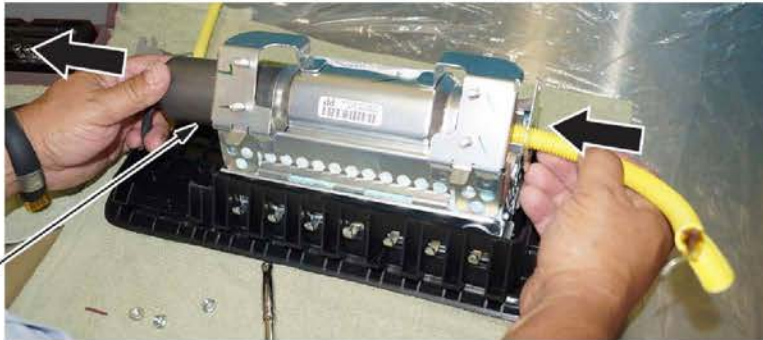
12. Remove the inflator by pushing it out.

INFLATOR
Do not reuse.
